Submitted by:  
AECOM  
Fort Collins, CO  
60635022  
January 17, 2024

# Basin Electric Power Cooperative Antelope Valley Station

## Coal Combustion Residual Landfill Annual Inspection Report – 2023

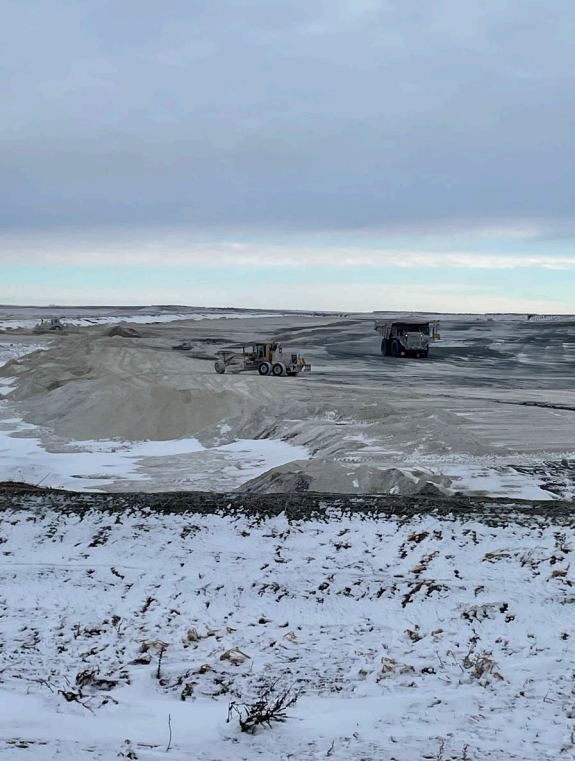
<b>Client Name:</b> Basin Electric Power Cooperative		<b>Site Location:</b> Antelope Valley Station, Beulah, ND	<b>Project No.:</b> 60635022
<b>Photo No.</b> <b>2</b>	<b>Date:</b> 12/12/23

<b>Direction Photo Taken:</b>  East			
<b>Description:</b>  <u>Location:</u> See Figure  Placement of ash in new landfill cell

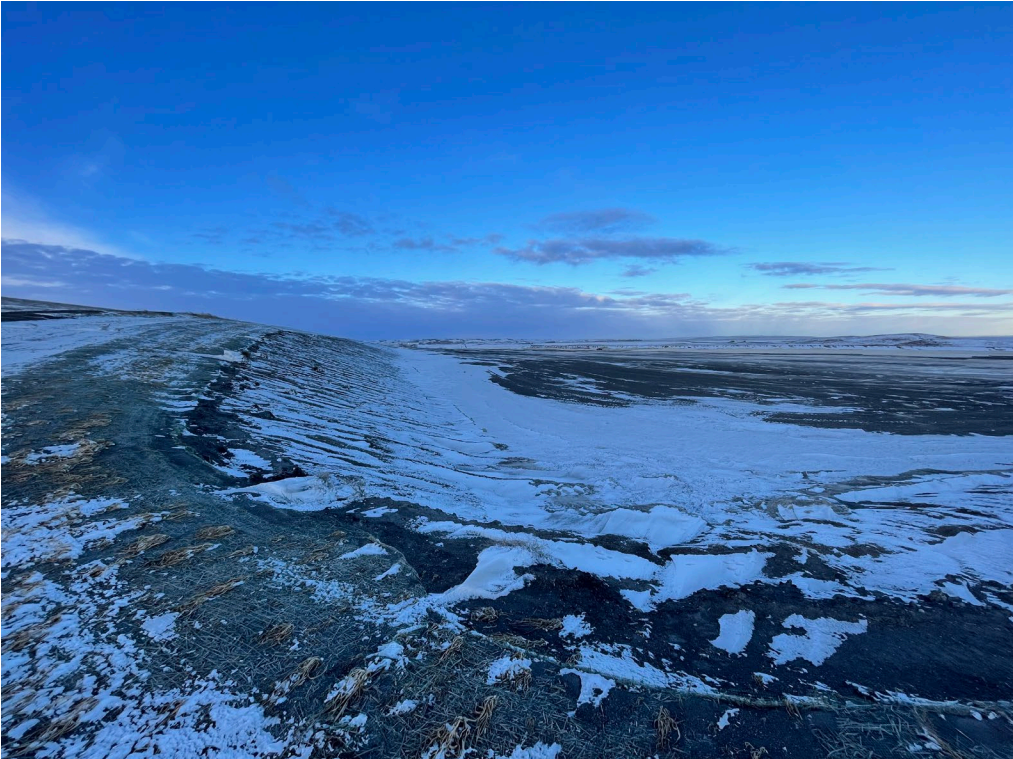
<b>Client Name:</b> Basin Electric Power Cooperative		<b>Site Location:</b> Antelope Valley Station, Beulah, ND	<b>Project No.:</b> 60635022
<b>Photo No.</b> <b>7</b>	<b>Date:</b> 12/12/23

<b>Direction Photo Taken:</b>  Northwest			
<b>Description:</b>  <u>Location:</u> See Figure  New landfill cell
