Submitted to:
Basin Electric Power Cooperative
Laramie River Station
Wheatland, WY

Submitted by:
AECOM
Fort Collins, CO
60732883
January 17, 2025

Basin Electric Power Cooperative Laramie River Station

Coal Combustion Residual Surface Impoundment Annual Inspection Report – 2024

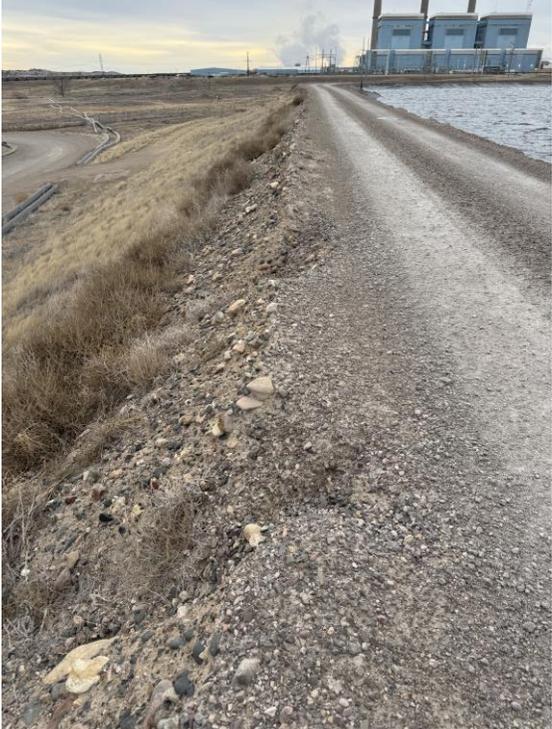
Client Name: Basin Electric Power Cooperative		Site Location: Laramie River Station, Wheatland, WY	Project No. 60732883
Photo No. 1	Date: 12/17/24

While no issues are significant and would impact the structural or containment integrity, Minor erosion, including divots and rills, was noted alongside the northern and eastern sides of BAP-1 (**Attachment C – Photo 1** and **Photo 4**), in addition to the southern and eastern sides of BAP-2 (**Attachment C – Photo 20**, **Photo 23**, and **Photo 25**). Overall, vegetation cover was good and well-distributed along the berms of the BAPs. However, it was observed that vegetation is slightly thinning and there is a large shrub (yucca plant) growing along the northern capped cell of BAP-3 (**Attachment C – Photo 11** and **Photo 22**). The shrub is planned for removed in 2025. The liners of the BAPs all appeared to be in good condition and no damage was observed. Minor sediment buildup on the liners along the southern sides of BAP-1, BAP-2, and BAP-3 was noted (**Attachment C – Photo 12**, **Photo 19**, and **Photo 28**). Additionally, small, not fully formed folds were observed in the pond liner alongside the northern side of BAP-1 (**Attachment C – Photo 2**) and should be monitored. It was also observed that the surface outfall piping into BAP-3 appeared to have a small leak that was contained within the lined pond footprint but should be monitored for changes (**Attachment C – Photo 26**). The area of the landfill where the material from the W-EHP is being placed (**Attachment C – Photo 16**) appears to be blowing into BAP-2 and may be responsible for the debris buildup noted within the pond (**Attachment C – Photo 13**). No releases were identified during inspection.

Direction Photo Taken: East			
Description: <u>Location:</u> northern side of Bottom Ash Pond (BAP)-1 Erosion rills are present along the northern side of the road.

While no issues are significant and would impact the structural or containment integrity, based on the observations noted during the annual inspections, it is recommended that LRS staff address the minor erosion and desiccation cracking present alongside BAP-1 and BAP-2. In addition, it is recommended that the large shrub be removed from the northern capped berm of BAP-3 (**Attachment C – Photo 22**). The outfall piping into BAP-3 should be inspected by maintenance personnel to ensure the leak will remain as minor and not pose any future problems. Sediment buildup noted on the liners, debris buildup within BAP-2, animal burrows, and the areas of thinning vegetation should be monitored. The liner sticking up in the northwest corner of E-EHP should be repaired (LRS indicated that it will be monitored and is scheduled for repair in summer 2025) (**Attachment C – Photo 33**).

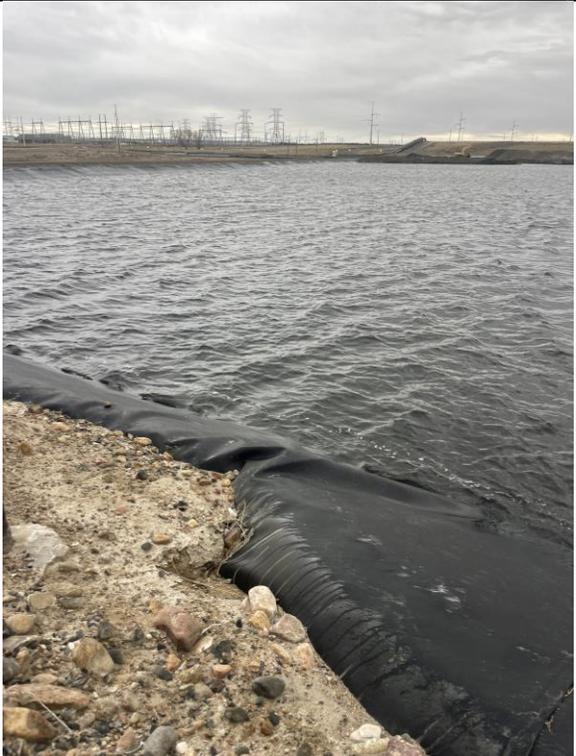
Client Name: Basin Electric Power Cooperative		Site Location: Laramie River Station, Wheatland, WY	Project No. 60732883
Photo No. 2	Date: 12/17/24

Direction Photo Taken: Southeast			
Description: <u>Location:</u> Northern side of BAP-1 Folds in pond liner that are not fully formed.

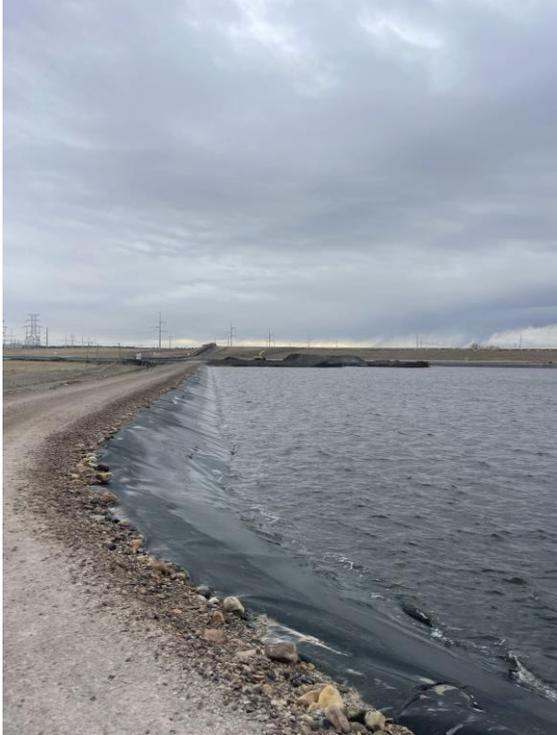
Client Name: Basin Electric Power Cooperative		Site Location: Laramie River Station, Wheatland, WY	Project No. 60732883
Photo No. 3	Date: 12/17/24

Direction Photo Taken: Southeast			
Description: <u>Location:</u> Northeast corner of BAP-1 Eastern side of BAP-1.

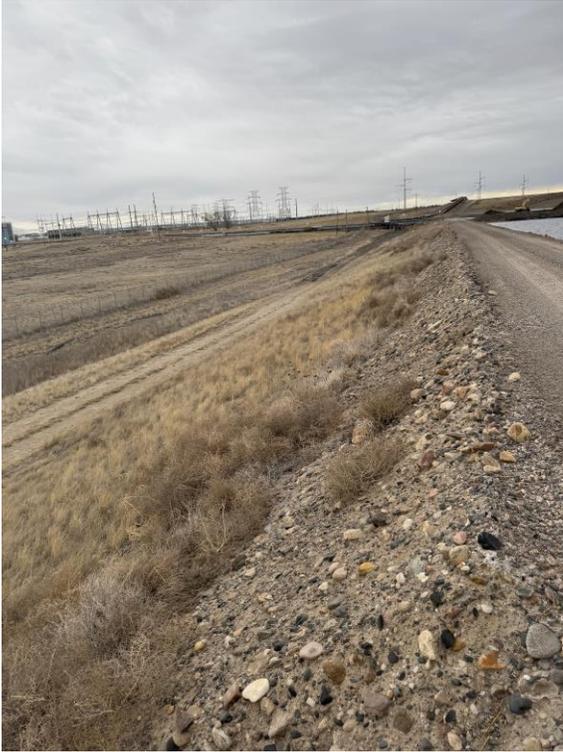
Client Name: Basin Electric Power Cooperative		Site Location: Laramie River Station, Wheatland, WY	Project No. 60732883
Photo No. 4	Date: 12/17/24

Direction Photo Taken: Southeast			
Description: <u>Location:</u> Northeast corner of BAP-1 Vegetation along the eastern berm of BAP-1.

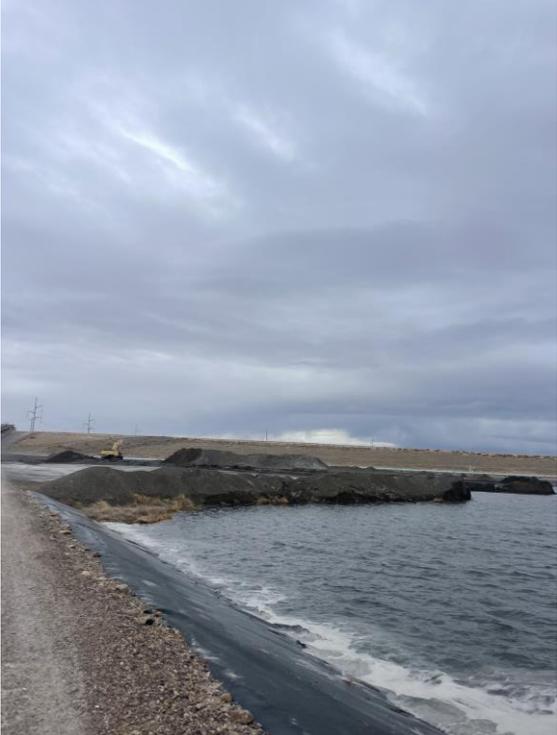
Client Name: Basin Electric Power Cooperative		Site Location: Laramie River Station, Wheatland, WY	Project No. 60732883
Photo No. 5	Date: 12/17/24

Direction Photo Taken: Southeast			
Description: <u>Location:</u> Southeast corner of BAP-1. CCR sediment build-up from outfall within the southeast corner of BAP-1.

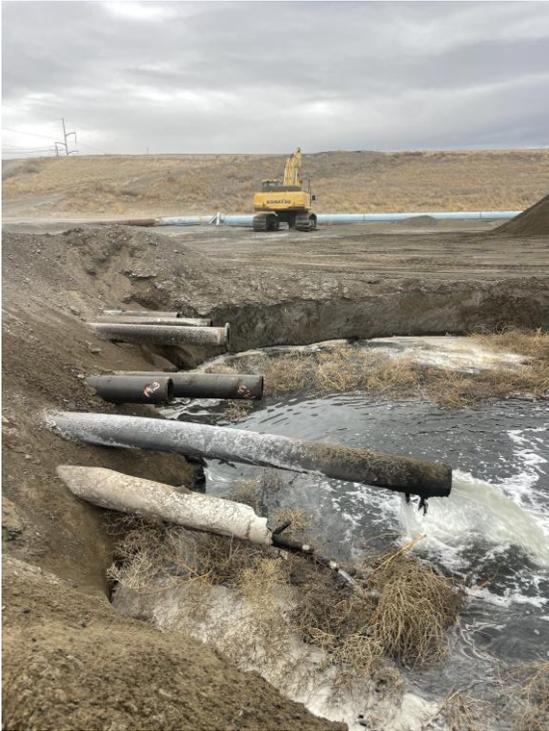
Client Name: Basin Electric Power Cooperative		Site Location: Laramie River Station, Wheatland, WY	Project No. 60732883
Photo No. 6	Date: 12/17/24

Direction Photo Taken: Southeast			
Description: <u>Location:</u> Southeast corner of BAP-1 Water inlets of BAP-1.

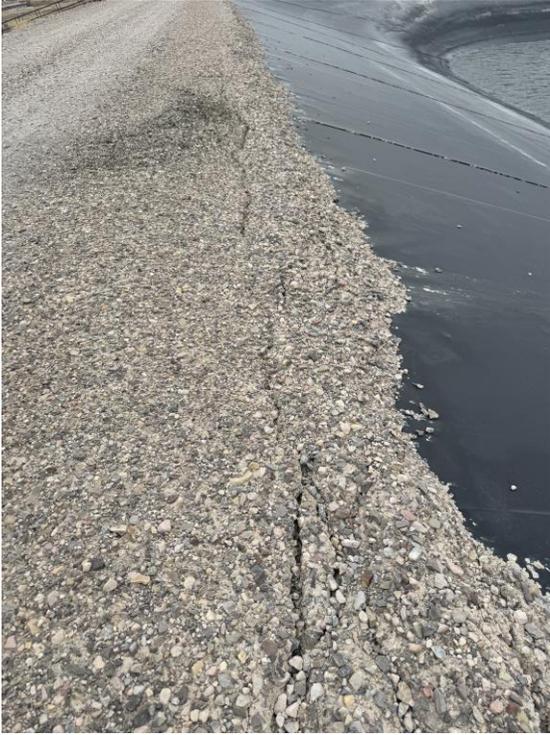
Client Name: Basin Electric Power Cooperative		Site Location: Laramie River Station, Wheatland, WY		Project No. 60732883
Photo No. 7	Date: 12/17/24

Direction Photo Taken: West				
Description: <u>Location:</u> Southern side of BAP-1 Minor desiccation cracking in the roadway along southern side of BAP-1.

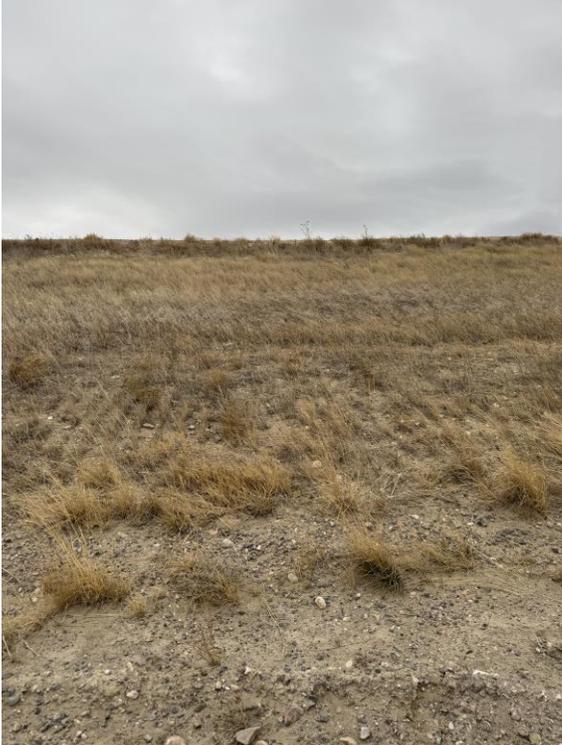
Client Name: Basin Electric Power Cooperative		Site Location: Laramie River Station, Wheatland, WY		Project No. 60732883
Photo No. 8	Date: 12/17/24

Direction Photo Taken: South				
Description: <u>Location:</u> Northern side of BAP-3. Vegetation along capped berm of BAP-3.

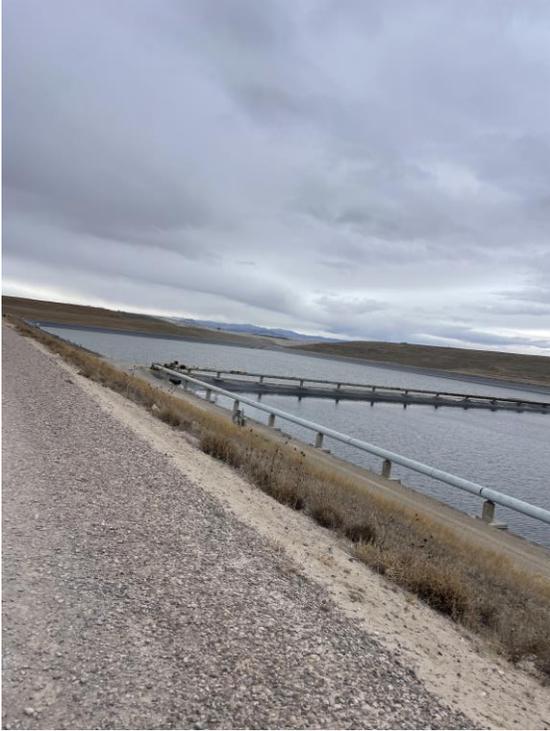
Client Name: Basin Electric Power Cooperative		Site Location: Laramie River Station, Wheatland, WY	Project No. 60732883
Photo No. 9	Date: 12/17/24

Direction Photo Taken: Northeast			
Description: <u>Location:</u> Southern side of BAP-1 Vegetation along southern side of BAP-1.

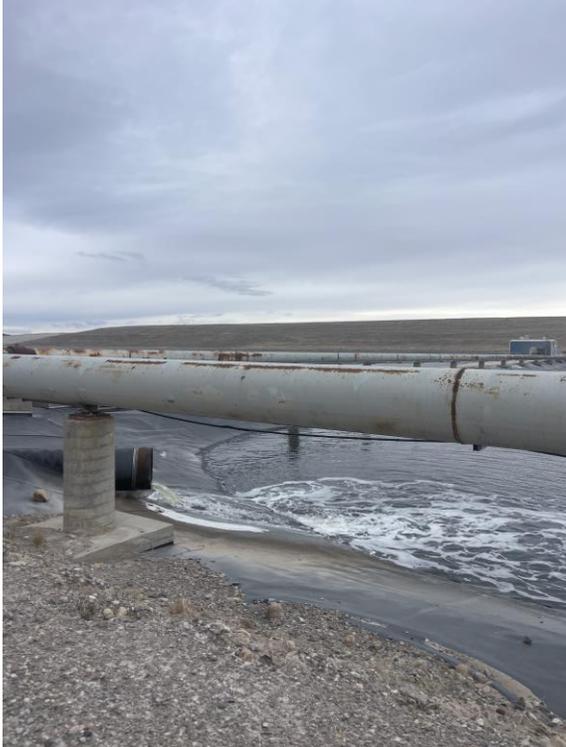
Client Name: Basin Electric Power Cooperative		Site Location: Laramie River Station, Wheatland, WY	Project No. 60732883
Photo No. 10	Date: 12/17/24

Direction Photo Taken: Northeast			
Description: <u>Location:</u> Southwest corner of BAP-1 Outfall into BAP-1.

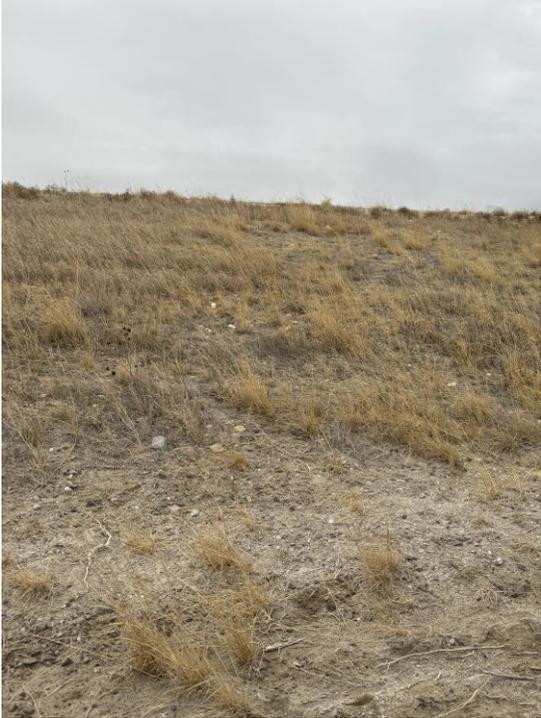
Client Name: Basin Electric Power Cooperative		Site Location: Laramie River Station, Wheatland, WY	Project No. 60732883
Photo No. 11	Date: 12/17/24

Direction Photo Taken: South			
Description: <u>Location:</u> Southwest corner of BAP-1. Slightly thinning vegetation along capped berm of BAP-3.

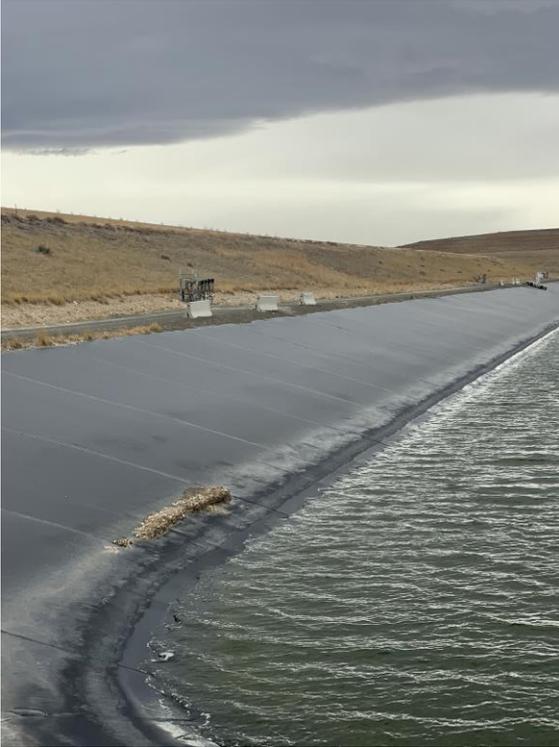
Client Name: Basin Electric Power Cooperative		Site Location: Laramie River Station, Wheatland, WY	Project No. 60732883
Photo No. 12	Date: 12/17/24

Direction Photo Taken: North			
Description: <u>Location:</u> Southeast corner of BAP-2 Slight sediment buildup on liner of BAP-2.

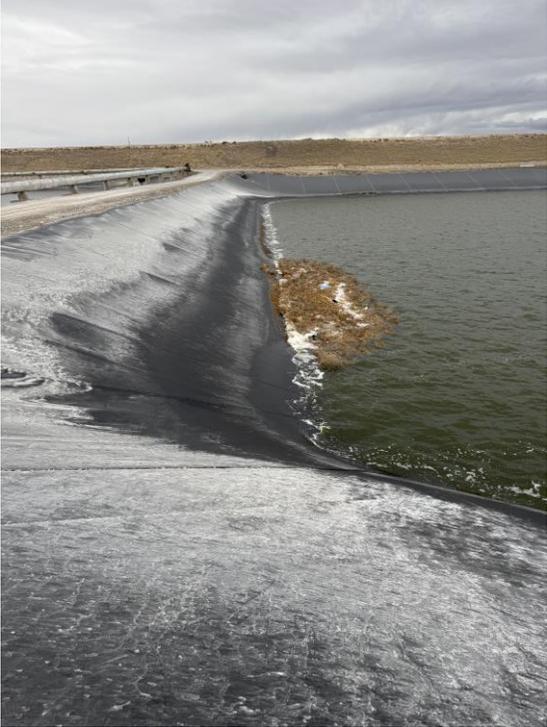
Client Name: Basin Electric Power Cooperative		Site Location: Laramie River Station, Wheatland, WY	Project No. 60732883
Photo No. 13	Date: 12/17/24

Direction Photo Taken: South			
Description: <u>Location:</u> Eastern side of BAP-2. Tumbleweed buildup in BAP-2.

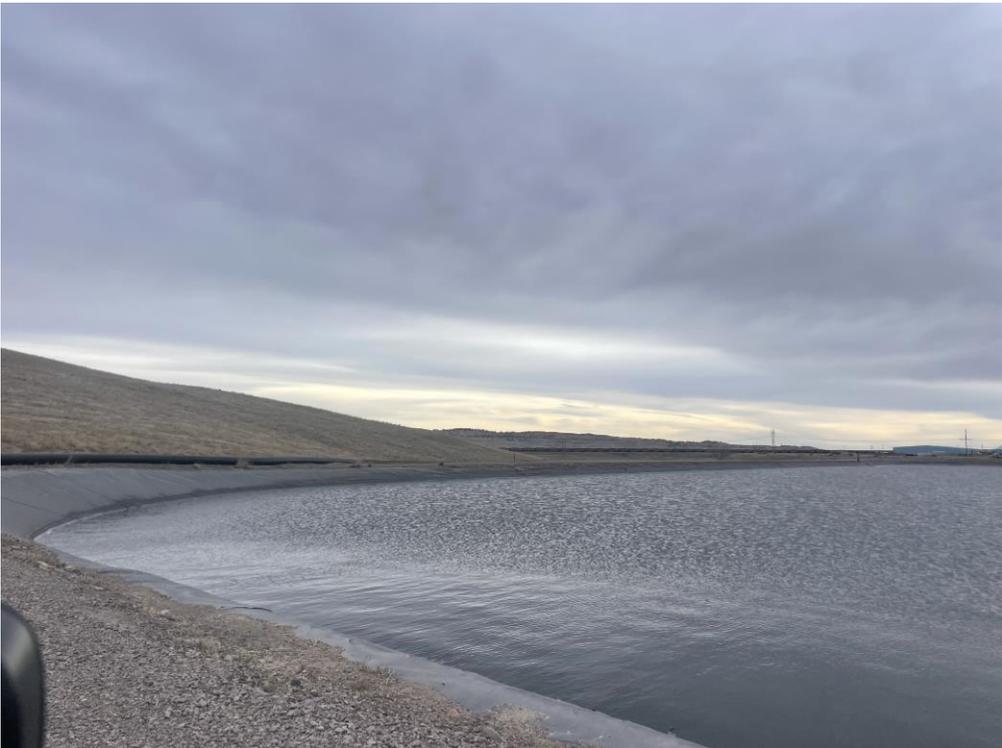
Client Name: Basin Electric Power Cooperative		Site Location: Laramie River Station, Wheatland, WY	Project No. 60732883
Photo No. 14	Date: 12/17/24

Direction Photo Taken: North			
Description: <u>Location:</u> Northwest corner of BAP-1 Water level of northwest corner of BAP-1.

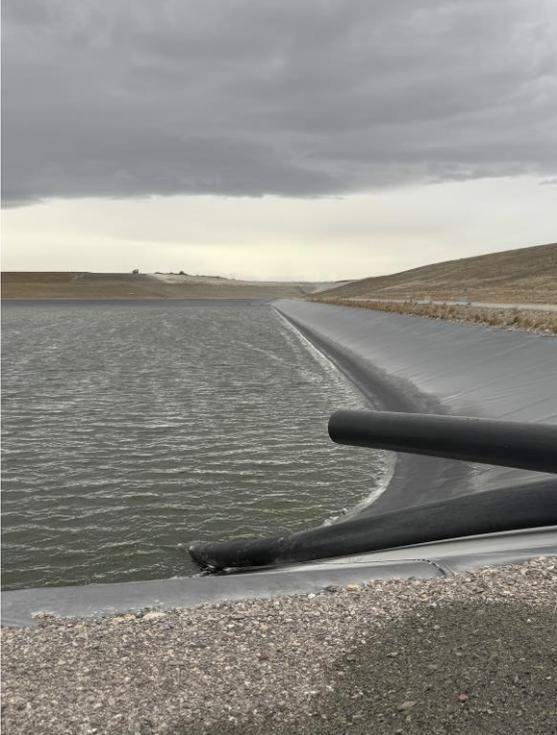
Client Name: Basin Electric Power Cooperative		Site Location: Laramie River Station, Wheatland, WY	Project No. 60732883
Photo No. 15	Date: 12/17/24

Direction Photo Taken: West			
Description: <u>Location:</u> Northeast corner of BAP-2. Outfall into BAP-2.

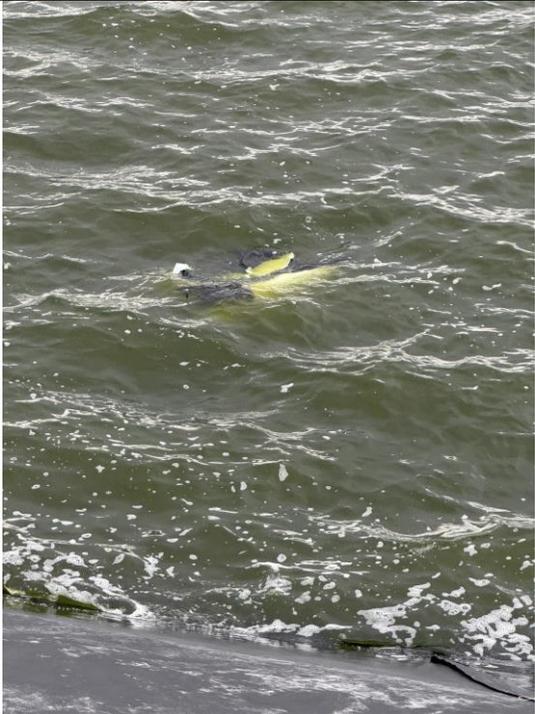
Client Name: Basin Electric Power Cooperative		Site Location: Laramie River Station, Wheatland, WY	Project No. 60732883
Photo No. 16	Date: 12/17/24

Direction Photo Taken: West			
Description: <u>Location:</u> Eastern side of BAP-2. Liner debris blown in from active working face of landfill. Debris not from BAP-2 liner system.

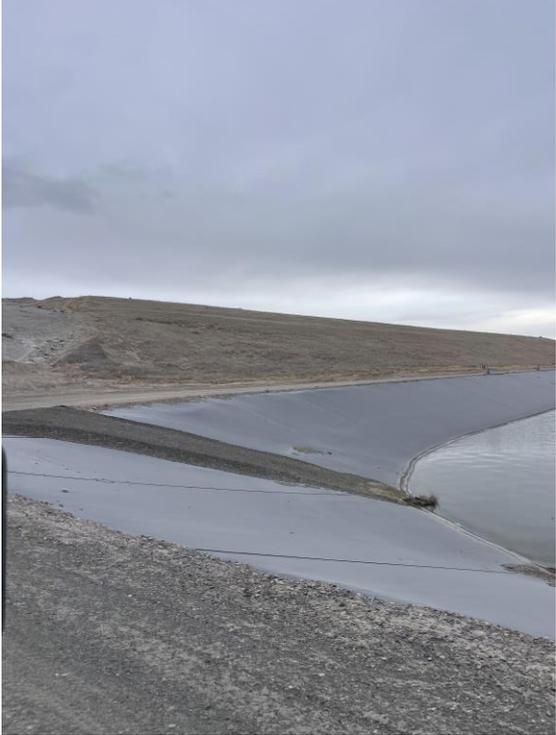
Client Name: Basin Electric Power Cooperative		Site Location: Laramie River Station, Wheatland, WY	Project No. 60732883
Photo No. 17	Date: 12/17/24

Direction Photo Taken: Northeast			
Description: <u>Location:</u> Northwest corner of BAP-2. Animal runway placed on the northwest corner of BAP-2.

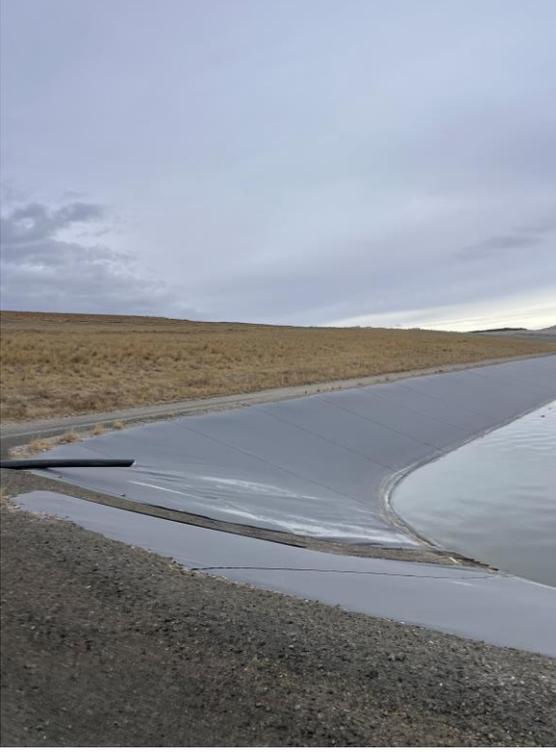
Client Name: Basin Electric Power Cooperative		Site Location: Laramie River Station, Wheatland, WY	Project No. 60732883
Photo No. 18	Date: 12/17/24

Direction Photo Taken: Northeast			
Description: <u>Location:</u> Southwest corner of BAP-2. Outfall into BAP-2.

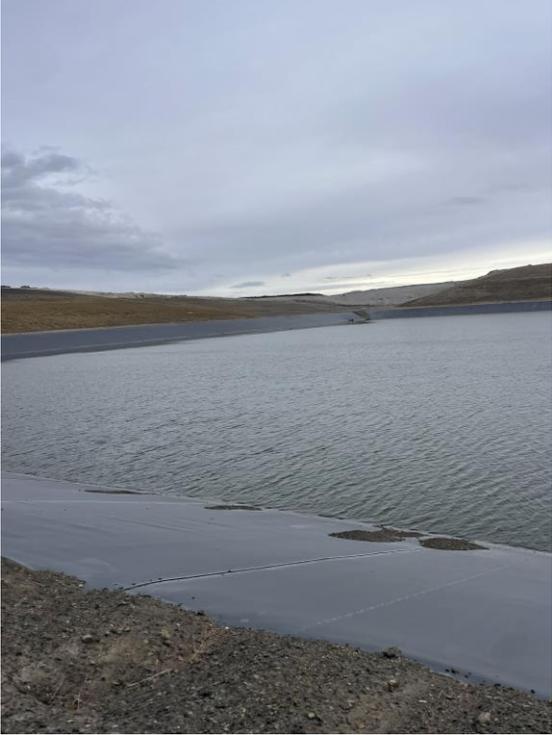
Client Name: Basin Electric Power Cooperative		Site Location: Laramie River Station, Wheatland, WY	Project No. 60732883
Photo No. 19	Date: 12/17/24

Direction Photo Taken: Northwest			
Description: <u>Location:</u> Southern side of BAP-2. Minor sediment buildup on liner.

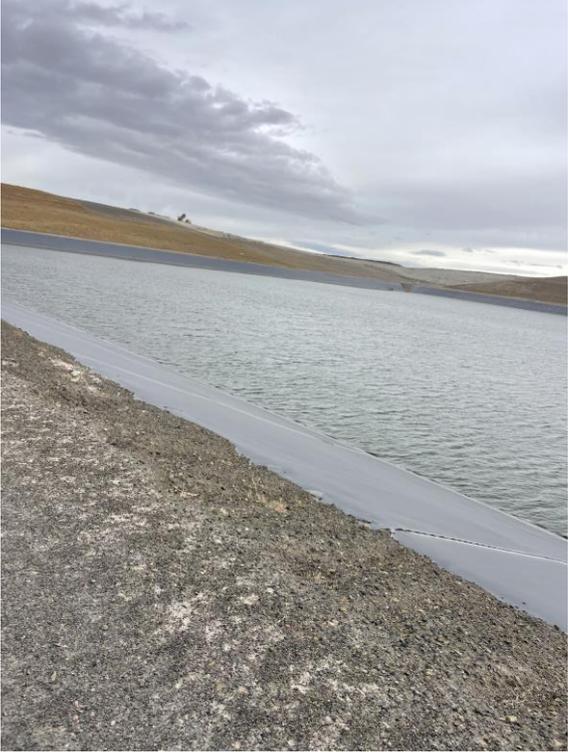
Client Name: Basin Electric Power Cooperative		Site Location: Laramie River Station, Wheatland, WY	Project No. 60732883
Photo No. 20	Date: 12/17/24

Direction Photo Taken: Northwest			
Description: <u>Location:</u> Southern side of BAP-2. Minor erosion divots along roadside. Roadway recently raised in elevation.

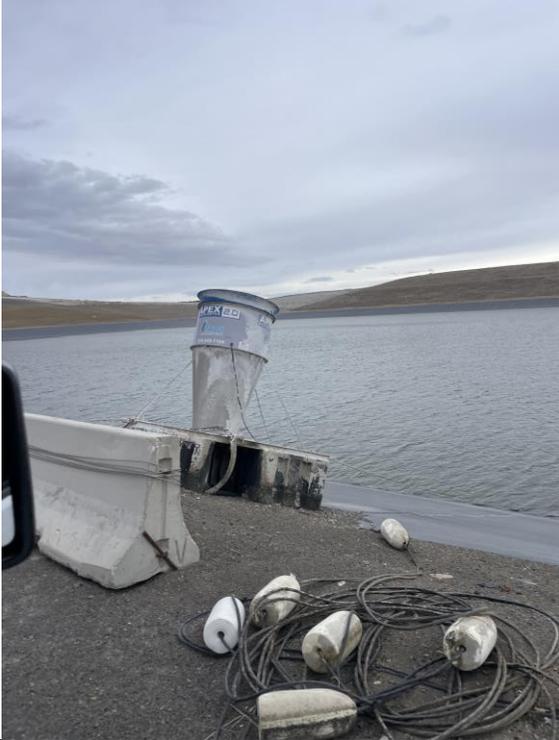
Client Name: Basin Electric Power Cooperative		Site Location: Laramie River Station, Wheatland, WY	Project No. 60732883
Photo No. 21	Date: 12/17/24

Direction Photo Taken: Northwest			
Description: <u>Location:</u> Southern side of BAP-2. Floating evaporator stationed along the southern side of BAP-2.

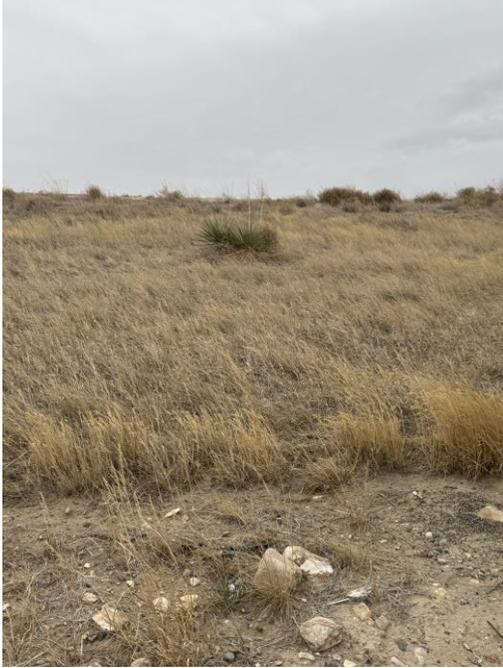
Client Name: Basin Electric Power Cooperative		Site Location: Laramie River Station, Wheatland, WY	Project No. 60732883
Photo No. 22	Date: 12/17/24

Direction Photo Taken: South			
Description: <u>Location:</u> Southern side of BAP-2. Large vegetation growing along the northern berm of BAP-3.

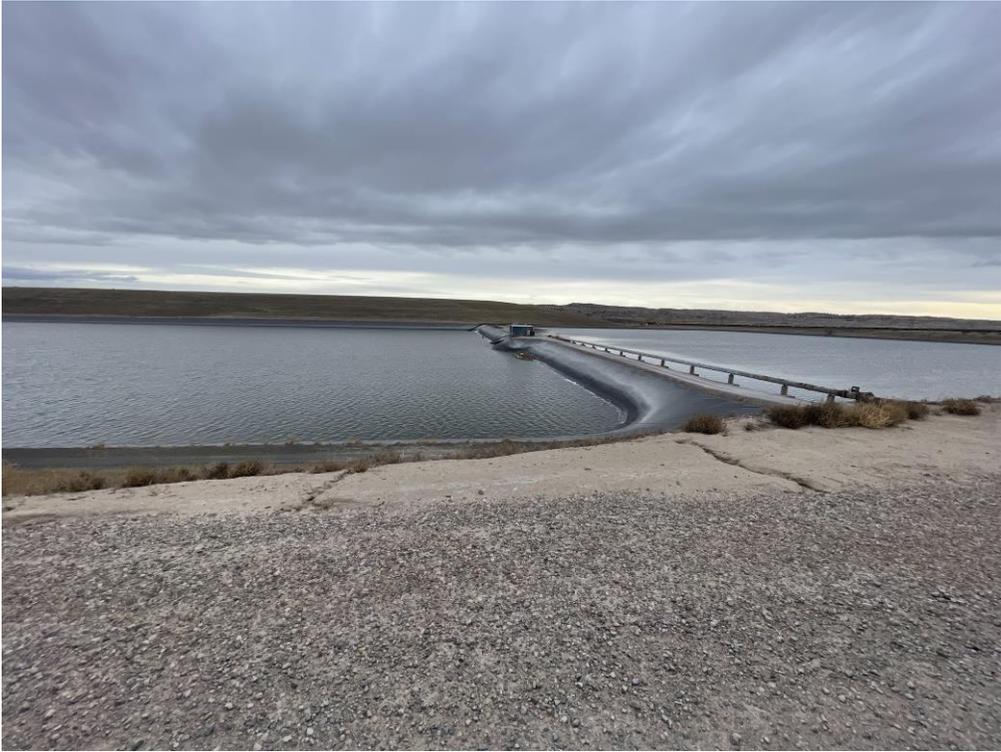
Client Name: Basin Electric Power Cooperative		Site Location: Laramie River Station, Wheatland, WY	Project No. 60732883
Photo No. 23	Date: 12/17/24

Direction Photo Taken: North			
Description: <u>Location:</u> Southwest corner of BAP-2 Erosion rills on berm north of BAP-3 and south of BAP-2.

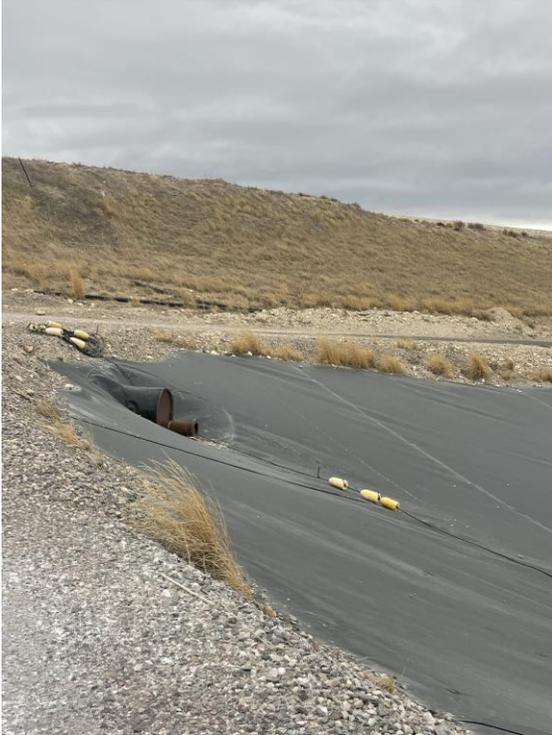
Client Name: Basin Electric Power Cooperative		Site Location: Laramie River Station, Wheatland, WY	Project No. 60732883
Photo No. 24	Date: 12/17/24

Direction Photo Taken: South			
Description: <u>Location:</u> Southeast corner of BAP-2 Outfall into BAP-2.

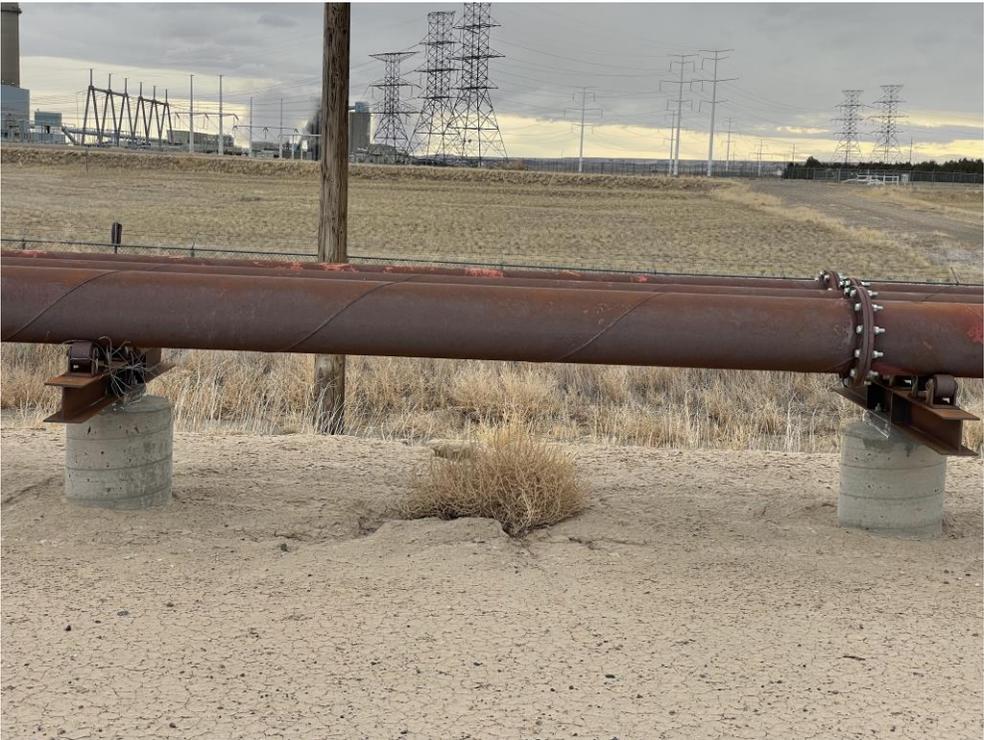
Client Name: Basin Electric Power Cooperative		Site Location: Laramie River Station, Wheatland, WY		Project No. 60732883
Photo No. 25	Date: 12/17/24

Direction Photo Taken: East				
Description: <u>Location:</u> Eastern side of BAP-3. Erosion rills under piping.

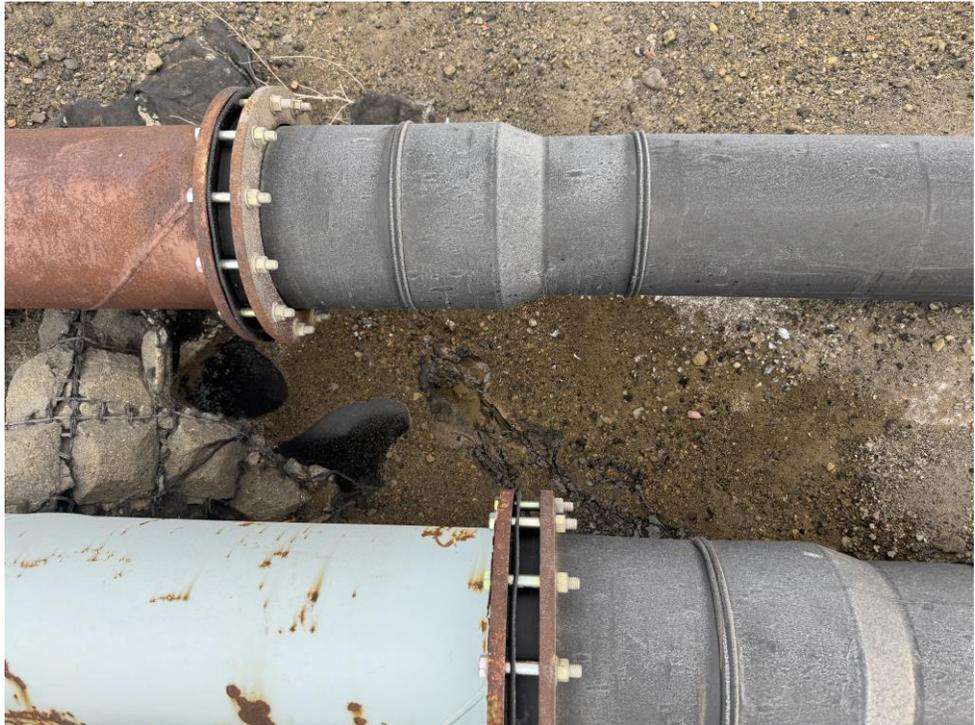
Client Name: Basin Electric Power Cooperative		Site Location: Laramie River Station, Wheatland, WY		Project No. 60732883
Photo No. 26	Date: 12/17/24

Direction Photo Taken: Birdseye view				
Description: <u>Location:</u> Eastern side of BAP-3. Minor leak in outfall piping into BAP-3. Leak is contained within lined footprint of BAP-3.

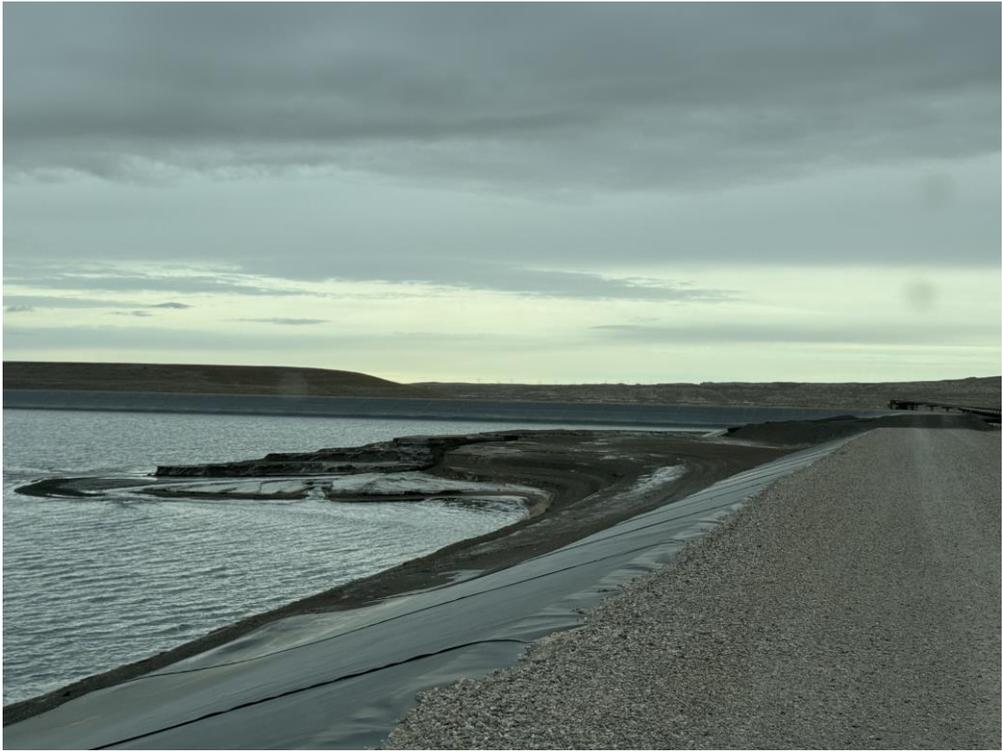
Client Name: Basin Electric Power Cooperative		Site Location: Laramie River Station, Wheatland, WY	Project No. 60732883
Photo No. 27	Date: 12/17/24

Direction Photo Taken: South			
Description: <u>Location:</u> Southeast corner of BAP-3. Outfall area of BAP-3.

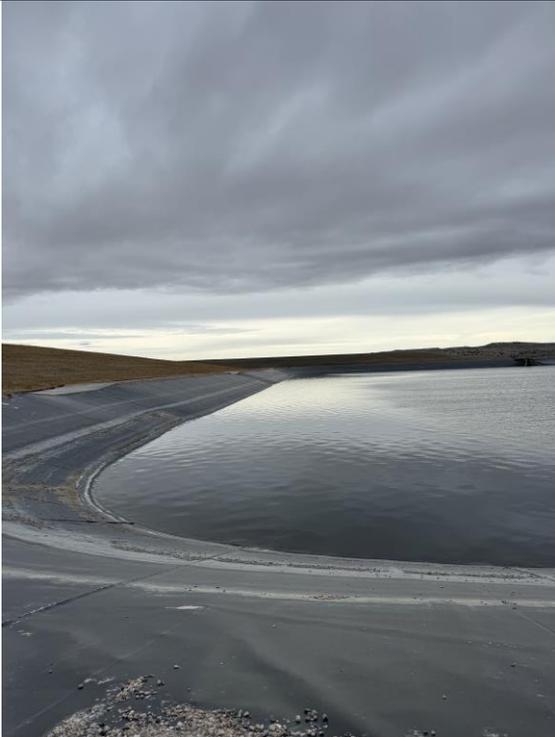
Client Name: Basin Electric Power Cooperative		Site Location: Laramie River Station, Wheatland, WY	Project No. 60732883
Photo No. 28	Date: 12/17/24

Direction Photo Taken: North			
Description: <u>Location:</u> Southwest corner of BAP-3. Sediment buildup on liner.

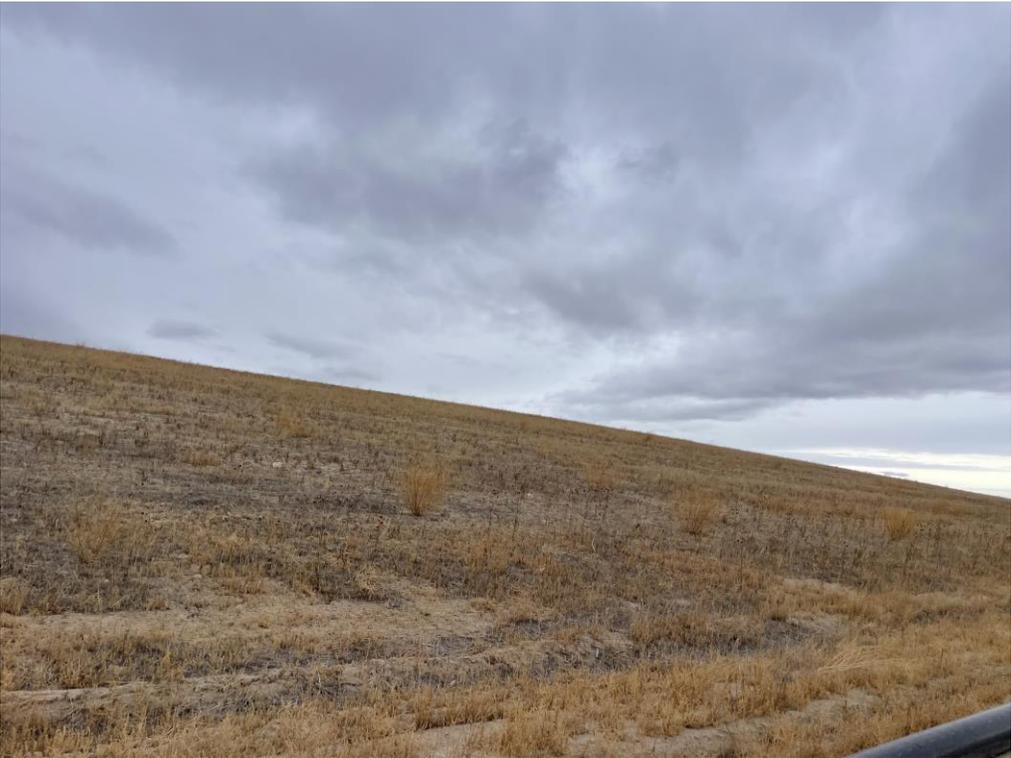
Client Name: Basin Electric Power Cooperative		Site Location: Laramie River Station, Wheatland, WY	Project No.: 60732883
Photo No. 29	Date: 12/17/24

Direction Photo Taken: East			
Description: <u>Location:</u> Western side of BAP-3. Vegetation cover.

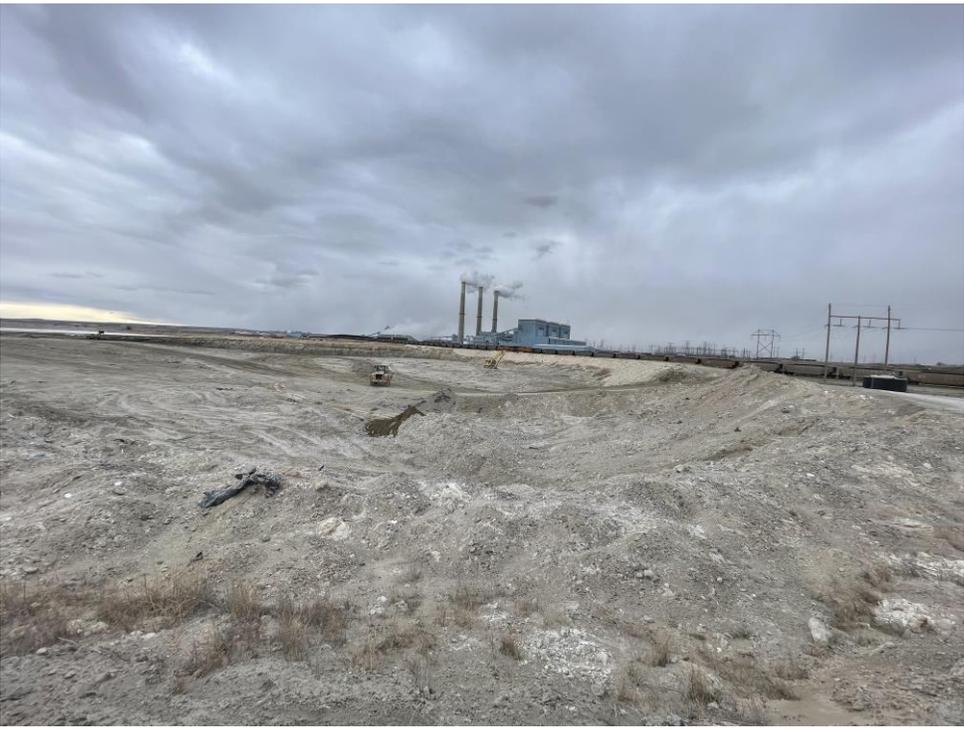
Direction Photo Taken: Southwest			
Description: <u>Location:</u> Northwest corner of West-Emergency Holding Pond (W-EHP). CCR sediment material removal is taking place within W-EHP.

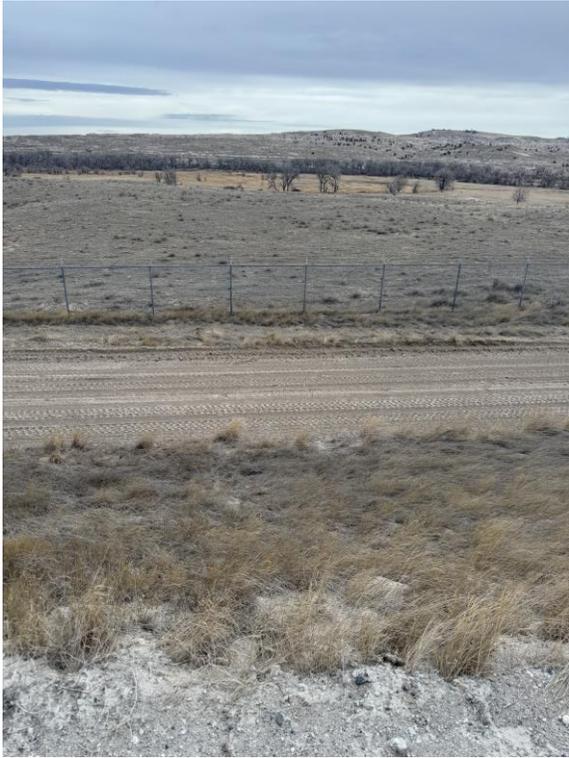
Direction Photo Taken: North			
Description: <u>Location:</u> Northern berm of W-EHP. Strong vegetation cover.

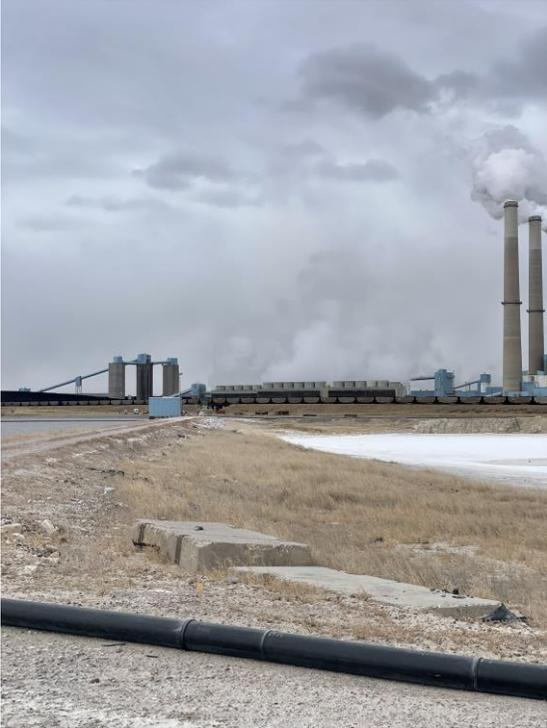
Direction Photo Taken: Southwest			
Description: <u>Location:</u> Eastern side of W-EHP. Strong vegetation cover.

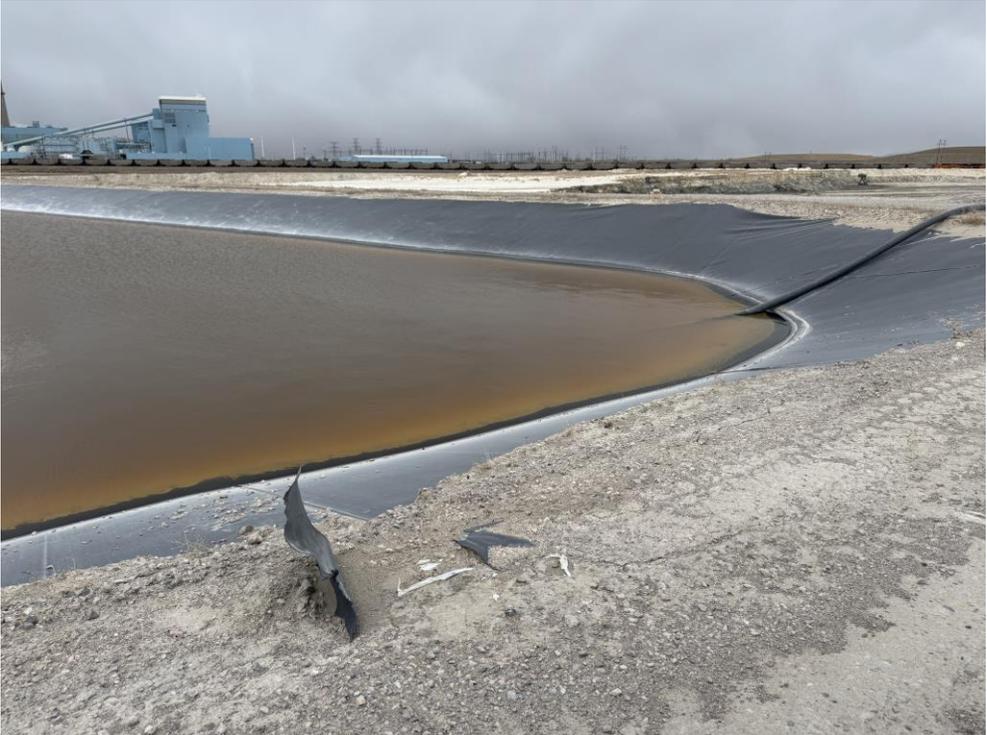
Direction Photo Taken: West			
Description: <u>Location:</u> Northwest corner of East-Emergency Holding Pond (E-EHP) Outfall into E-EHP and limited liner damage above high water line in impoundment.

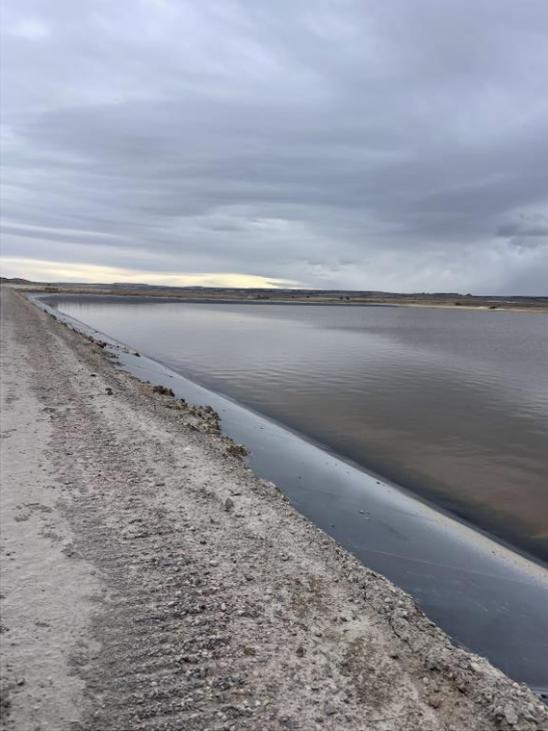
Direction Photo Taken: Northeast			
Description: <u>Location:</u> Northern side of E-EHP. Slight sediment buildup on liner.

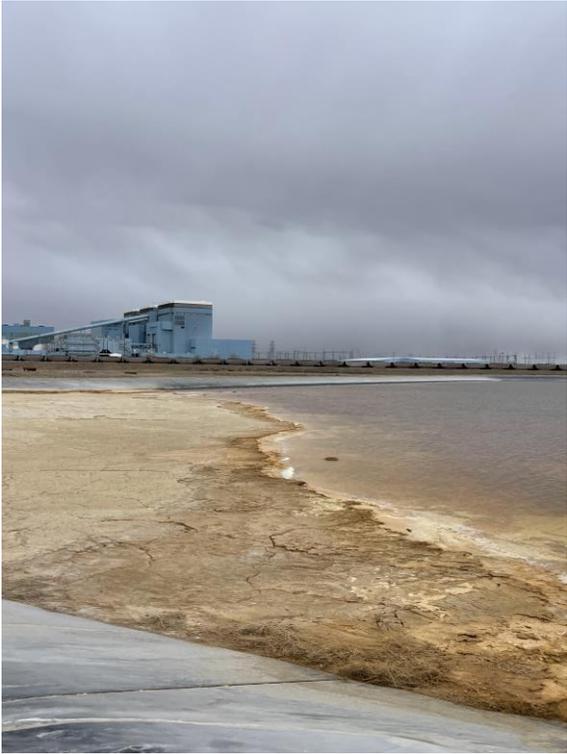
Direction Photo Taken: Northwest			
Description: <u>Location:</u> Southeast corner of E-EHP. Sediment within outfall area of E-EHP.

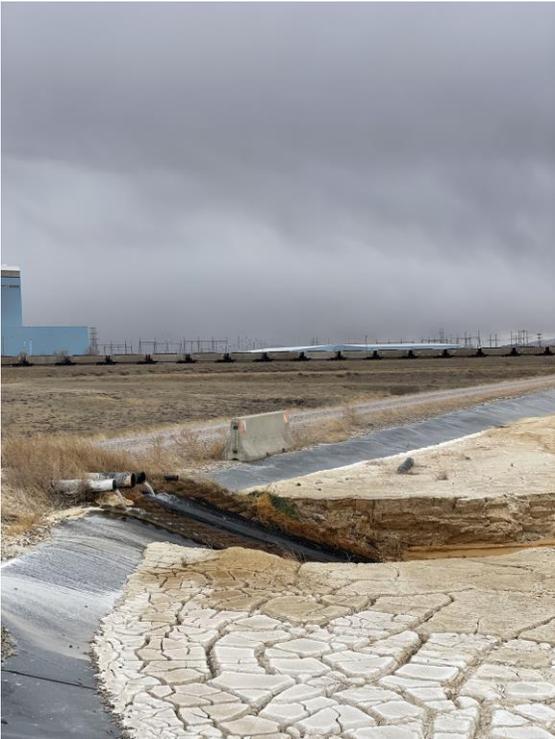
Direction Photo Taken: Southwest			
Description: <u>Location:</u> Southwest corner of E-EHP. Outfall into E-EHP.

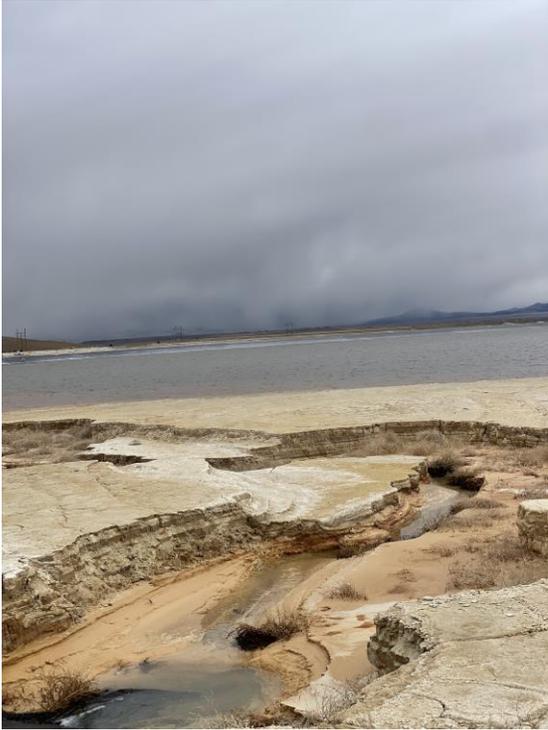
Direction Photo Taken: Northwest			
Description: <u>Location:</u> Southeast corner of E-EHP. Channel formed by outfall into E-EHP.

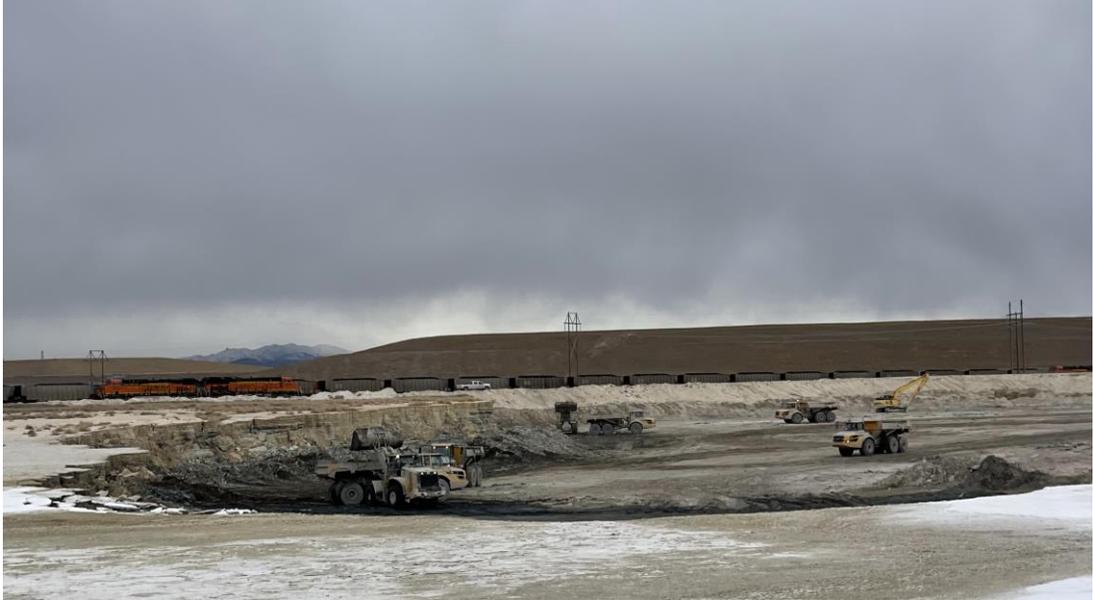
Direction Photo Taken: West			
Description: <u>Location:</u> Eastern side of W-EHP. CCR material being moved from W-EHP to the landfill.

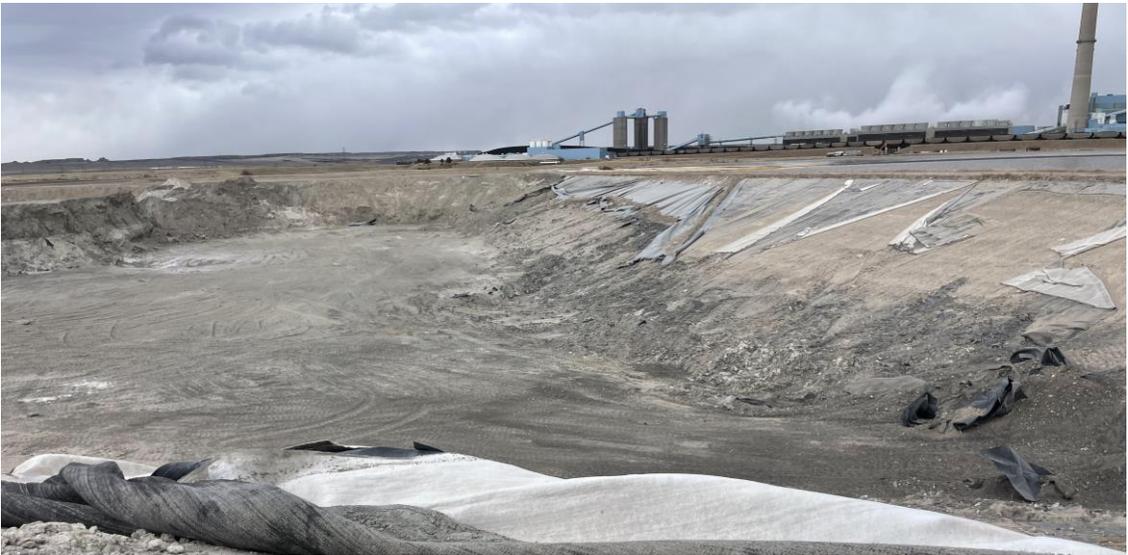
Direction Photo Taken: Southeast			
Description: <u>Location:</u> Northwest corner of eastern lobe of E-EHP (EL-EHP). Liner being removed as part of excavation efforts.

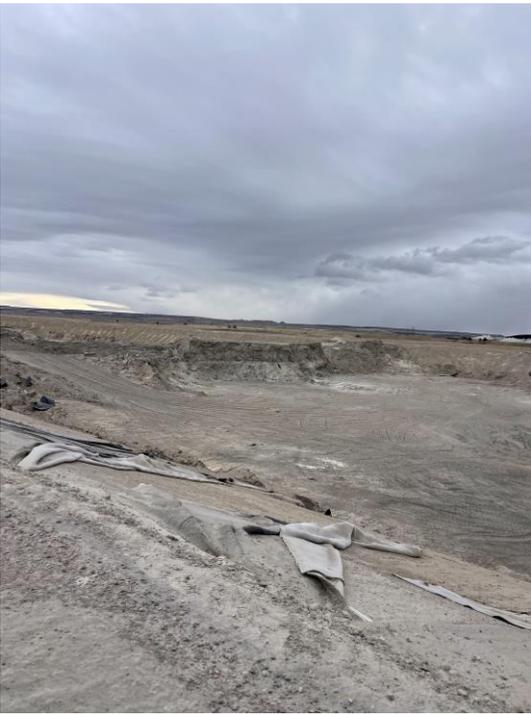
Direction Photo Taken: Southeast			
Description: <u>Location:</u> Northern side of EL-EHP. Liner being removed as part of excavation efforts.
