Submitted to:
Basin Electric Power Cooperative
Laramie River Station
Wheatland, WY

Submitted by:
AECOM
Fort Collins, CO
60732883
January 17, 2025

Basin Electric Power Cooperative Laramie River Station

Coal Combustion Residual Surface Impoundment Annual Inspection Report – 2024

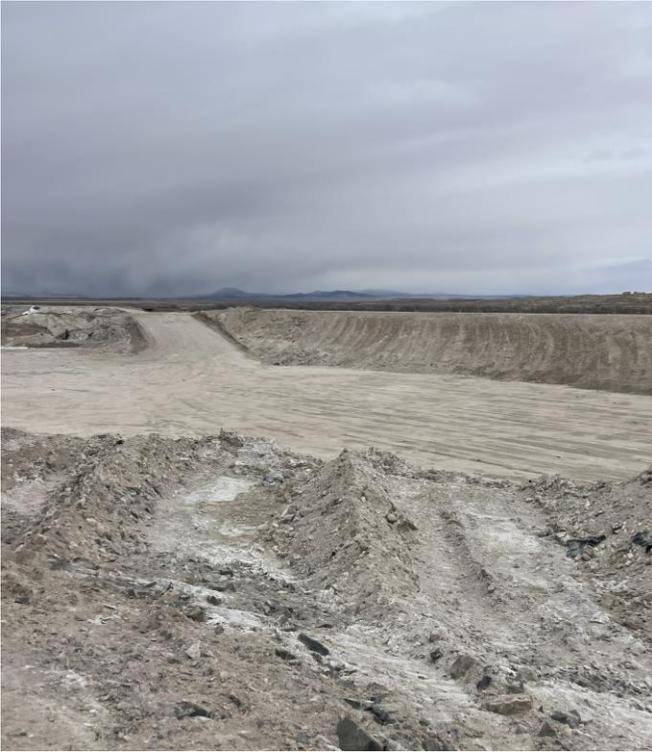
Direction Photo Taken: Northwest			
Description: <u>Location:</u> Southern side of EL-EHP. Current state of EL-EHP.

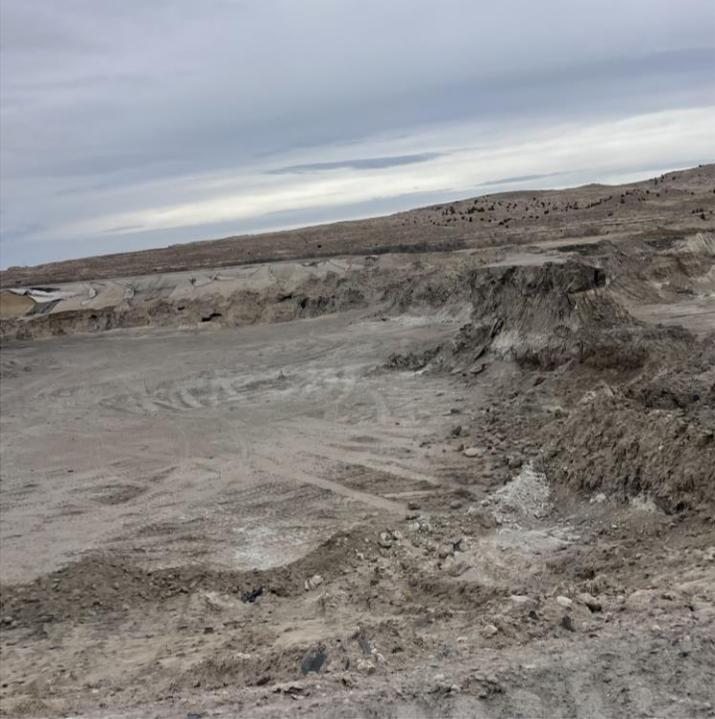
Direction Photo Taken: North			
Description: <u>Location:</u> Southern side of EL-EHP. Sediment wall within EL-EHP.

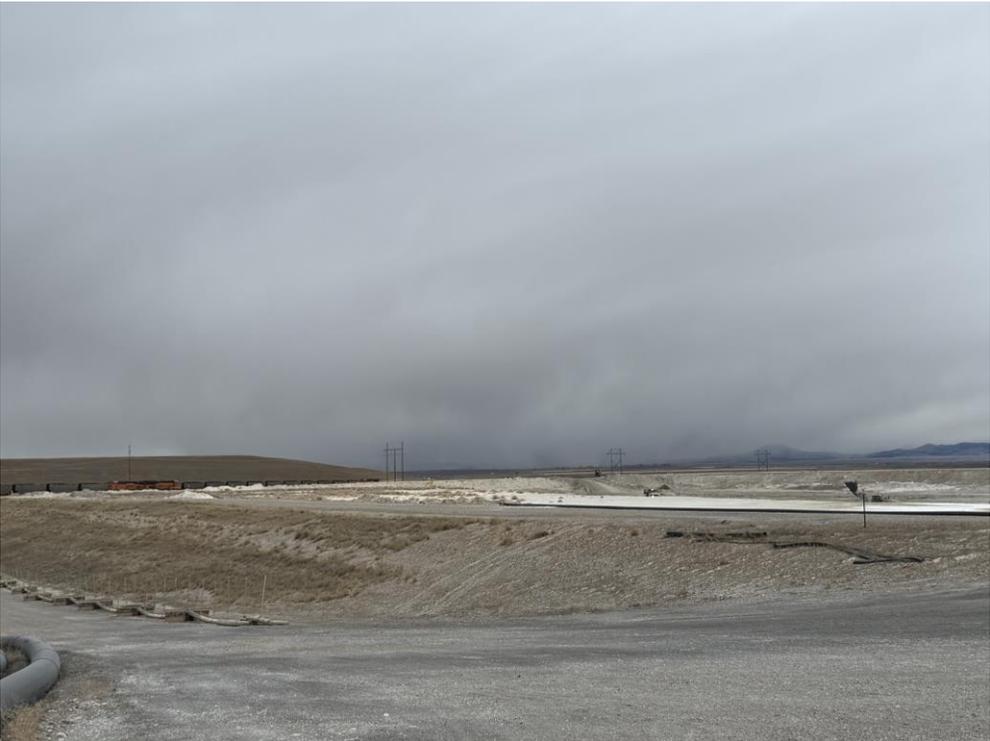
Direction Photo Taken: East			
Description: <u>Location:</u> Southern berm of W-EHP. Vegetation along southern berm.

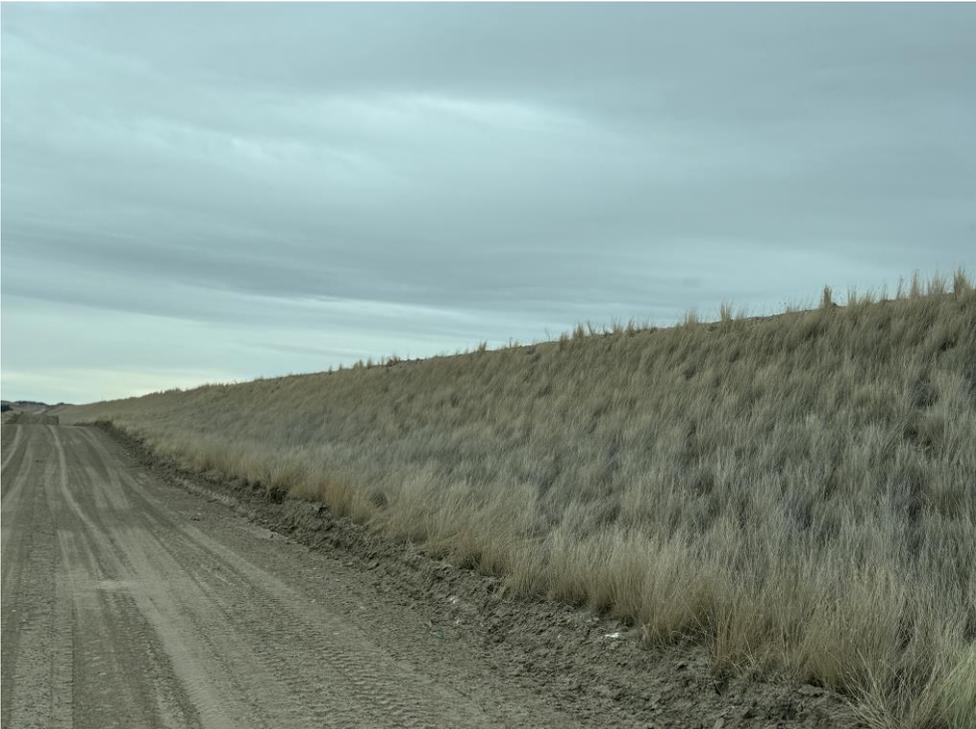
Direction Photo Taken: East			
Description: <u>Location:</u> Northern berm of W-EHP. Strong vegetation cover.

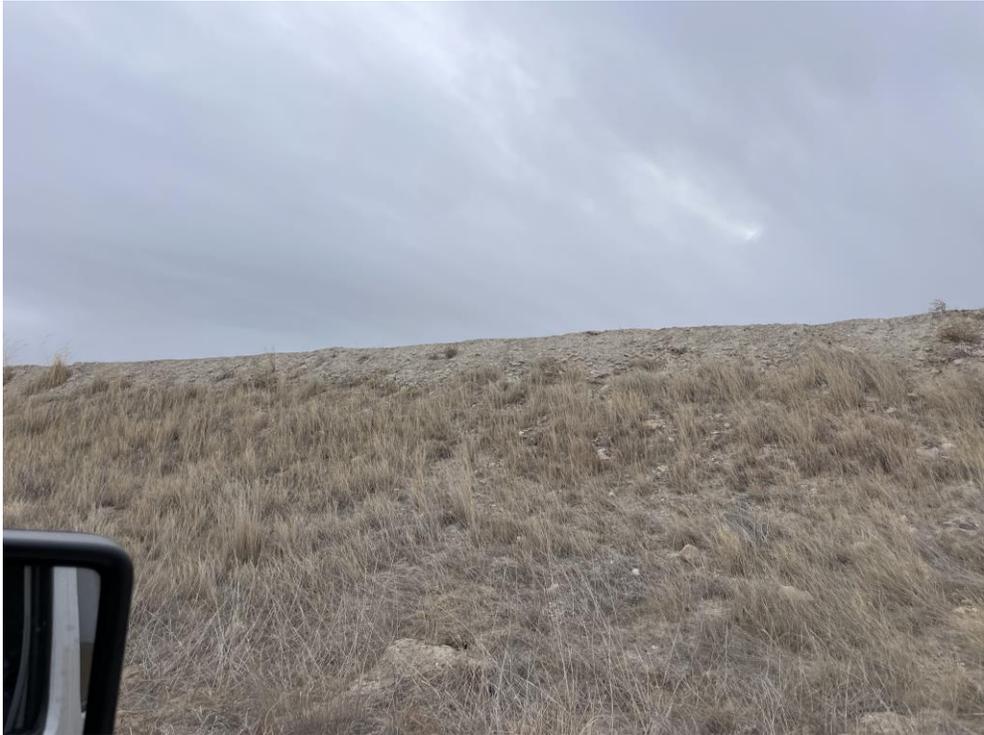
Direction Photo Taken: Southwest			
Description: <u>Location:</u> Northern berm of E-EHP. Slightly thinning vegetation towards top of berm.

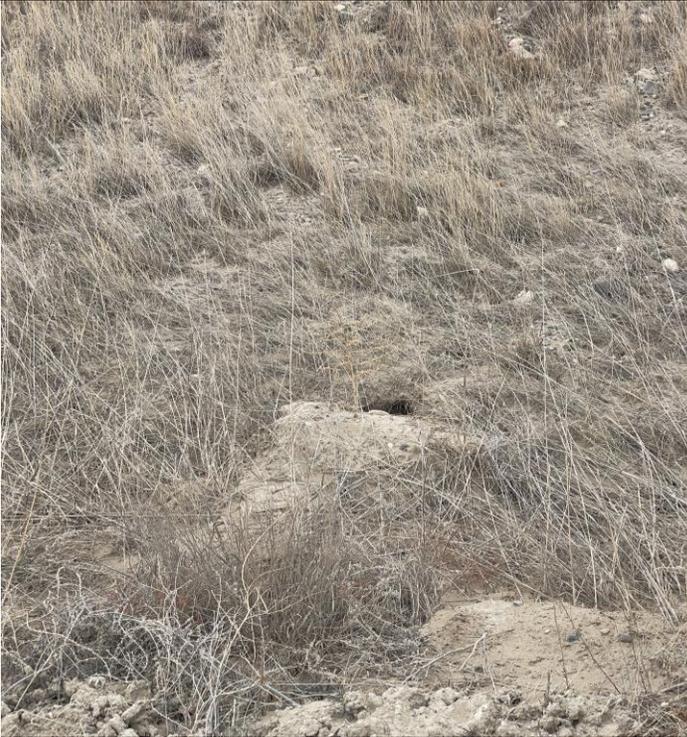
Direction Photo Taken: Southwest			
Description: <u>Location:</u> Northern berm of EL-EHP. Small animal burrow.

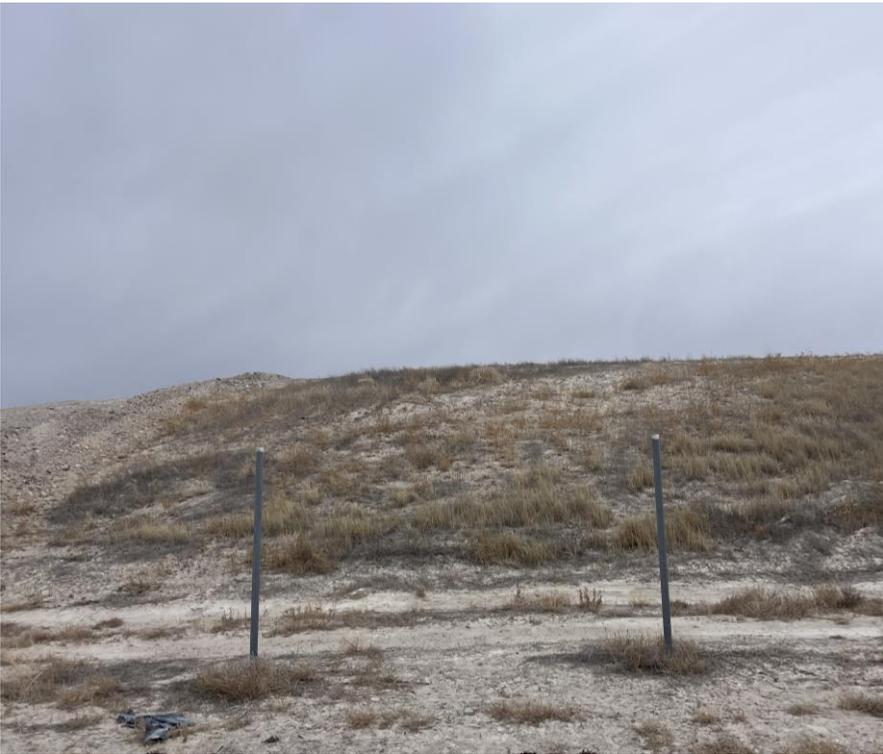
Thinned vegetation. Berm is scheduled to be removed during future regrading project.
