2025 Annual Landfill Inspection

Antelope Valley Station Coal Ash Landfill

Prepared for
Basin Electric Power Cooperative

Prepared by
Barr Engineering Co.

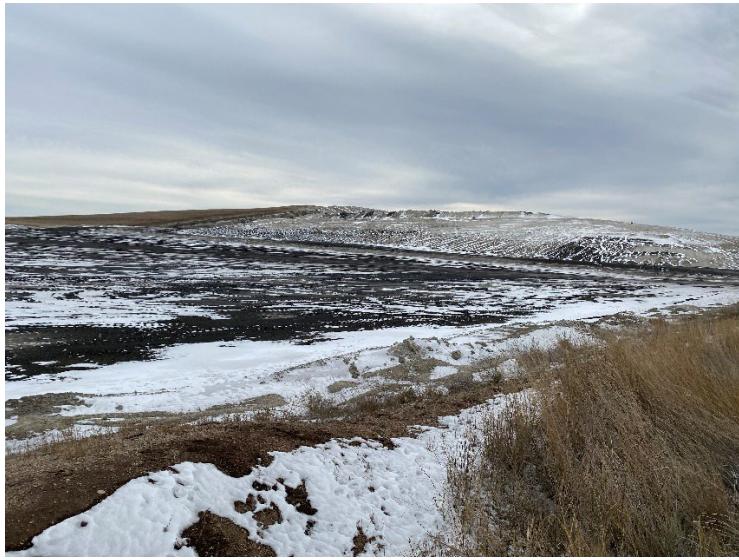
Subject: Active area, view to southeast

Comments: Bottom liner of expansion area has been protected by layer of CCRs; fill progression appears consistent with plan.

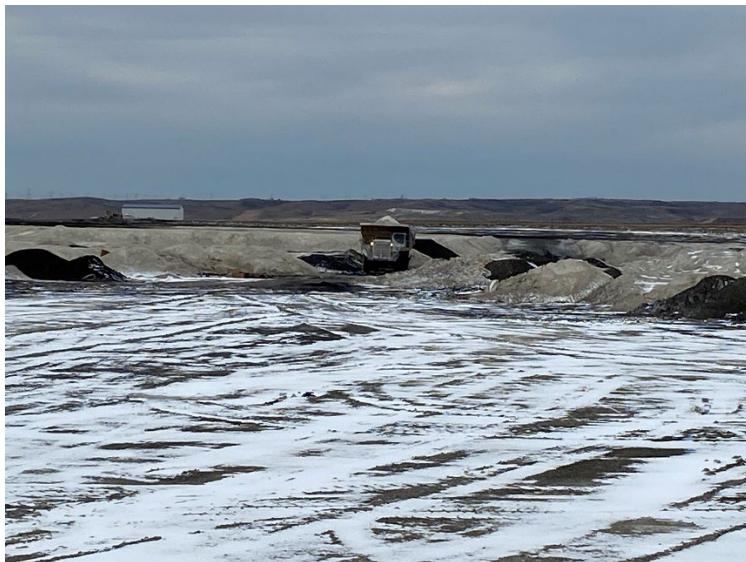
Subject: Haul truck in active area, view to west

Comments: No fugitive dust observed during hauling or dumping

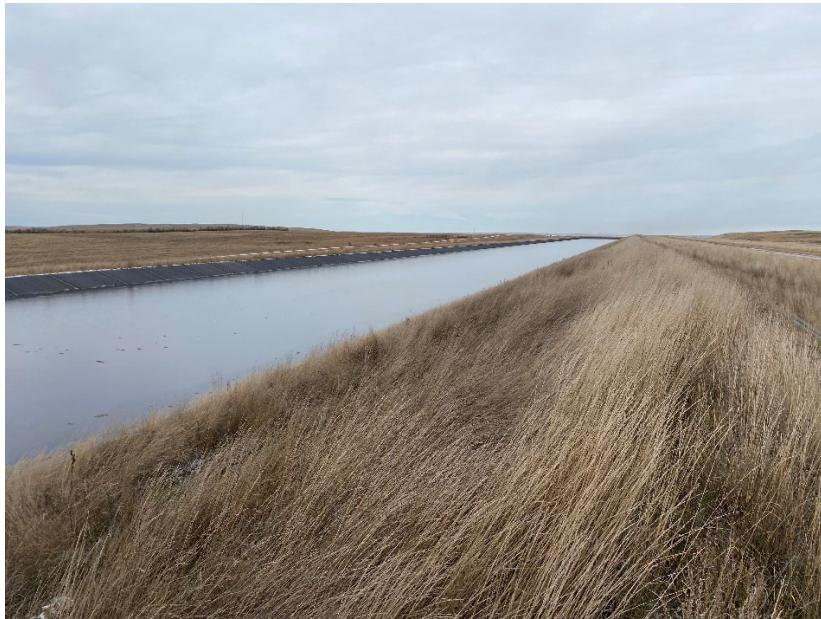
Subject: Leachate evaporation pond, view to northwest

Comments: Pond has adequate freeboard.

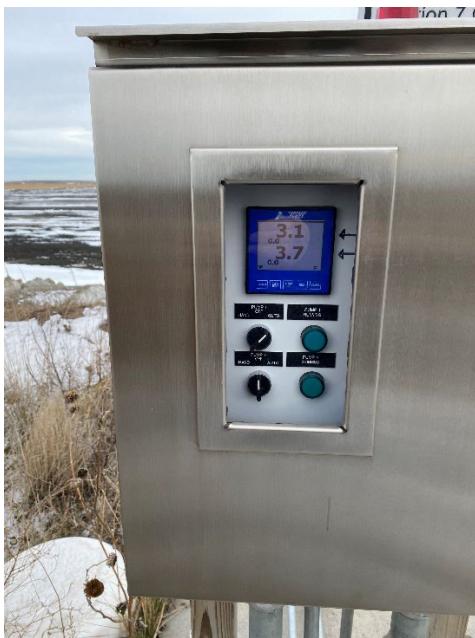
Subject: Leachate collection system controller - west side of landfill expansion area

Comments: Controller appears to be operating correctly.
