2025 Annual Landfill Inspection

Leland Olds Station Coal Ash Landfill

Prepared for
Basin Electric Power Cooperative

Prepared by
Barr Engineering Co.

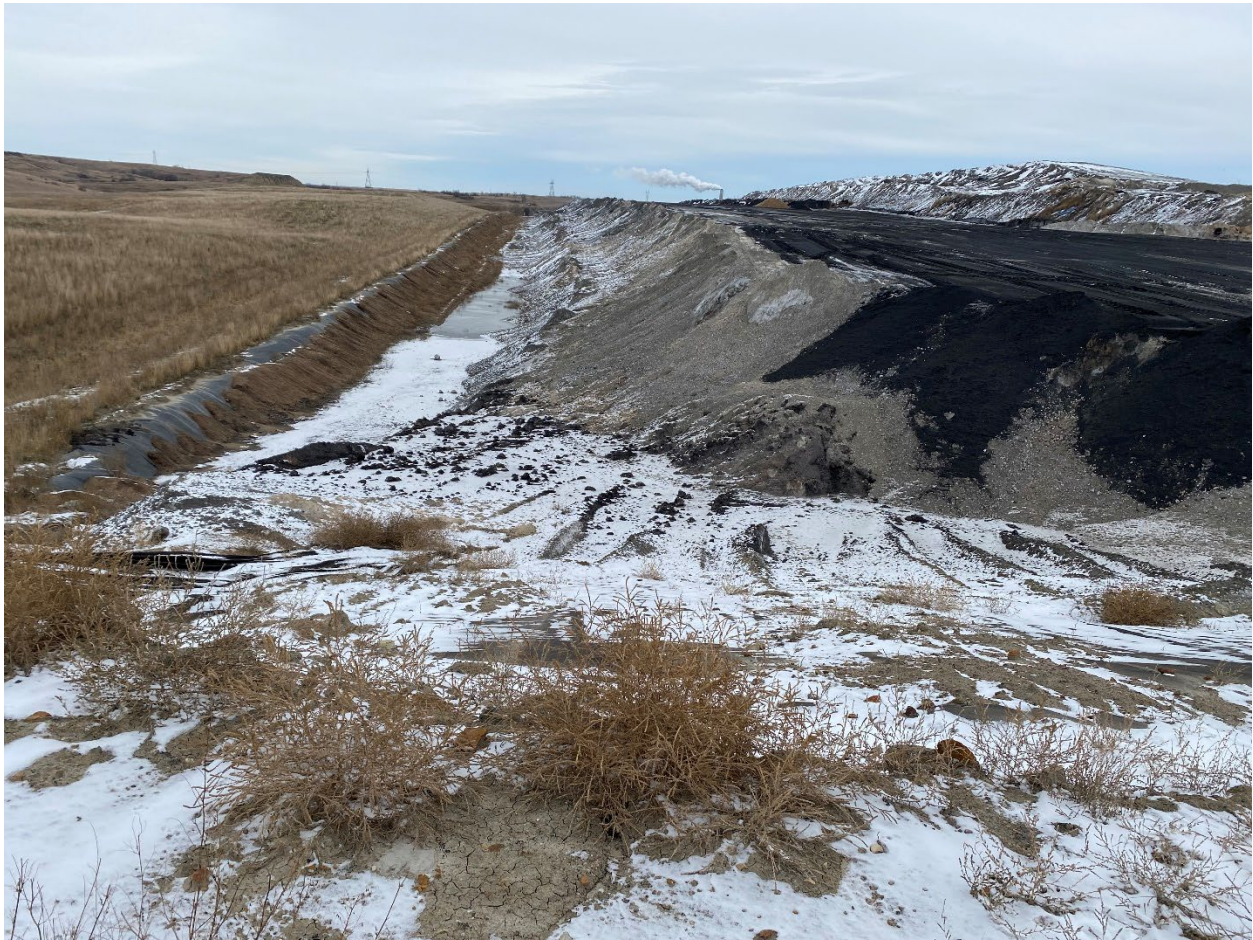
Subject: Active area, view to north, toe of waste slope on expansion cell

Comments: Maintain gap between waste and edge of liner. Fill progression appears consistent with plan.

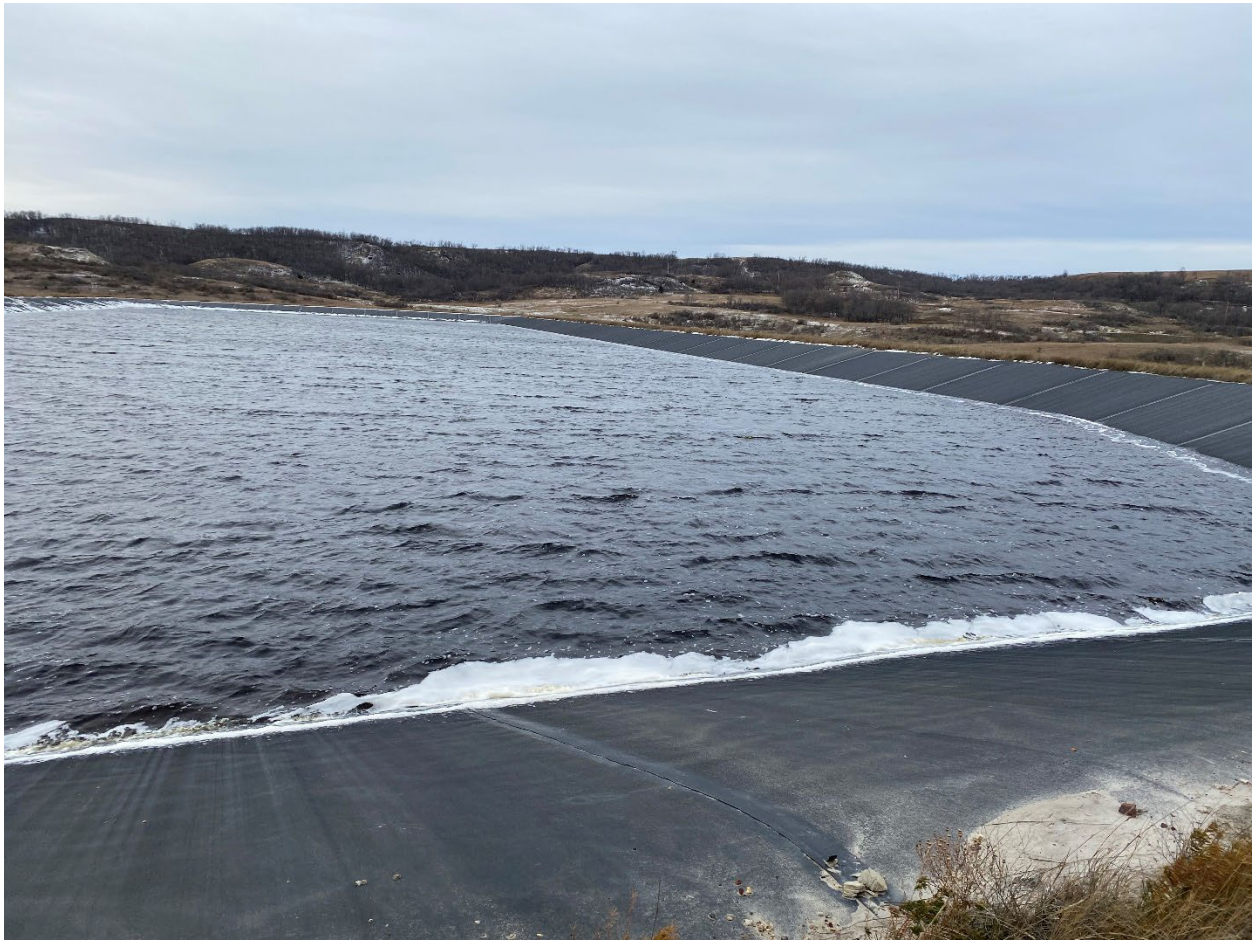
Subject: Leachate pond, view to south

Comments: No damage to exposed HDPE liner; pond has adequate freeboard.
