Submitted by:  
AECOM  
Fort Collins, CO  
60732883  
January 2026

# Basin Electric Power Cooperative Laramie River Station

## Coal Combustion Residual Landfill Annual Inspection Report – 2025

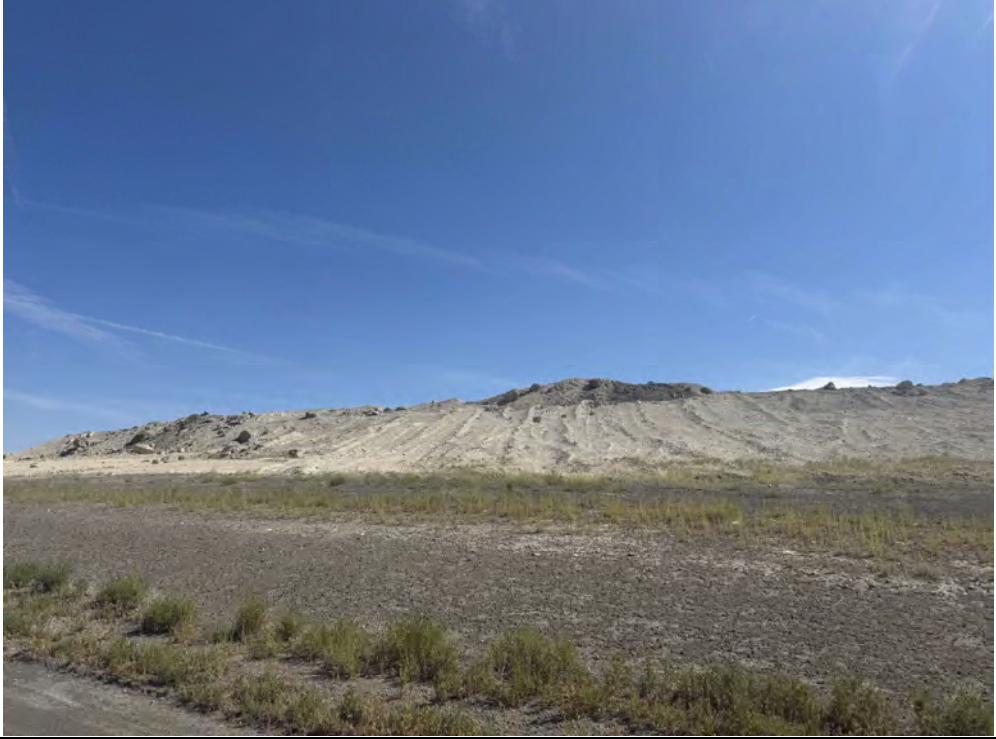
<b>Client Name:</b> Basin Electric Power Cooperative		<b>Site Location:</b> Laramie River Station, Wheatland, WY	<b>Project No.</b> 60732883
<b>Photo No.</b> <b>1</b>	<b>Date:</b> 9/8/2025		
<b>Direction Photo Taken:</b>  East			
<b>Description:</b>  <u>Location:</u> West side of landfill.  Wall of sediment and ash materials is pictured. Active portion of landfill.

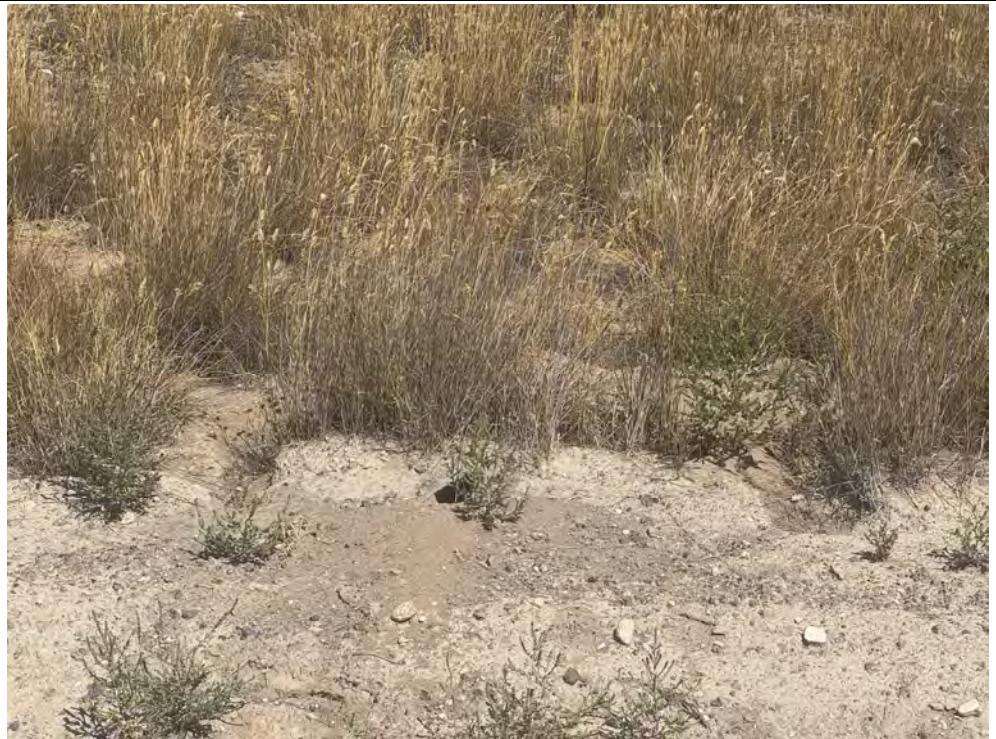
No significant deficiencies were noted as part of this annual inspection or document review. No releases were identified during the annual inspection. Approximately 20-30 small animal burrows (less than 3 inches in diameter) and several ant hills were observed on the top of Cells 1 and 5 (**Attachment C – Photos 3, 4, 16, and 17**). Animal burrows were also observed along the side of road on the south side of Cell 6 (**Attachment C – Photo 2**).

<b>Client Name:</b> Basin Electric Power Cooperative		<b>Site Location:</b> Laramie River Station, Wheatland, WY	<b>Project No.</b> 60732883
<b>Photo No.</b> <b>2</b>	<b>Date:</b> 9/8/2025		
<b>Direction Photo Taken:</b>  North			
<b>Description:</b>  <u>Location:</u> Southern side of Cell 6.  A small animal burrow.

- Continue to be observant and watch for the potential erosion of the western slope of Cell 3 and correct (until expansion Cell 10 is constructed).
- Continue observation of animal burrows and implement corrective actions if necessary

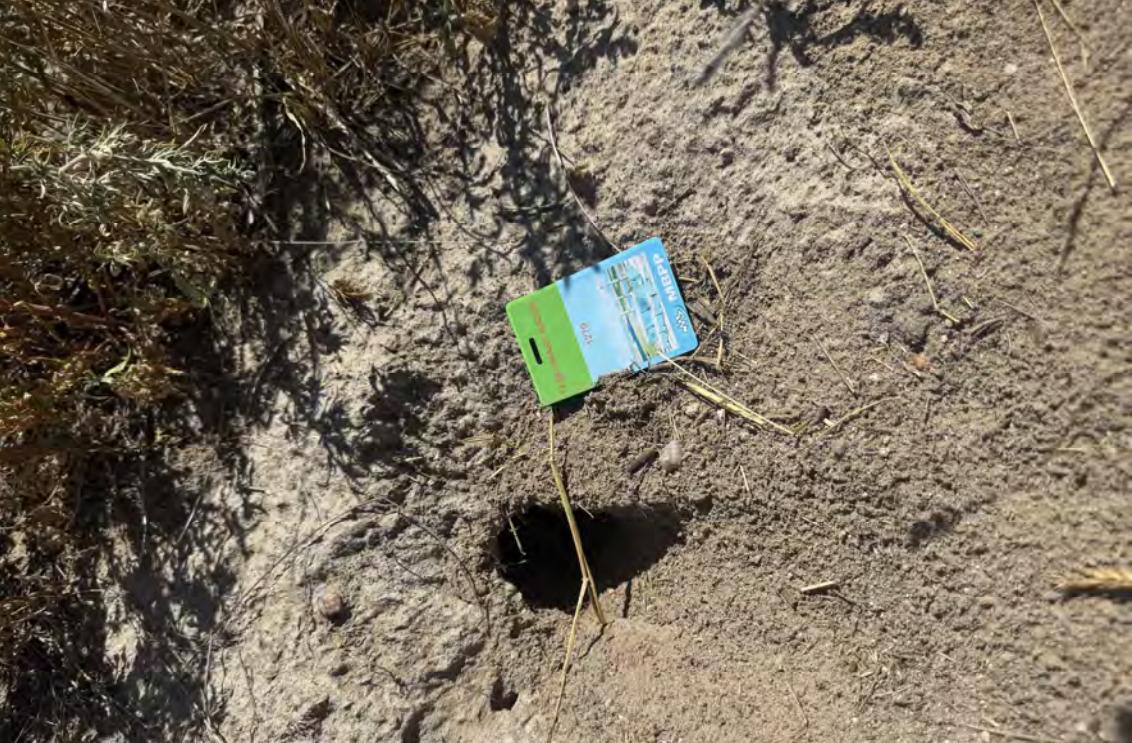
<b>Client Name:</b> Basin Electric Power Cooperative		<b>Site Location:</b> Laramie River Station, Wheatland, WY	<b>Project No.</b> 60732883
<b>Photo No.</b> 3	<b>Date:</b> 9/8/2025

<b>Direction Photo Taken:</b>  Bird's-eye view			
<b>Description:</b>  <u>Location:</u> Southern side of Cell 6.  Closeup of the small animal burrow pictured above.

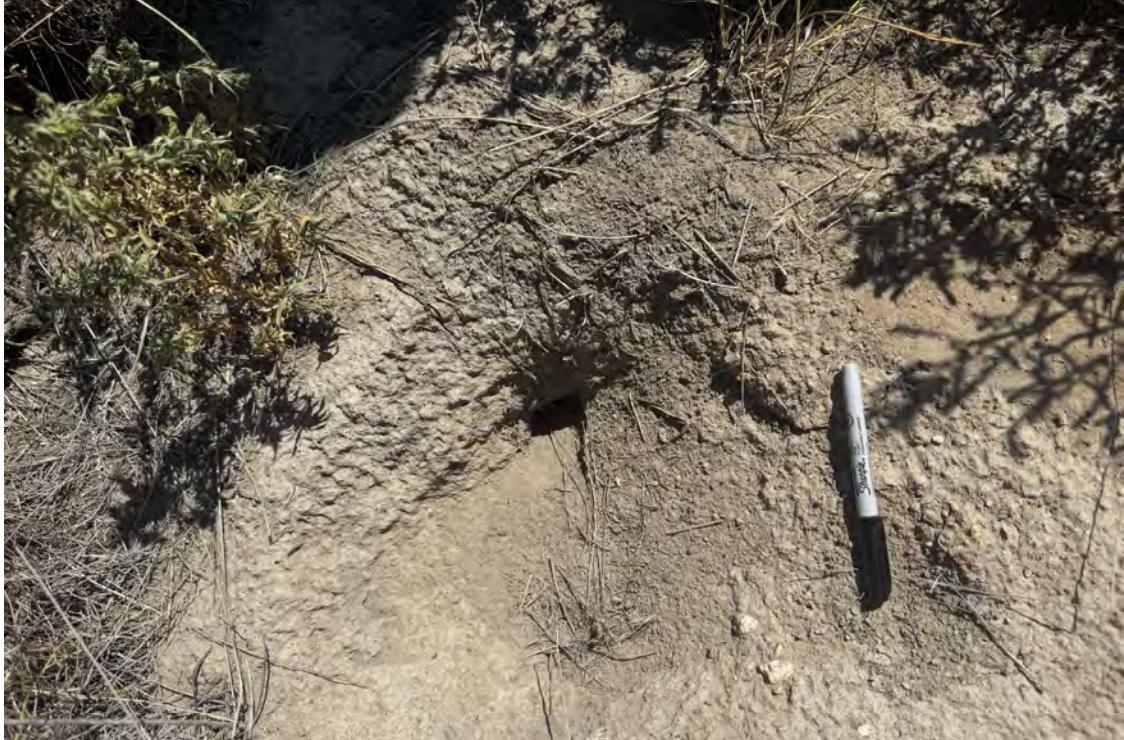
<b>Client Name:</b> Basin Electric Power Cooperative		<b>Site Location:</b> Laramie River Station, Wheatland, WY	<b>Project No.</b> 60732883
<b>Photo No.</b> 4	<b>Date:</b> 9/8/2025

<b>Direction Photo Taken:</b>  Bird's-eye view			
<b>Description:</b>  <u>Location:</u> Southern side of Cell 6.  A small animal burrow.

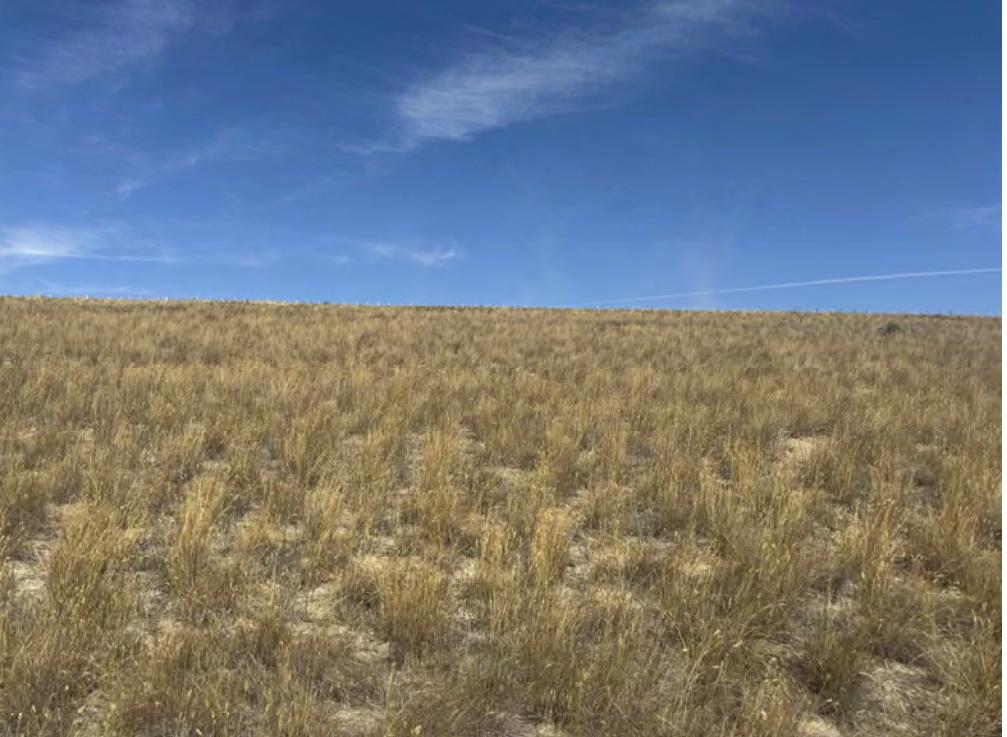
<b>Client Name:</b> Basin Electric Power Cooperative		<b>Site Location:</b> Laramie River Station, Wheatland, WY	<b>Project No.</b> 60732883
<b>Photo No.</b> <b>5</b>	<b>Date:</b> 9/8/2025

<b>Direction Photo Taken:</b>  West			
<b>Description:</b>  <u>Location:</u> Eastern side of Cell 6.  Strong vegetation growth.

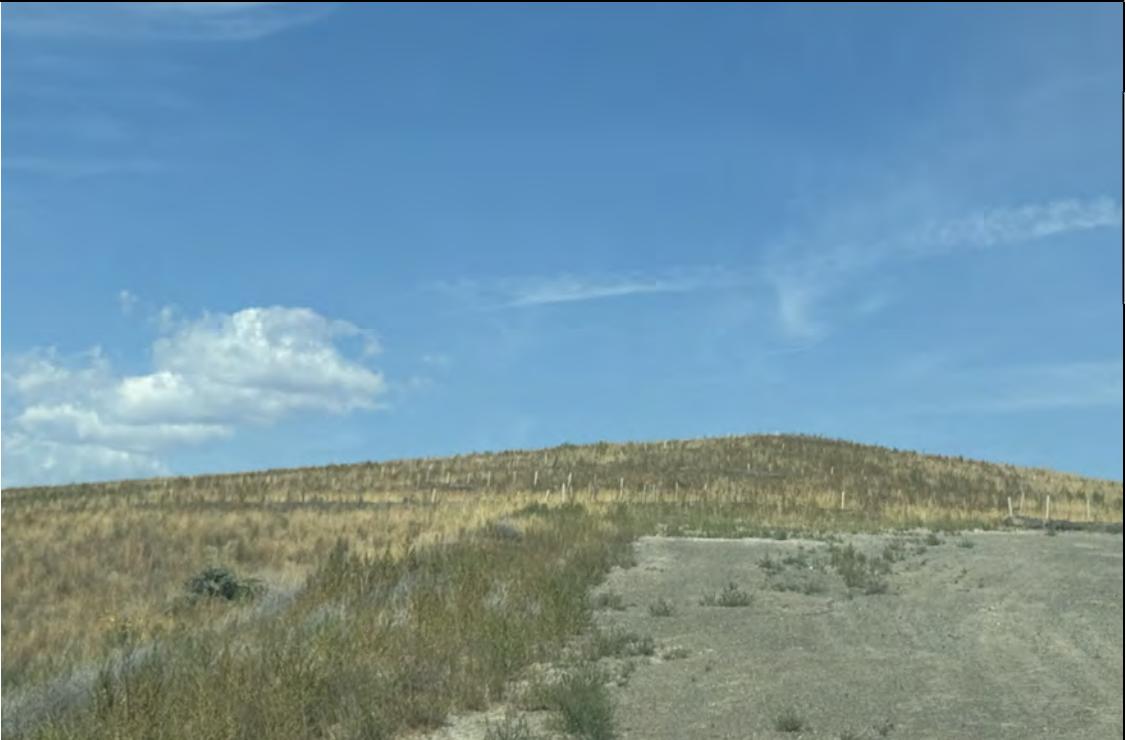
<b>Client Name:</b> Basin Electric Power Cooperative		<b>Site Location:</b> Laramie River Station, Wheatland, WY	<b>Project No.</b> 60732883
<b>Photo No.</b> <b>6</b>	<b>Date:</b> 9/8/2025

<b>Direction Photo Taken:</b>  Southwest			
<b>Description:</b>  <u>Location:</u> Northeast corner of Cell 7.  Straw wattles are present to minimize erosion.

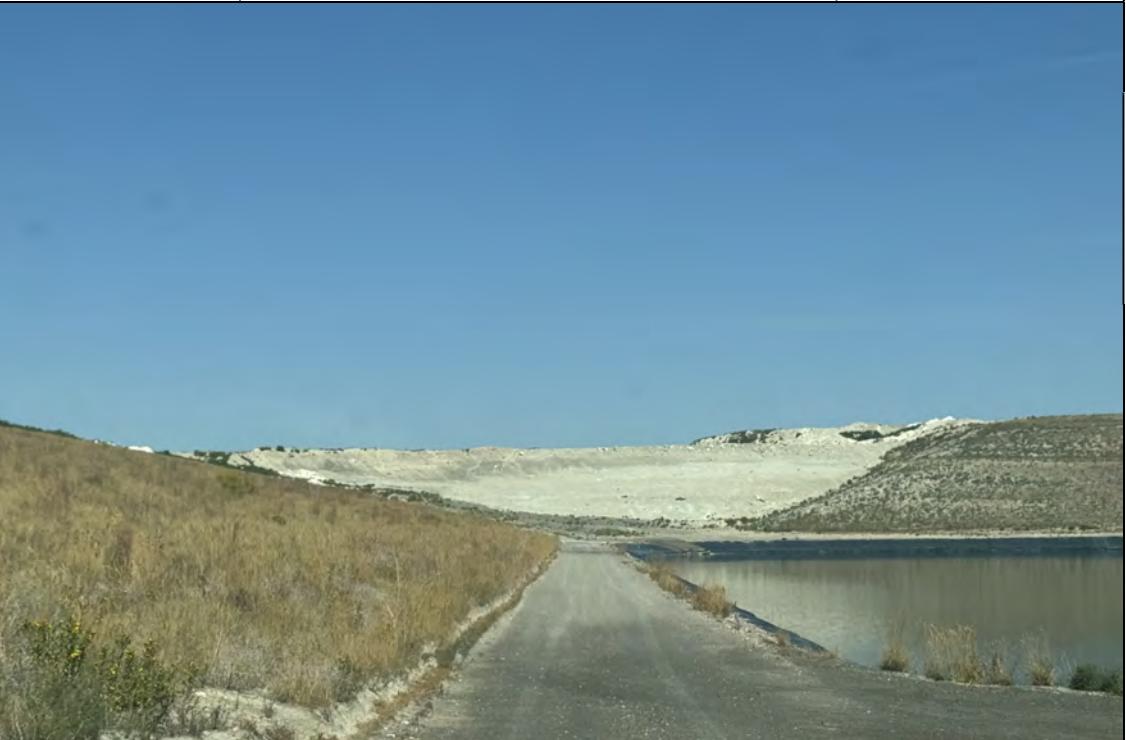
<b>Client Name:</b> Basin Electric Power Cooperative		<b>Site Location:</b> Laramie River Station, Wheatland, WY	<b>Project No.</b> 60732883
<b>Photo No.</b> 7	<b>Date:</b> 9/8/2025

<b>Direction Photo Taken:</b>			North
<b>Description:</b> <p><u>Location:</u> Western side of BAP-2.</p> <p>Active landfill face.</p>

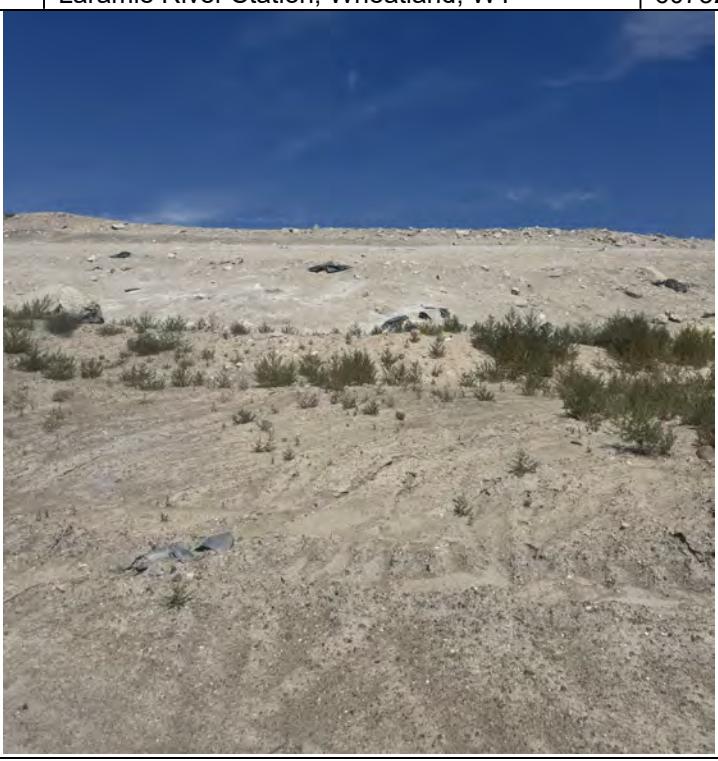
<b>Client Name:</b> Basin Electric Power Cooperative		<b>Site Location:</b> Laramie River Station, Wheatland, WY	<b>Project No.</b> 60732883
<b>Photo No.</b> 8	<b>Date:</b> 9/8/2025

<b>Direction Photo Taken:</b>			North
<b>Description:</b> <p><u>Location:</u> Cells 2 and 8.</p> <p>Closeup of the active landfill face.</p>

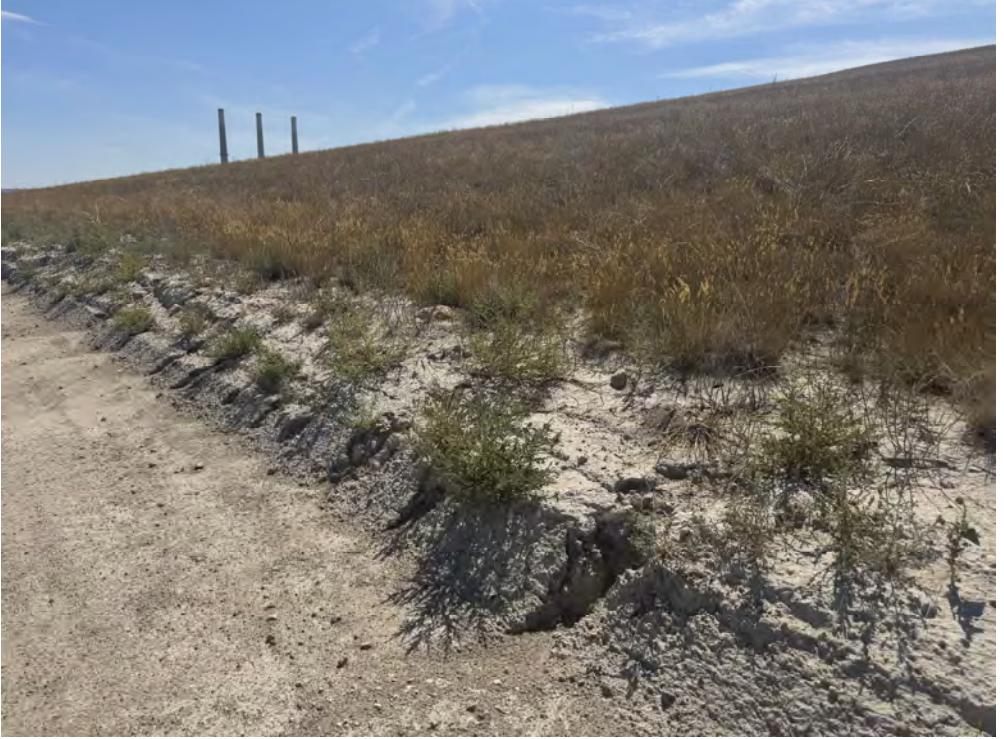
<b>Client Name:</b> Basin Electric Power Cooperative		<b>Site Location:</b> Laramie River Station, Wheatland, WY	<b>Project No.</b> 60732883
<b>Photo No.</b> <b>9</b>	<b>Date:</b> 9/8/2025

<b>Direction Photo Taken:</b>  East			
<b>Description:</b>  <u>Location:</u> Northern side of Cell 4.  Slight erosion alongside the edge of the road.

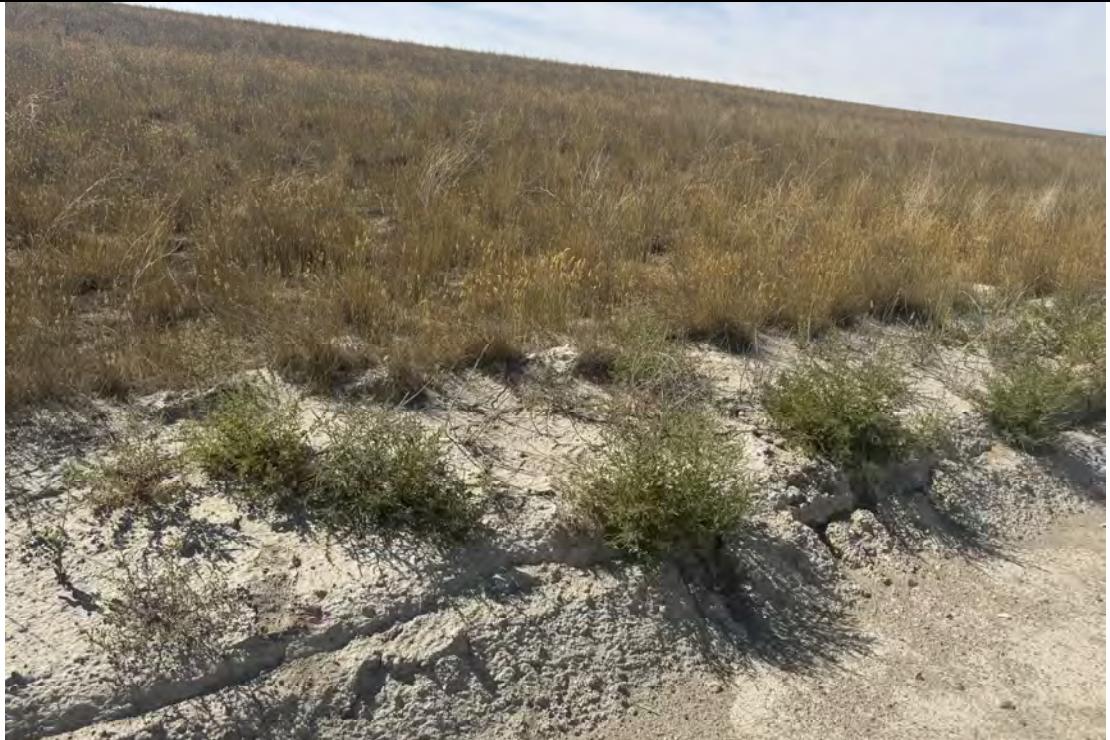
<b>Client Name:</b> Basin Electric Power Cooperative		<b>Site Location:</b> Laramie River Station, Wheatland, WY	<b>Project No.</b> 60732883
<b>Photo No.</b> <b>10</b>	<b>Date:</b> 9/8/2025

<b>Direction Photo Taken:</b>  East			
<b>Description:</b>  <u>Location:</u> Northern side of Cell 4.  Closeup of the erosion along the edge of the road.

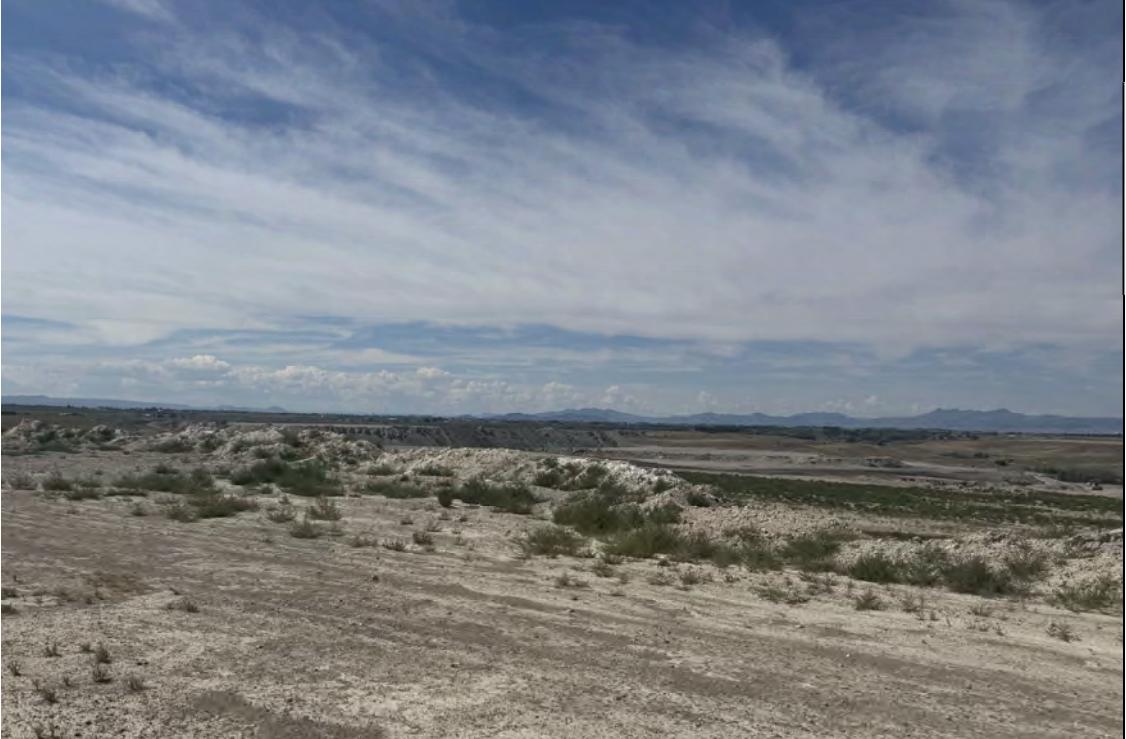
<b>Client Name:</b> Basin Electric Power Cooperative		<b>Site Location:</b> Laramie River Station, Wheatland, WY	<b>Project No.</b> 60732883
<b>Photo No.</b> <b>11</b>	<b>Date:</b> 9/8/2025

<b>Direction Photo Taken:</b>  West			
<b>Description:</b>  <u>Location:</u> Top of Cell 3.  View of Future Cell 10.

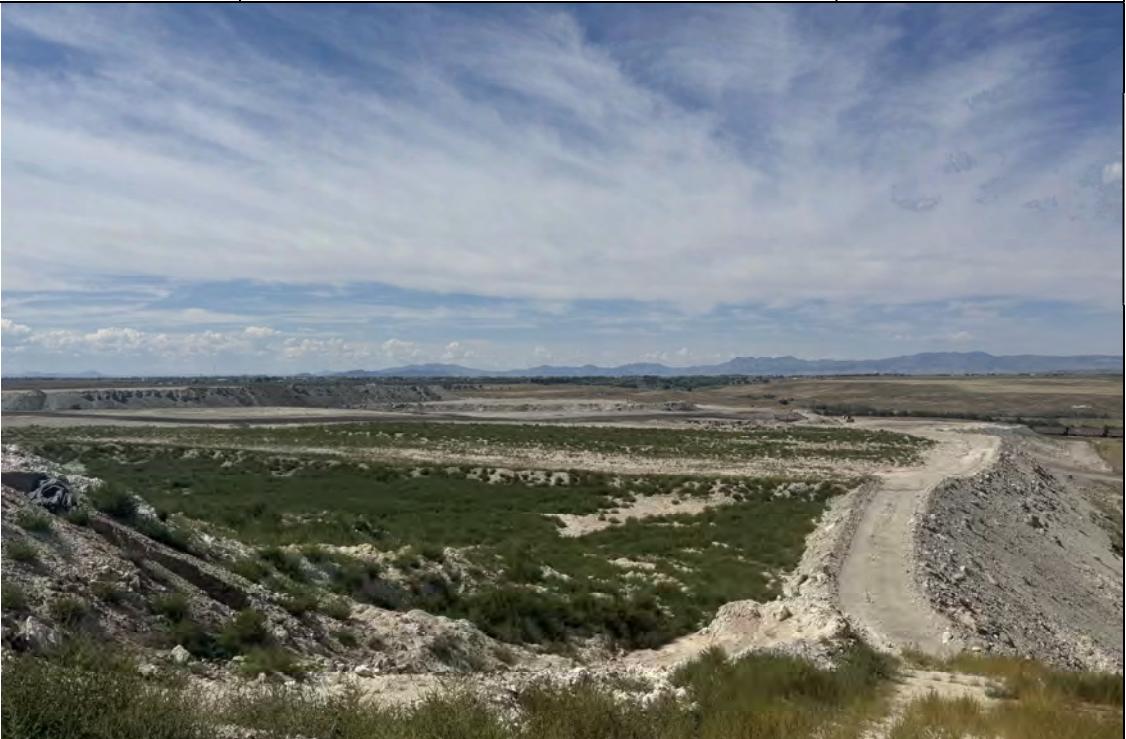
<b>Client Name:</b> Basin Electric Power Cooperative		<b>Site Location:</b> Laramie River Station, Wheatland, WY	<b>Project No.</b> 60732883
<b>Photo No.</b> <b>12</b>	<b>Date:</b> 9/8/2025

<b>Direction Photo Taken:</b>  West			
<b>Description:</b>  <u>Location:</u> Top of Cell 3.  View of Future Cell 10.

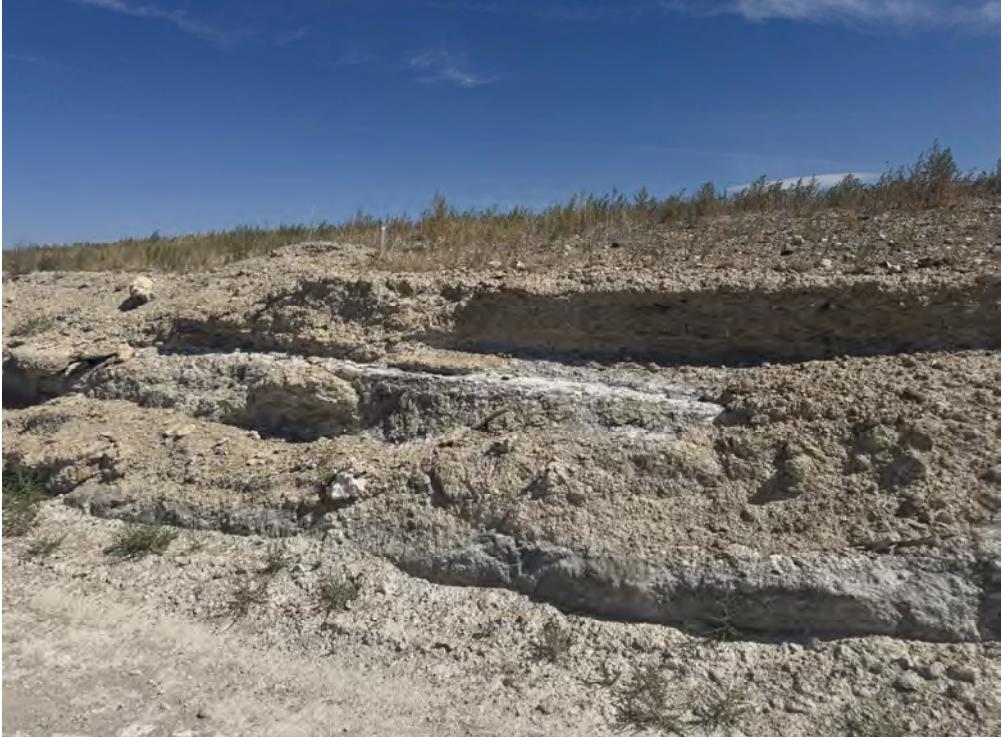
<b>Client Name:</b> Basin Electric Power Cooperative		<b>Site Location:</b> Laramie River Station, Wheatland, WY	<b>Project No.</b> 60732883
<b>Photo No.</b> <b>13</b>	<b>Date:</b> 9/8/2025

While no significant issues were observed that would impact the structural or containment integrity of the landfill, fly ash, as well as a larger piece of solidified ash, are exposed along the western side of Cell 3 (**Attachment C – Photos 13, 14, and 15**). Limited vegetation coverage was also noted alongside the western slope of Cell 3 (**Attachment C – Photo 15**). Based on the observations noted during the annual inspections, it is recommended that LRS staff address the following:

<b>Direction Photo Taken:</b> East			
<b>Description:</b> <u>Location:</u> Western side of Cell 3. Poor vegetation cover. Exposed layers of presumed ash are visible.

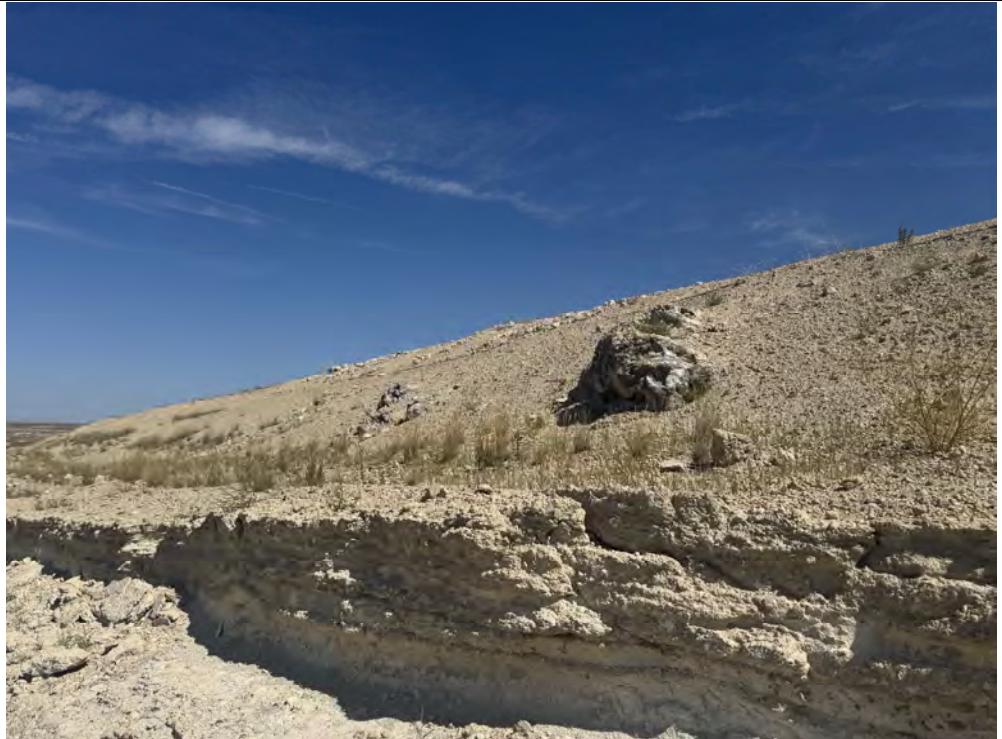
<b>Client Name:</b> Basin Electric Power Cooperative		<b>Site Location:</b> Laramie River Station, Wheatland, WY	<b>Project No.</b> 60732883
<b>Photo No.</b> <b>14</b>	<b>Date:</b> 9/8/2025

<b>Direction Photo Taken:</b> East			
<b>Description:</b> <u>Location:</u> Western side of Cell 3. Poor vegetation cover. An exposed block of presumed ash is visible.

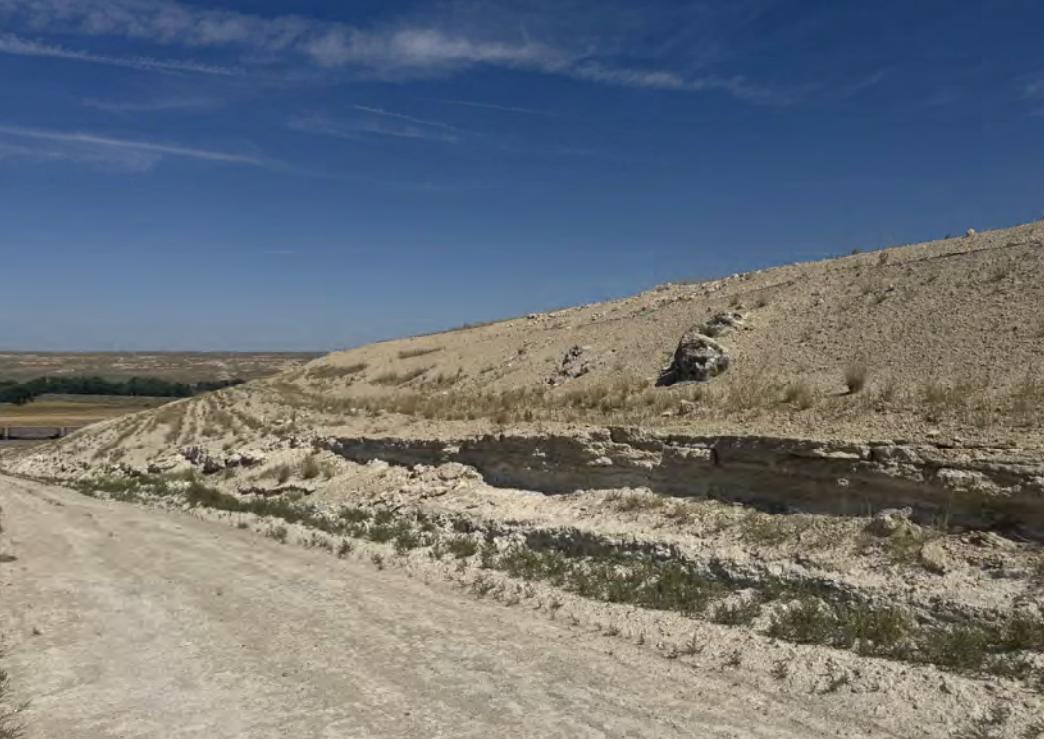
<b>Client Name:</b> Basin Electric Power Cooperative		<b>Site Location:</b> Laramie River Station, Wheatland, WY	<b>Project No.</b> 60732883
<b>Photo No.</b> <b>15</b>	<b>Date:</b> 9/8/2025

<b>Direction Photo Taken:</b>  Northeast			
<b>Description:</b>  <u>Location:</u> Western side of Cell 3.  Poor vegetation cover.  A distant view of the presumed block of ash pictured above.

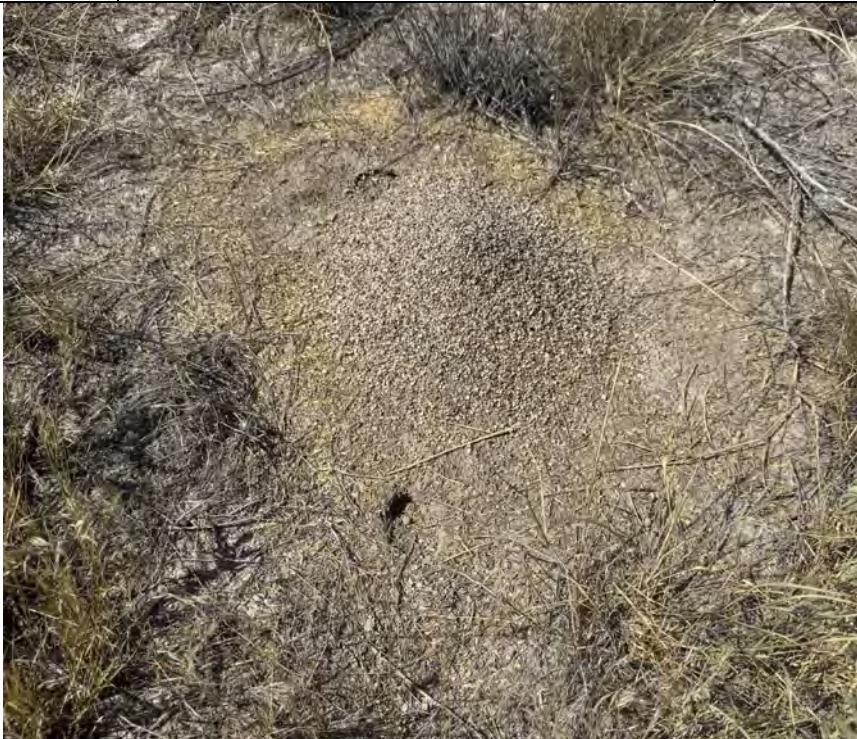
<b>Client Name:</b> Basin Electric Power Cooperative		<b>Site Location:</b> Laramie River Station, Wheatland, WY	<b>Project No.</b> 60732883
<b>Photo No.</b> <b>16</b>	<b>Date:</b> 9/8/2025

<b>Direction Photo Taken:</b>  Bird's-eye view			
<b>Description:</b>  <u>Location:</u> Cell 2.  An anthill is shown.

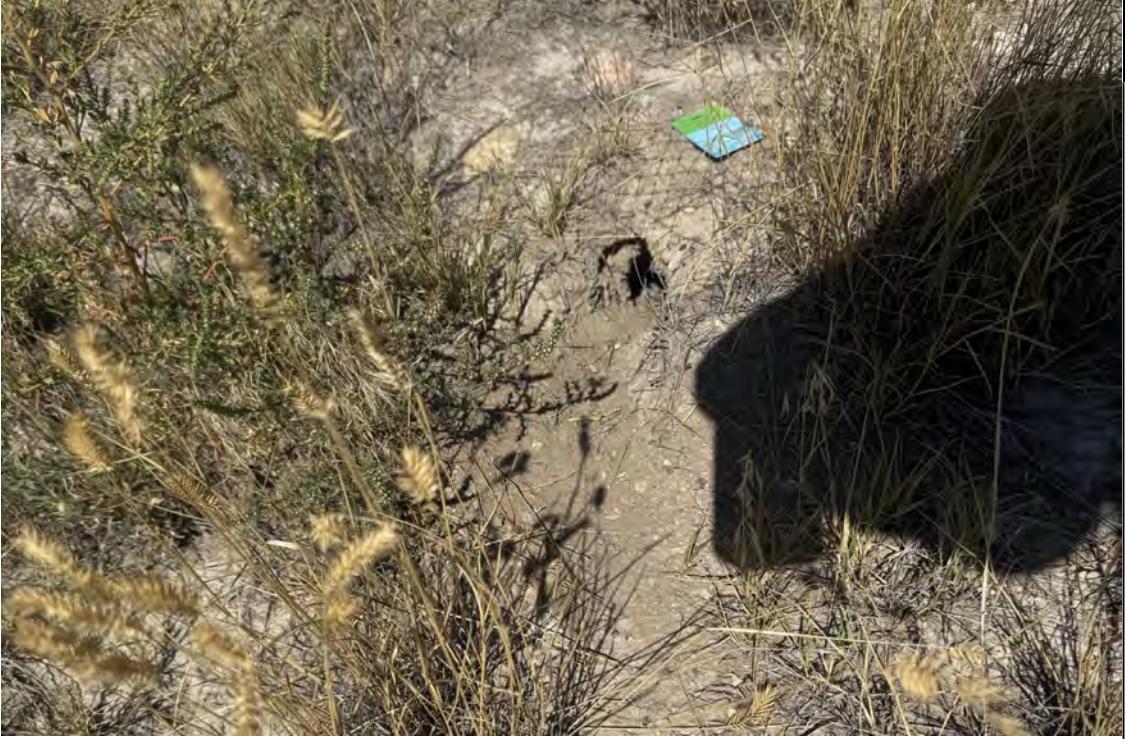
<b>Client Name:</b> Basin Electric Power Cooperative		<b>Site Location:</b> Laramie River Station, Wheatland, WY	<b>Project No.</b> 60732883
<b>Photo No.</b> <b>17</b>	<b>Date:</b> 9/8/2025

<b>Direction Photo Taken:</b>  Bird's eye view			
<b>Description:</b>  <u>Location:</u> Cell 5.  A small animal burrow is pictured.

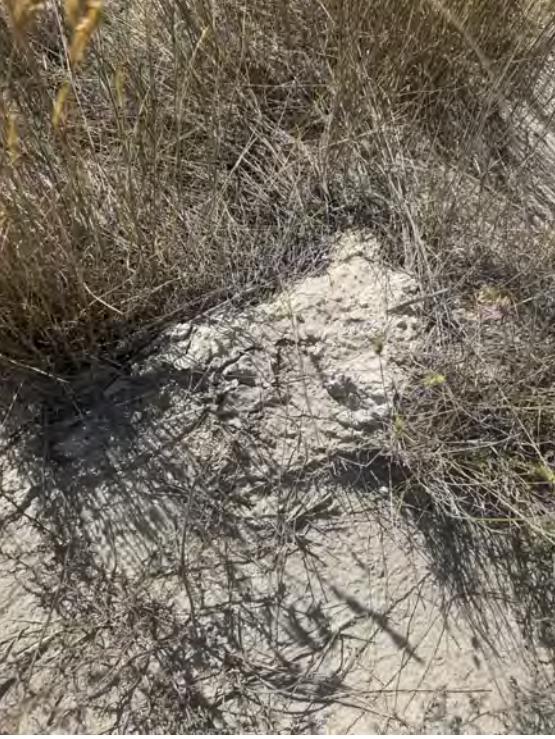
<b>Client Name:</b> Basin Electric Power Cooperative		<b>Site Location:</b> Laramie River Station, Wheatland, WY	<b>Project No.</b> 60732883
<b>Photo No.</b> <b>18</b>	<b>Date:</b> 9/8/2025

<b>Direction Photo Taken:</b>  Birds-eye view			
<b>Description:</b>  <u>Location:</u> Northern side of Cell 4.  Suspect ash is pictured above the ground surface along the road side.
