Submitted by:
AECOM
Fort Collins, CO
60732883
January 2026

Basin Electric Power Cooperative Laramie River Station

Coal Combustion Residual Surface Impoundment Annual Inspection Report – 2025

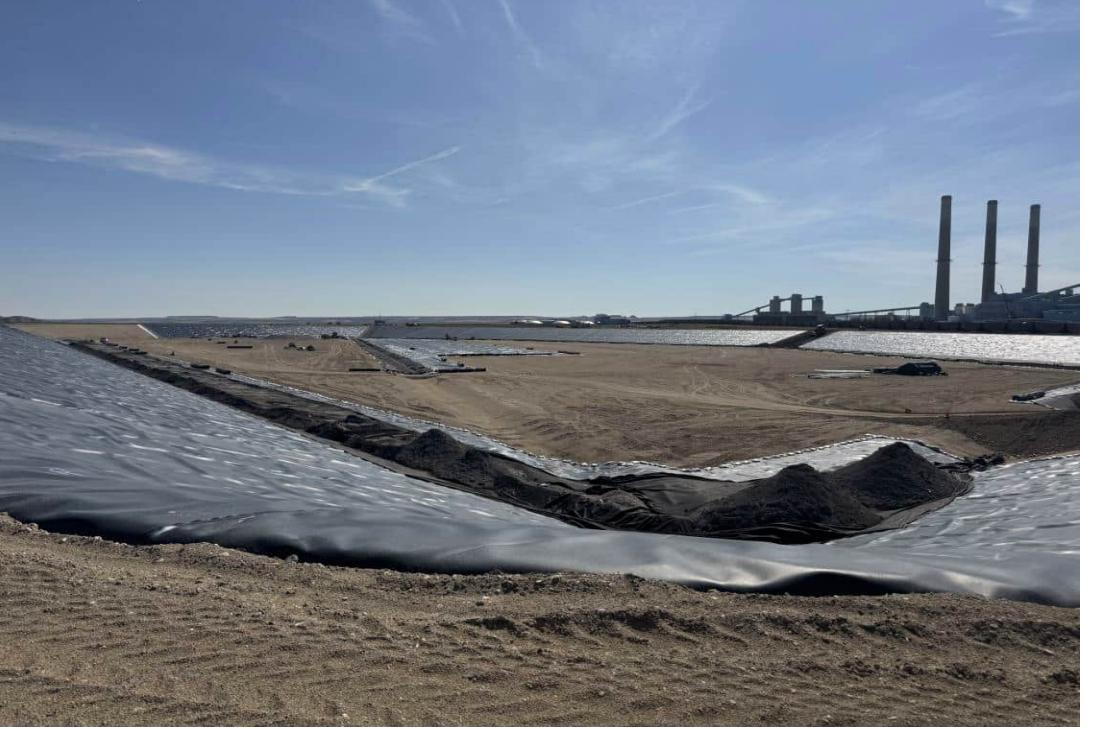
Client Name: Basin Electric Power Cooperative		Site Location: Laramie River Station, Wheatland, WY	Project No. 60732883
Photo No. 1	Date: 9/8/25	Direction Photo Taken: Southeast	
Description: <u>Location:</u> Northwest corner of W-EHP. Liner being installed in W-EHP.

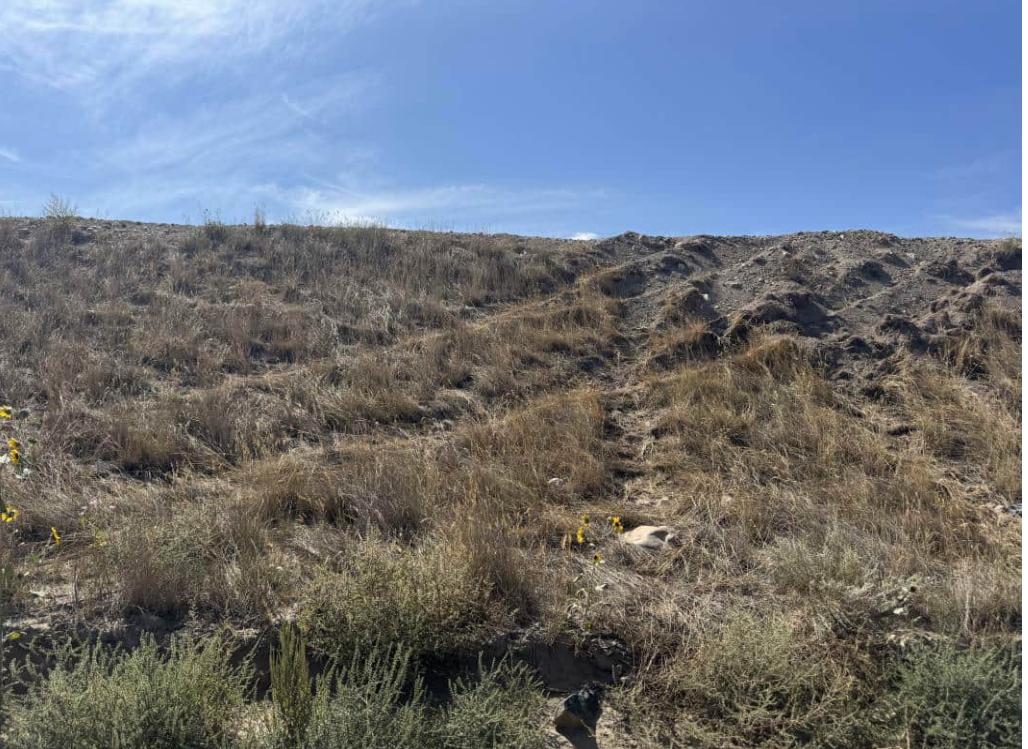
Client Name: Basin Electric Power Cooperative		Site Location: Laramie River Station, Wheatland, WY	Project No. 60732883	
Photo No. 2	Date: 9/8/25	Direction Photo Taken: Northwest	Description: <u>Location:</u> Berm along the south side of W-EHP. Vehicle tracks along the berm, most likely from construction activities taking place.

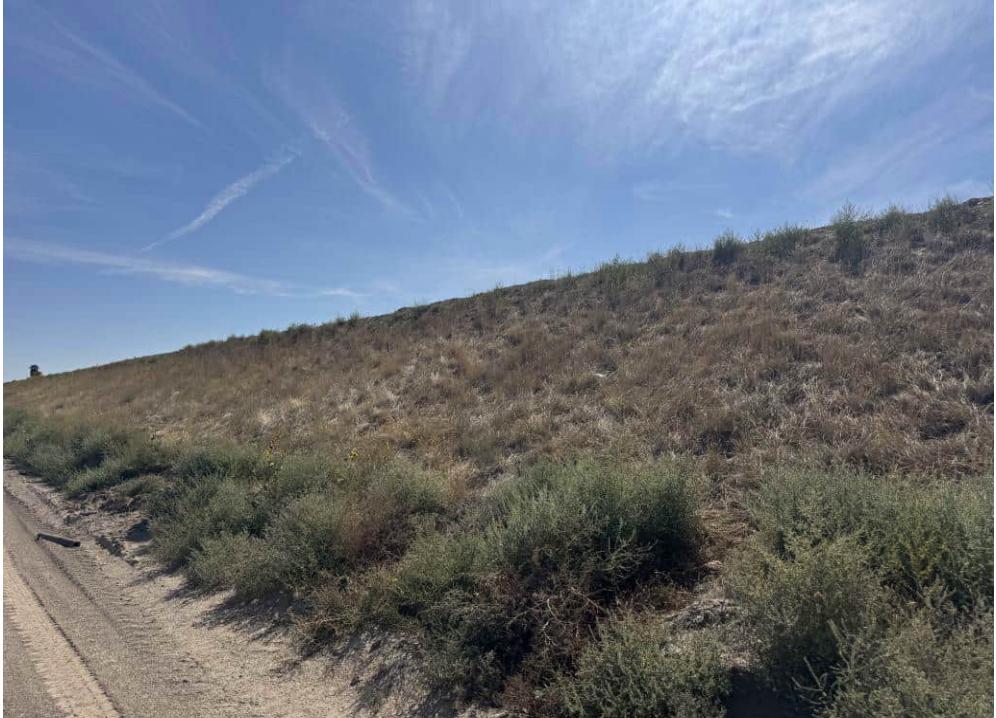
Client Name: Basin Electric Power Cooperative		Site Location: Laramie River Station, Wheatland, WY	Project No. 60732883
Photo No. 3	Date: 9/8/25

Direction Photo Taken: Northeast			
Description: <u>Location:</u> Berm along the north side of the W-EHP. Strong vegetation along the berm.

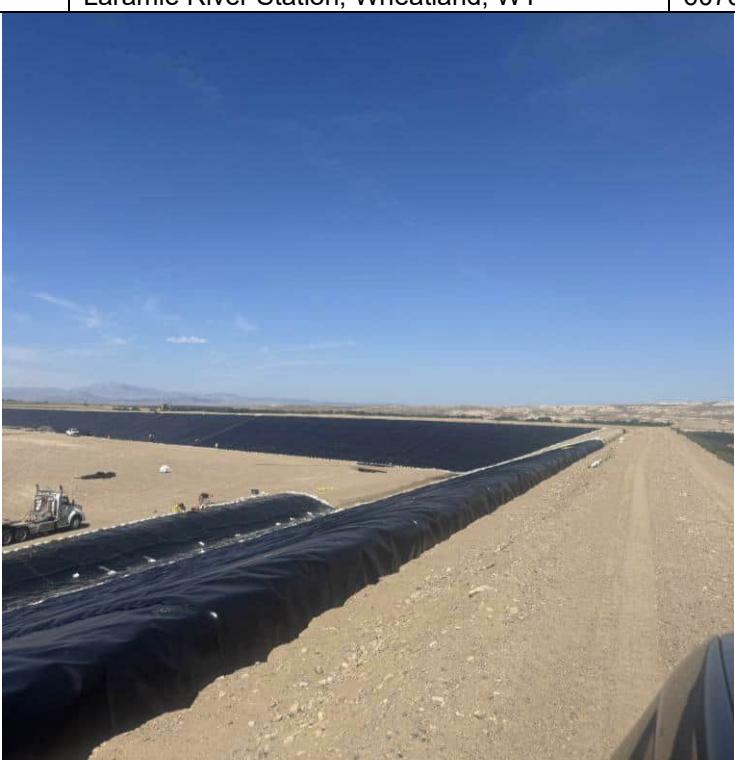
Client Name: Basin Electric Power Cooperative		Site Location: Laramie River Station, Wheatland, WY	Project No. 60732883
Photo No. 4	Date: 9/8/25

Direction Photo Taken: Northwest			
Description: <u>Location:</u> Between the W-EHP and E-EHP. Liner system being installed in W-EHP.

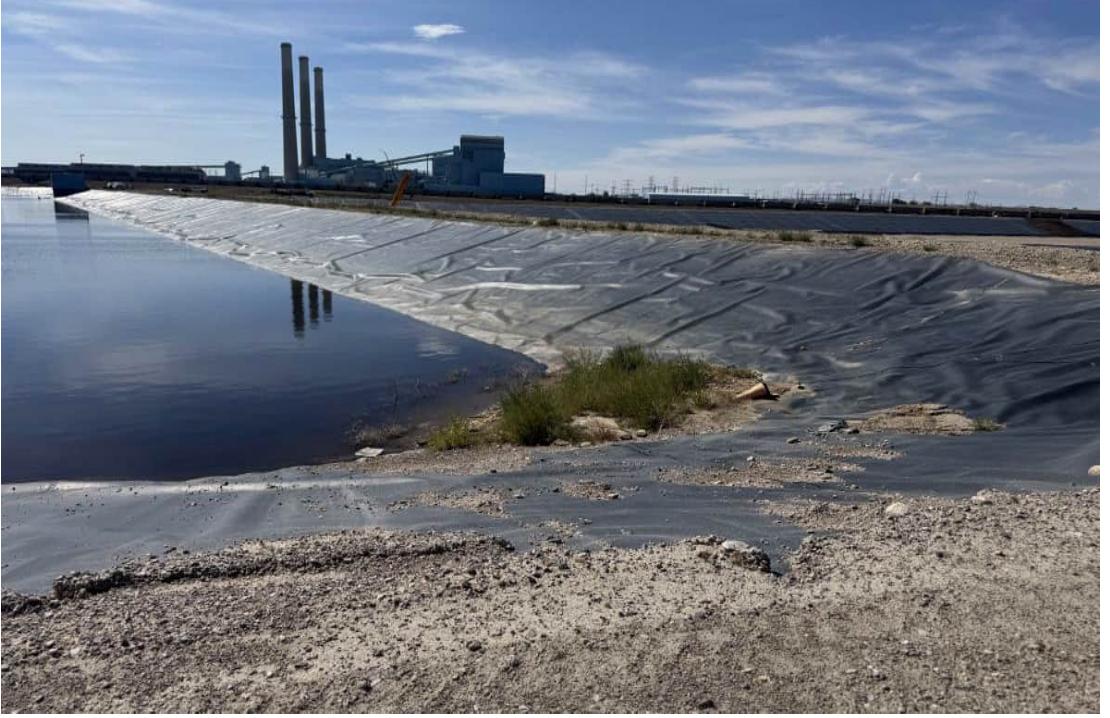
Client Name: Basin Electric Power Cooperative		Site Location: Laramie River Station, Wheatland, WY	Project No. 60732883
Photo No. 5	Date: 9/8/25

Direction Photo Taken: Southwest			
Description: <u>Location:</u> Northwest corner of E-EHP. Vegetation and sediment buildup in the northwest corner of the E-EHP.

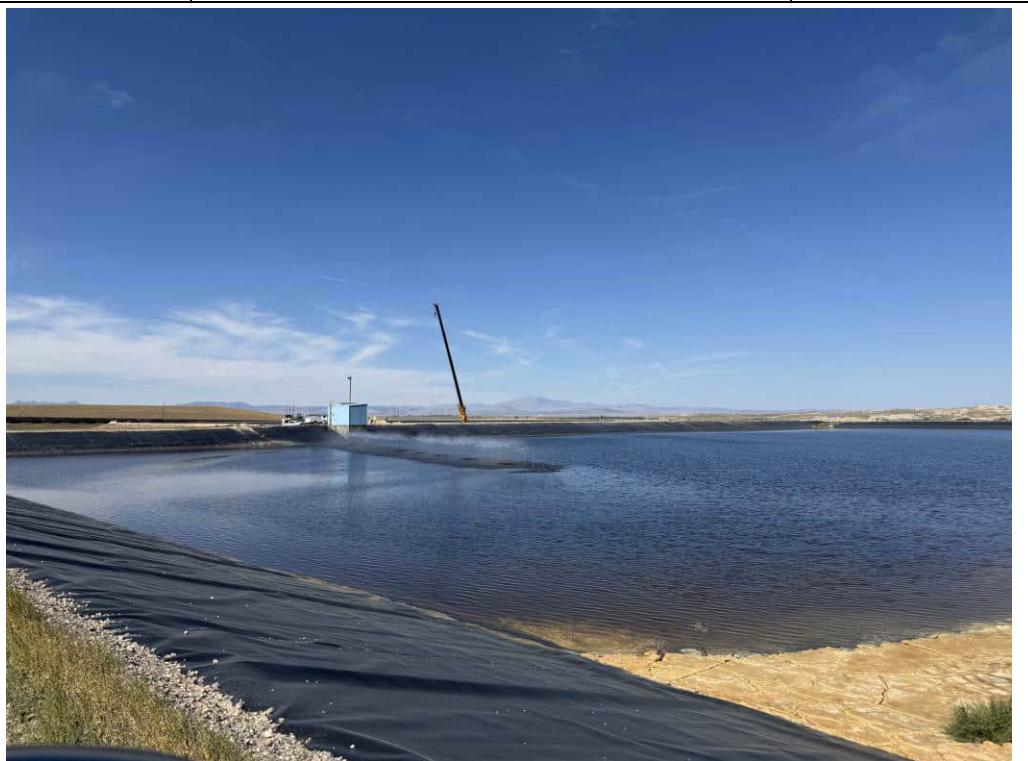
Client Name: Basin Electric Power Cooperative		Site Location: Laramie River Station, Wheatland, WY	Project No. 60732883
Photo No. 6	Date: 9/8/25

Direction Photo Taken: Northeast			
Description: <u>Location:</u> South side of E-EHP. View of E-EHP and evaporators in the pond.

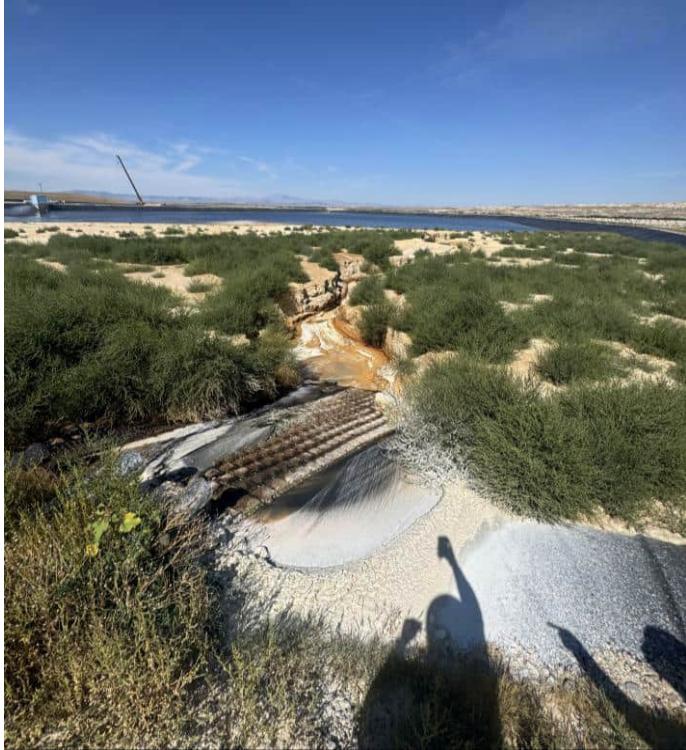
Client Name: Basin Electric Power Cooperative		Site Location: Laramie River Station, Wheatland, WY	Project No. 60732883
Photo No. 7	Date: 9/8/25		
Direction Photo Taken: North			
Description: <u>Location:</u> Southeast corner of E-EHP. Outfall into E-EHP and the surrounding sediment and vegetation buildup.

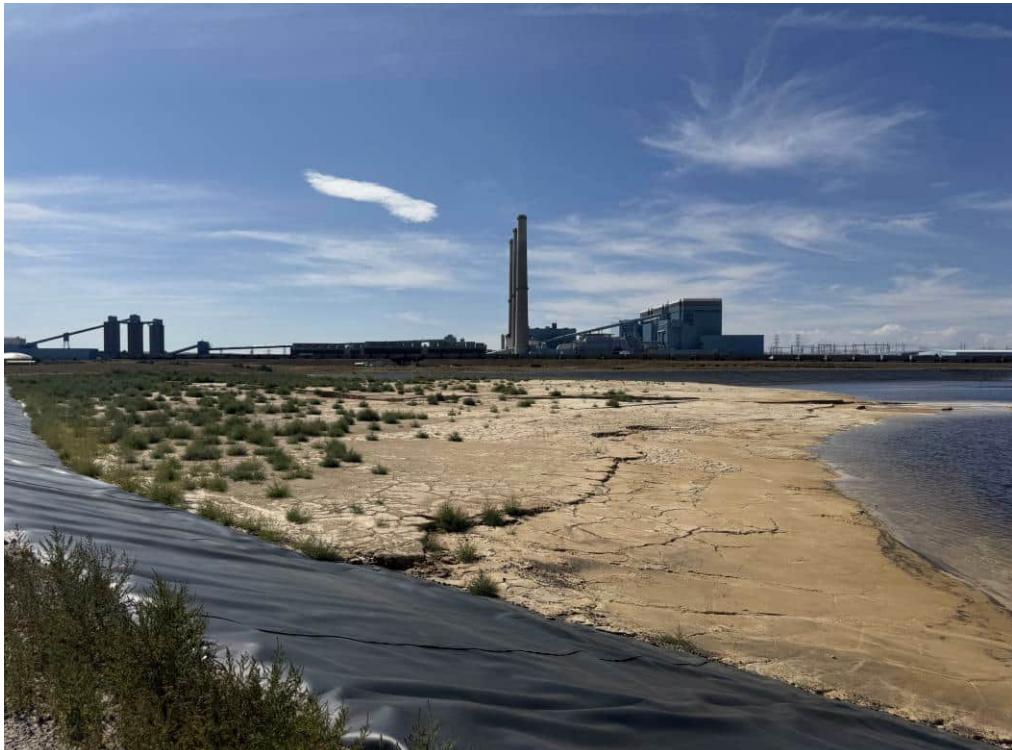
Client Name: Basin Electric Power Cooperative		Site Location: Laramie River Station, Wheatland, WY	Project No. 60732883
Photo No. 8	Date: 9/8/25		
Direction Photo Taken: Southeast			
Description: <u>Location:</u> Eastern side of E-EHP. Sediment buildup and vegetation growth within the southeast corner of E-EHP.

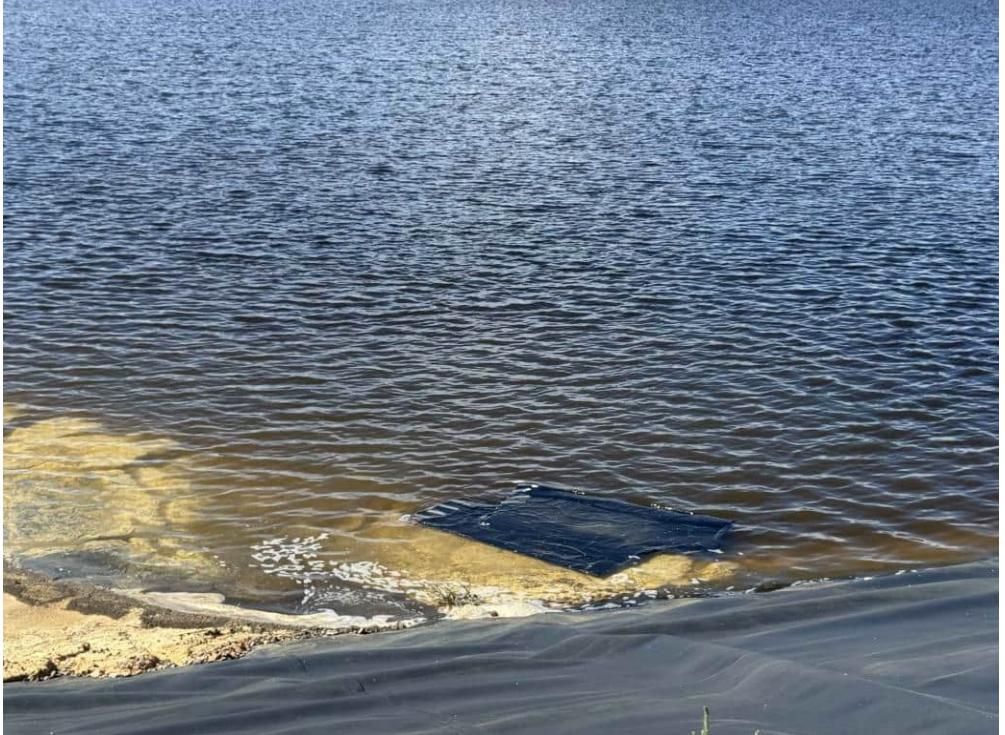
Client Name: Basin Electric Power Cooperative		Site Location: Laramie River Station, Wheatland, WY	Project No. 60732883
Photo No. 9	Date: 9/8/25

Direction Photo Taken:			East
Description:			<u>Location:</u> Eastern side of E-EHP. A piece of debris floating in E-EHP.

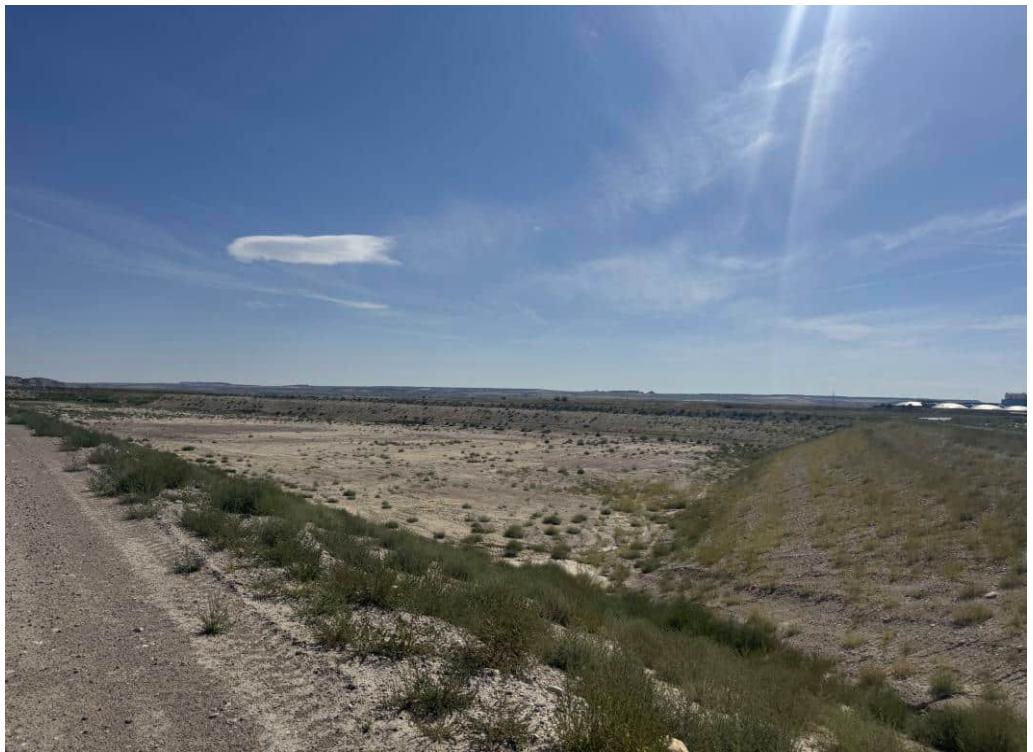
Client Name: Basin Electric Power Cooperative		Site Location: Laramie River Station, Wheatland, WY	Project No. 60732883
Photo No. 10	Date: 9/8/25

Direction Photo Taken:			Northeast
Description:			<u>Location:</u> Northwest corner of EL-EHP. A view of EL-EHP, which is empty and no longer has a liner. All CCR was removed.

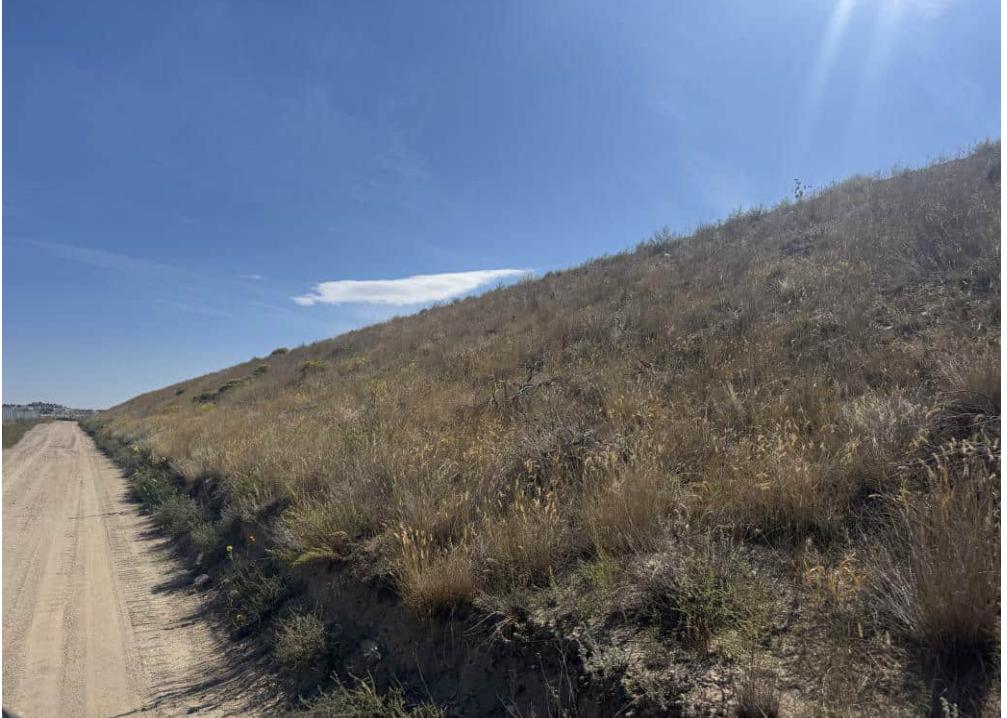
Client Name: Basin Electric Power Cooperative		Site Location: Laramie River Station, Wheatland, WY	Project No. 60732883
Photo No. 11	Date: 9/8/25

Direction Photo Taken: Northeast			
Description: <u>Location:</u> Northern side of EL-EHP. Strong vegetation along the northern berm of EL-EHP.

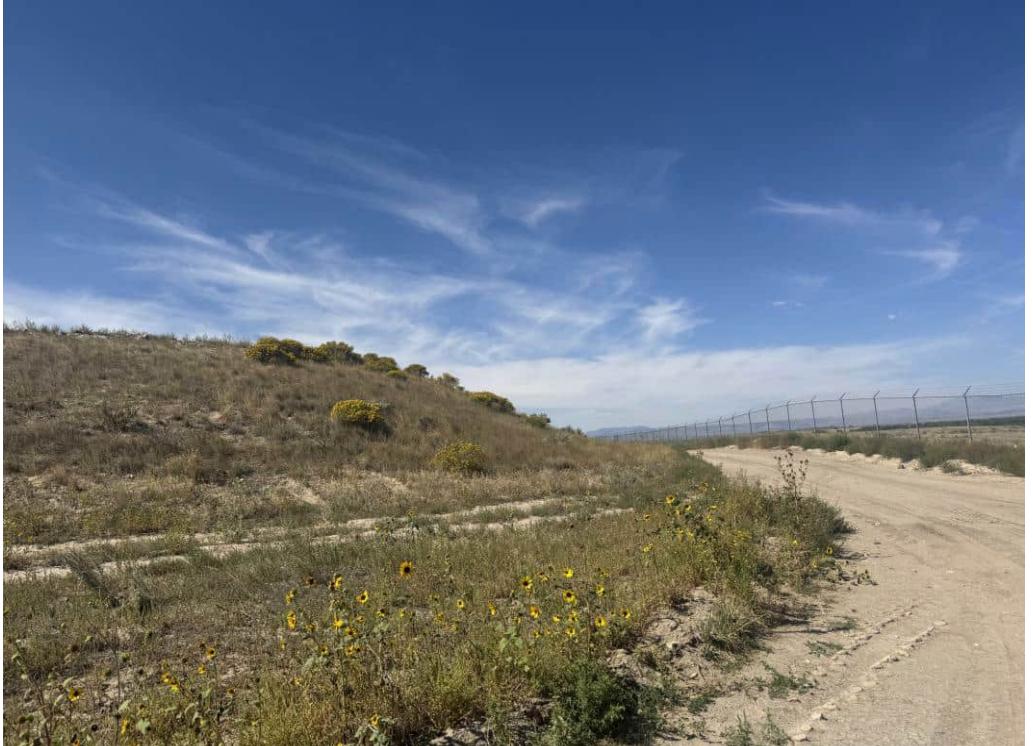
Client Name: Basin Electric Power Cooperative		Site Location: Laramie River Station, Wheatland, WY	Project No. 60732883
Photo No. 12	Date: 9/8/25

Direction Photo Taken: Northwest			
Description: <u>Location:</u> Northeast corner of EL-EHP. A two-track road has formed along the eastern side of EL-EHP, likely from construction activities.

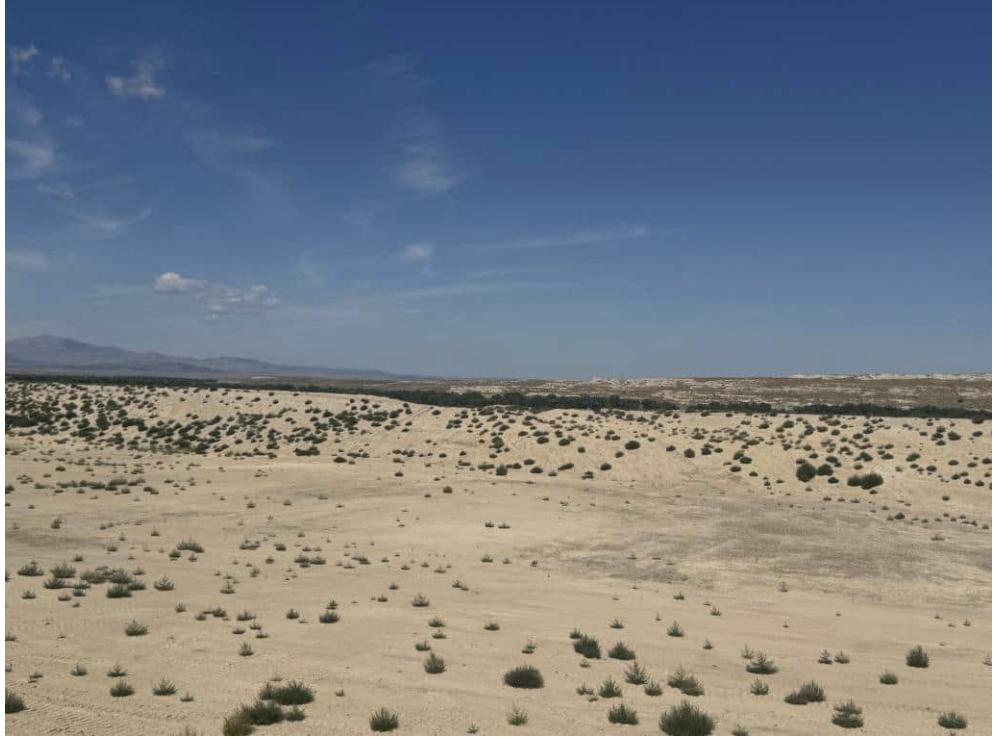
Client Name: Basin Electric Power Cooperative		Site Location: Laramie River Station, Wheatland, WY	Project No. 60732883
Photo No. 13	Date: 9/8/25

Direction Photo Taken: Northwest			
Description: <p><u>Location:</u> Southern side of EL-EHP.</p> <p>View of EL-EHP. The liner system has been removed and vegetation has started to grow within EL-EHP.</p>

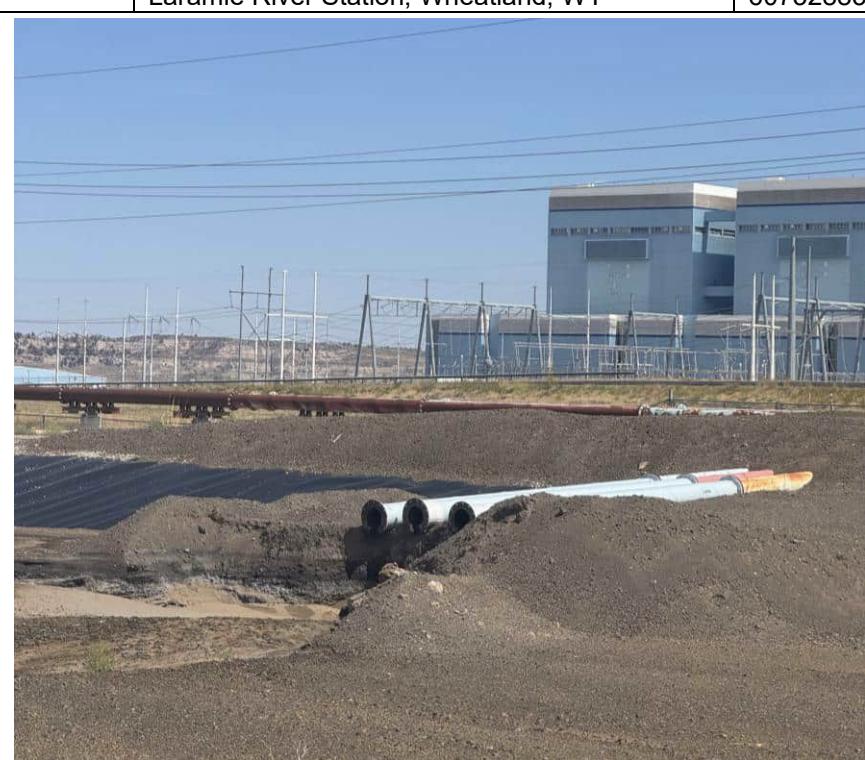
Client Name: Basin Electric Power Cooperative		Site Location: Laramie River Station, Wheatland, WY	Project No. 60732883
Photo No. 14	Date: 9/8/25

Direction Photo Taken: Northeast			
Description: <p><u>Location:</u> Southeast corner of BAP-3.</p> <p>Outfall into BAP-3.</p>

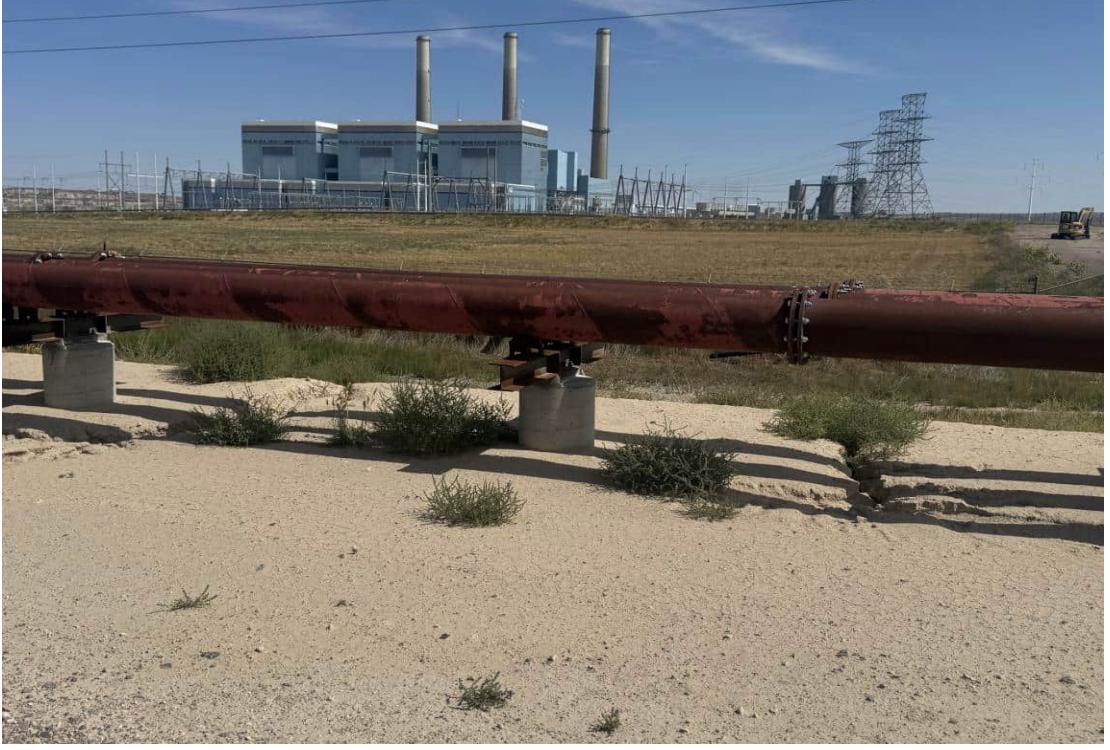
Client Name: Basin Electric Power Cooperative		Site Location: Laramie River Station, Wheatland, WY	Project No. 60732883
Photo No. 15	Date: 9/8/25

No significant deficiencies were noted as part of this annual inspection or document review. Minor erosion and desiccation cracking is present alongside BAP-1 and BAP-3 (**Attachment C – Photos 15, 16, and 28**). Large shrubs are present on the southern berm of BAP-2 (**Attachment C – Photo 22**). One of the outfall pipes in the northeast corner of BAP-2 is submerged in the pond (**Attachment C – Photo 25**).

Direction Photo Taken:			East
Description:			<p><u>Location:</u> Eastern side of BAP-3.</p> <p>Erosion rills under the piping.</p>

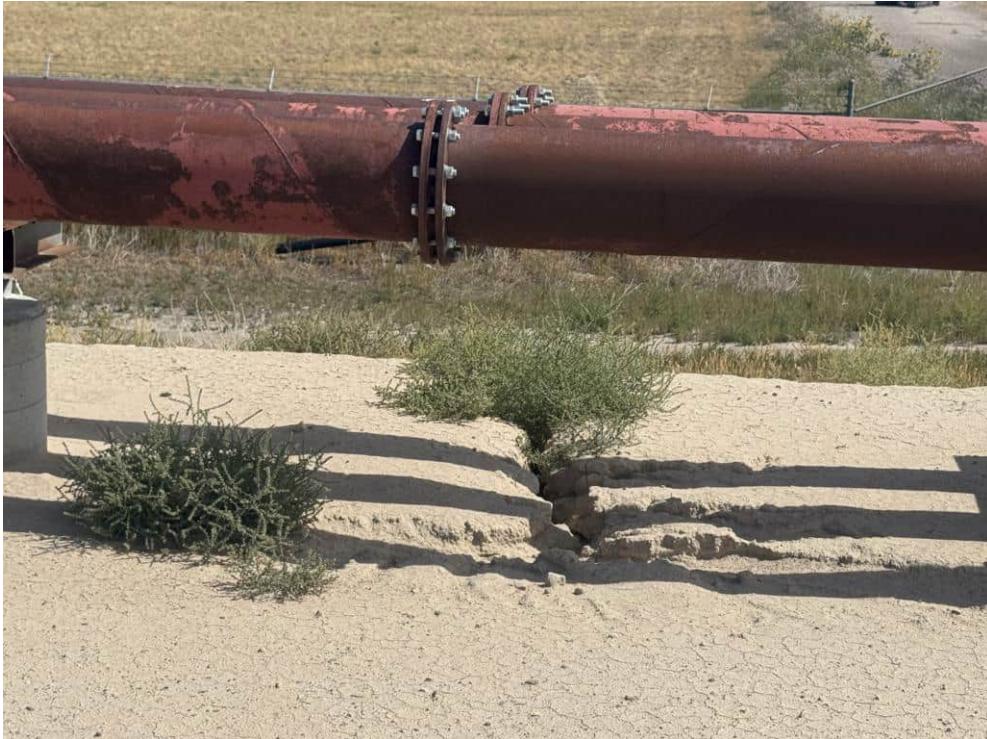
Client Name: Basin Electric Power Cooperative		Site Location: Laramie River Station, Wheatland, WY	Project No. 60732883
Photo No. 16	Date: 9/8/25

Direction Photo Taken:			East
Description:			<p><u>Location:</u> Eastern side of BAP-3.</p> <p>Closeup of an erosion rill under the piping.</p>

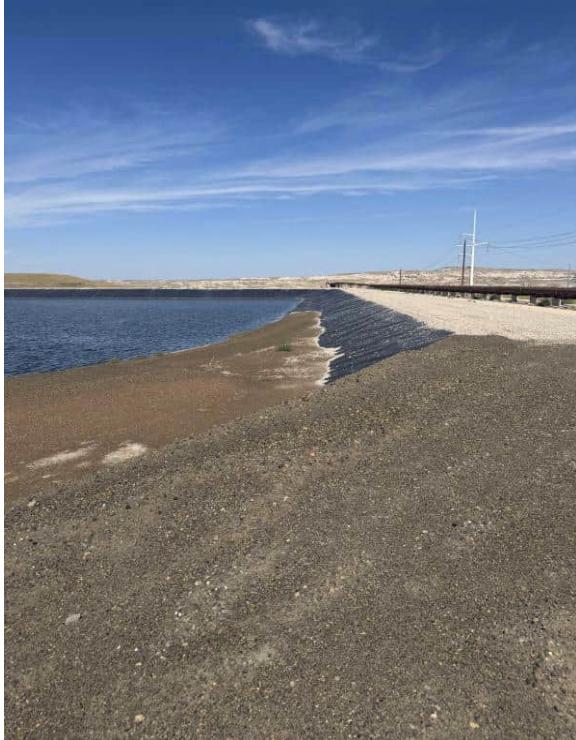
Client Name: Basin Electric Power Cooperative		Site Location: Laramie River Station, Wheatland, WY	Project No. 60732883
Photo No. 17	Date: 9/8/25		
Direction Photo Taken: North			
Description: <u>Location:</u> Eastern side of BAP-3. Sediment along the liner.

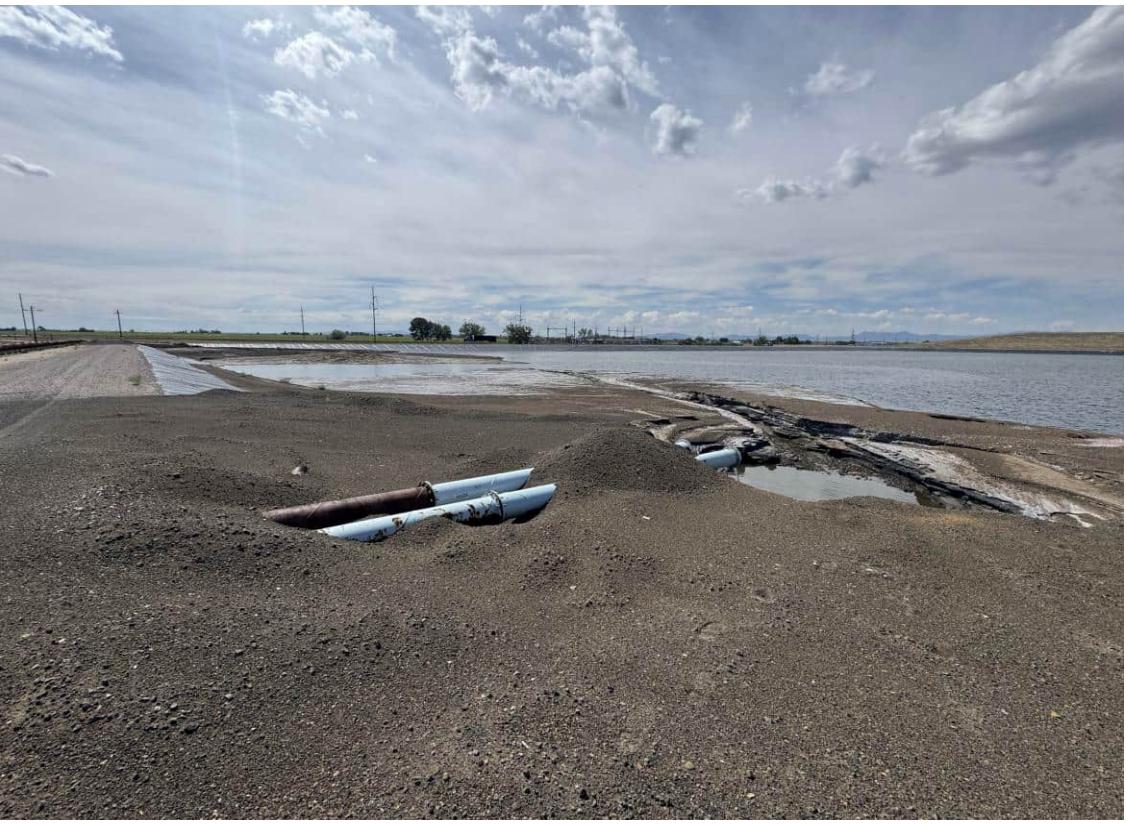
Client Name: Basin Electric Power Cooperative		Site Location: Laramie River Station, Wheatland, WY	Project No. 60732883
Photo No. 18	Date: 9/8/25		
Direction Photo Taken: Southwest

Description: <u>Location:</u> Eastern side of BAP-3. Outfall into BAP-3 with surrounding sediment.

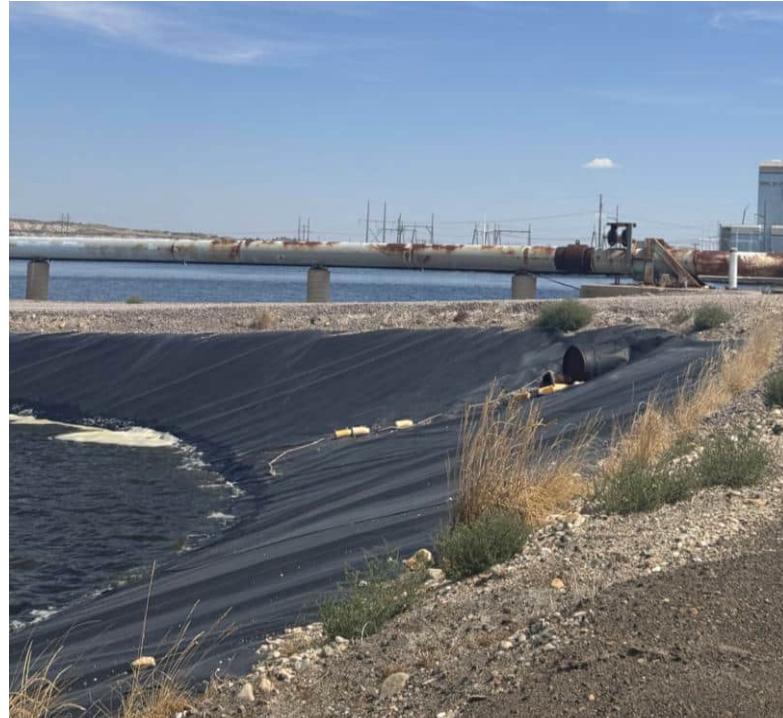
Client Name: Basin Electric Power Cooperative		Site Location: Laramie River Station, Wheatland, WY	Project No. 60732883
Photo No. 19	Date: 9/8/25		
Direction Photo Taken:			
East			
Description:			
<u>Location:</u> Southeast corner of BAP-2. Outfall into BAP-2.

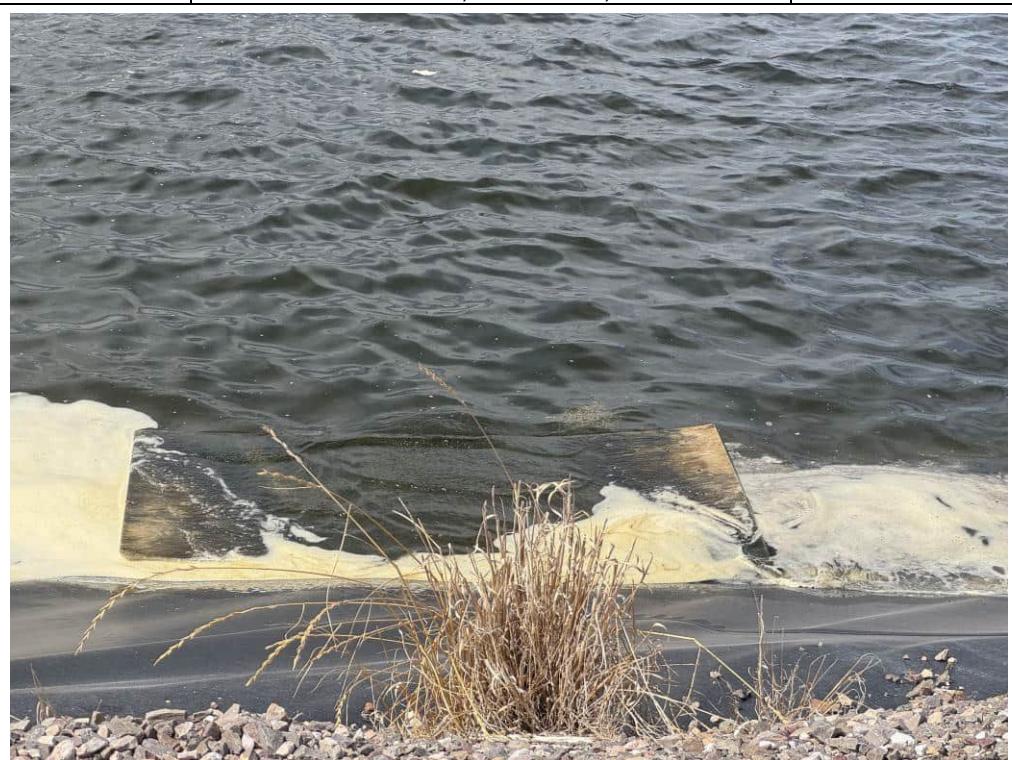
Client Name: Basin Electric Power Cooperative		Site Location: Laramie River Station, Wheatland, WY	Project No. 60732883
Photo No. 20	Date: 9/8/25		
Direction Photo Taken:			
West

Description:			
<u>Location:</u> Southeast corner of BAP-2. A piece of debris floating in BAP-2.

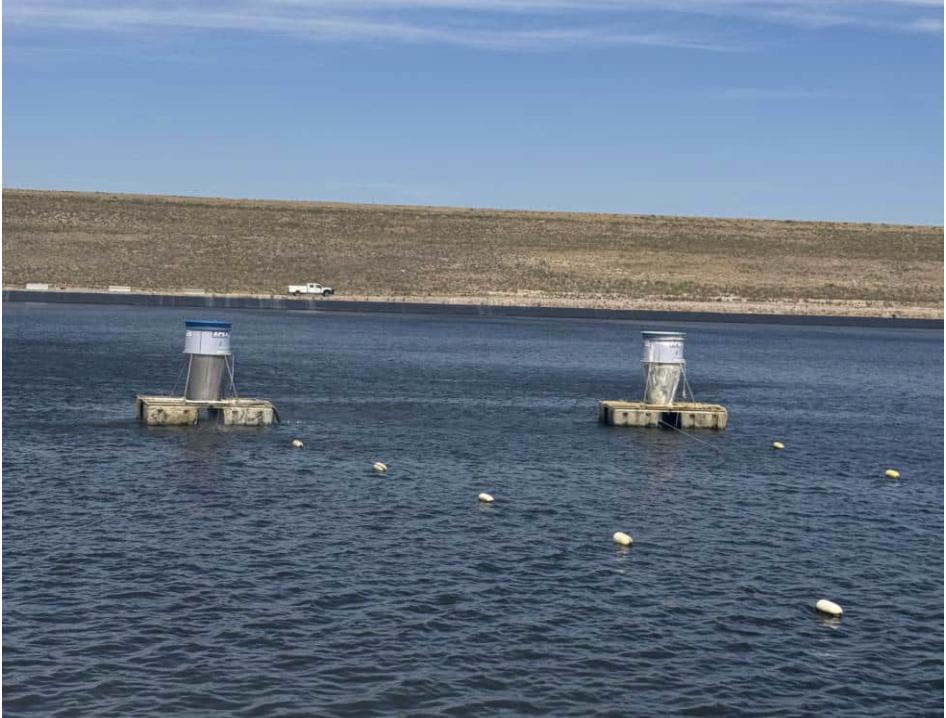
Client Name: Basin Electric Power Cooperative		Site Location: Laramie River Station, Wheatland, WY	Project No. 60732883
Photo No. 21	Date: 9/8/25

Direction Photo Taken:			
North			
Description:			
<p><u>Location:</u> South side of BAP-2.</p> <p>Evaporators present in BAP-2.</p>

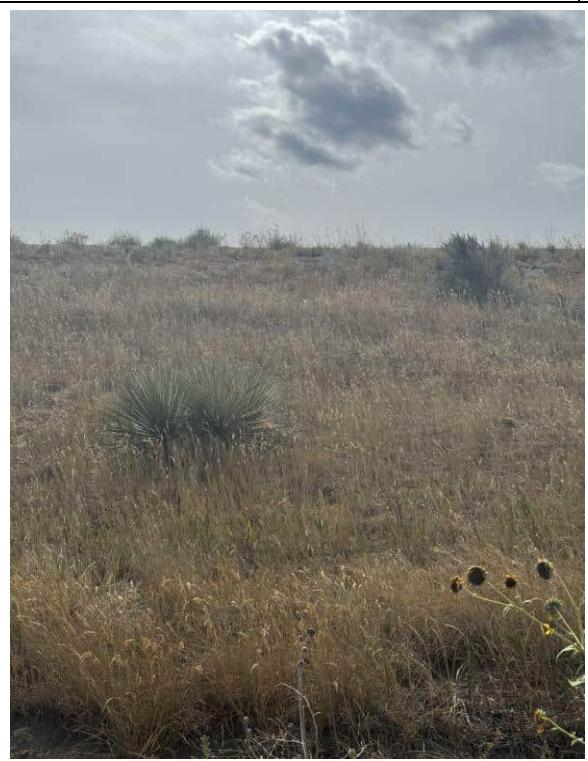
Client Name: Basin Electric Power Cooperative		Site Location: Laramie River Station, Wheatland, WY	Project No. 60732883
Photo No. 22	Date: 9/8/25

Direction Photo Taken:			
South			
Description:			
<p><u>Location:</u> Southern berm of BAP-2.</p> <p>Strong vegetation growing along the berm, which includes some larger plants.</p>

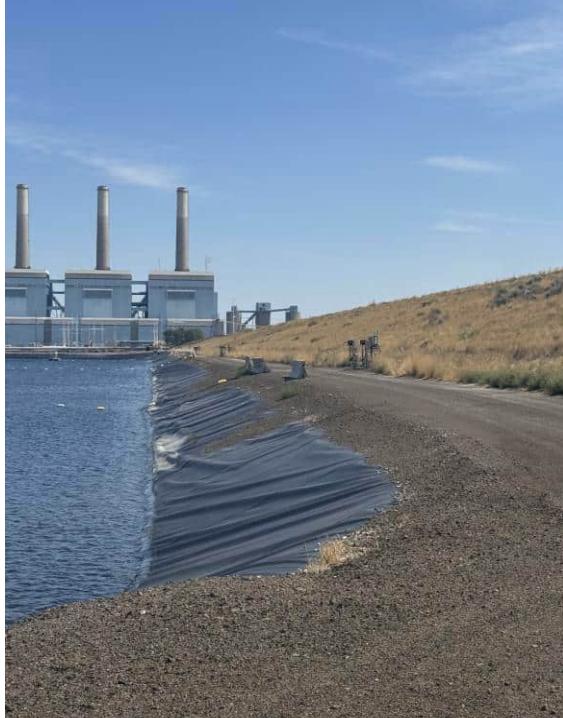
Client Name: Basin Electric Power Cooperative		Site Location: Laramie River Station, Wheatland, WY	Project No. 60732883
Photo No. 23	Date: 9/8/25		
Direction Photo Taken:			
East			
Description:			
<p><u>Location:</u> Southwest corner of BAP-2.</p> <p>Small amounts of gravel on the southern liner of BAP-2.</p>

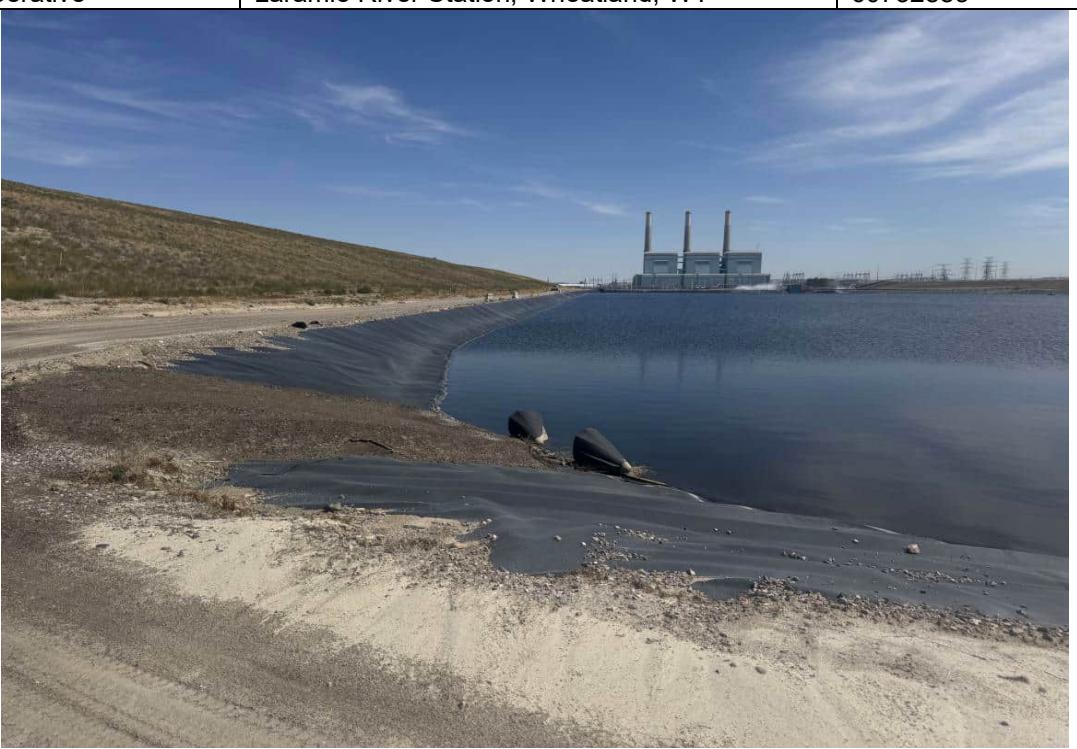
Client Name: Basin Electric Power Cooperative		Site Location: Laramie River Station, Wheatland, WY	Project No. 60732883
Photo No. 24	Date: 9/8/25		
Direction Photo Taken:			
East			
Description:			
<p><u>Location:</u> Northwest corner of BAP-2.</p> <p>Gravel ramp into BAP-2.</p>

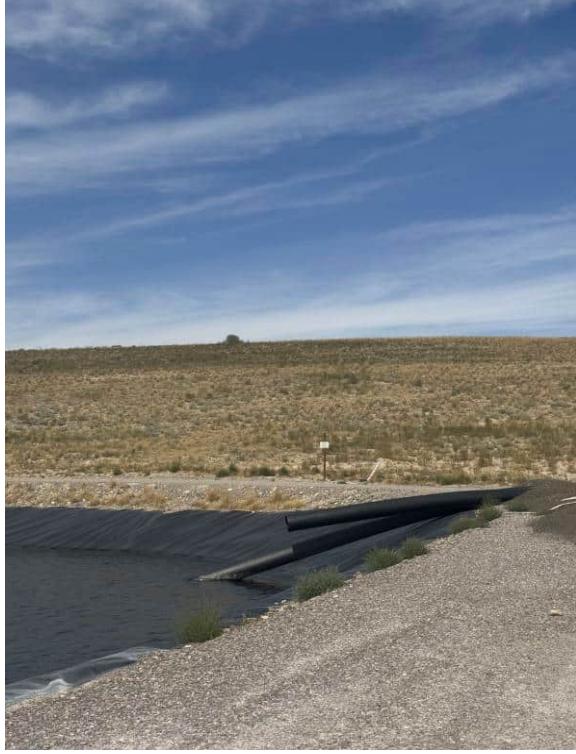
§ 257.83(b)(2)(iv)	Remaining estimated storage capacity (2025 inspection): <ul style="list-style-type: none"> - BAP-1: 16.42 MG - BAP-2: 34.86 MG - BAP-3: 87.80 MG
§ 257.83(b)(2)(v)	Approximate volume of impounded water and CCR (2025 inspection): <ul style="list-style-type: none"> - BAP-1: 119.2 MG - BAP-2: 179.3 MG - BAP-3: 151.5 MG
§ 257.83(b)(2)(vi)	There are no appearances of an actual or potential structural weakness of the impoundments, nor are there any existing conditions that are disrupting or have the potential to disrupt the operation and safety of the BAPs and appurtenant structures. Minor erosion and desiccation cracking was noted at BAP-1 and BAP-3 (Attachment C – Photos 15, 16, and 28). Connective piping between BAPs appear to be in good condition; however, one of two temporary pump transfer pipes in the northeast corner of BAP-2 was noted as being submerged (Attachment C – Photo 25).

Client Name: Basin Electric Power Cooperative		Site Location: Laramie River Station, Wheatland, WY	Project No. 60732883
Photo No. 25	Date: 9/8/25		
Direction Photo Taken: Northwest			
Description: <u>Location:</u> Northeast corner of BAP-2. Piping into BAP-2. One of the pipes is submerged in the pond.

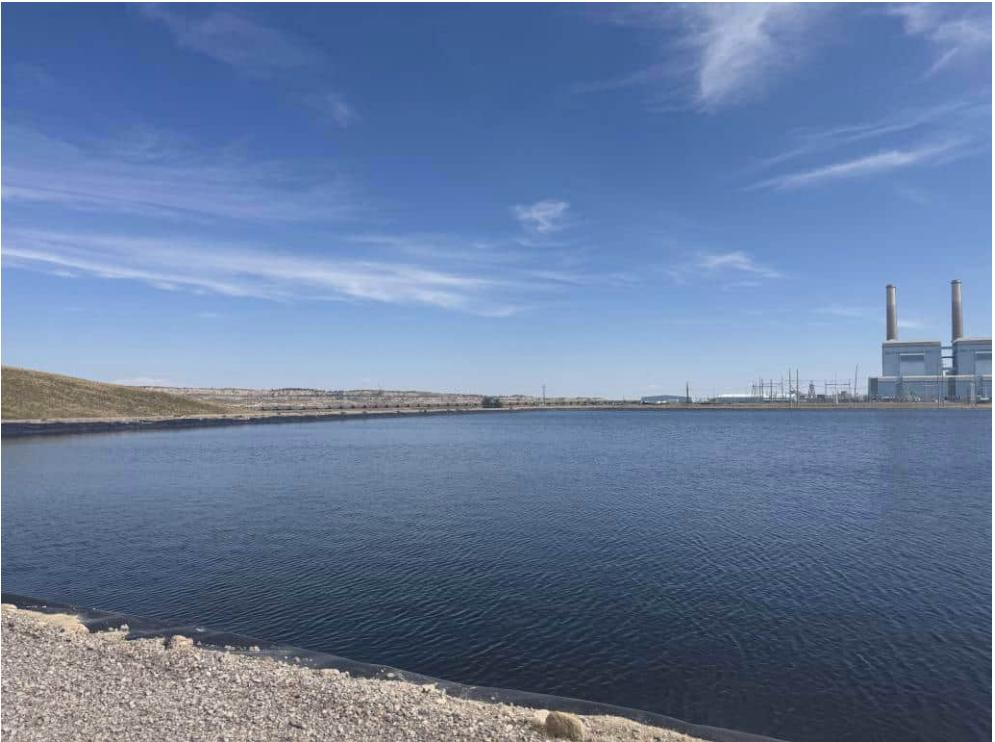
Client Name: Basin Electric Power Cooperative		Site Location: Laramie River Station, Wheatland, WY	Project No. 60732883
Photo No. 26	Date: 9/8/25		
Direction Photo Taken: Northeast			
Description: <u>Location:</u> Road between BAP-2 and BAP-1. View of BAP-1.

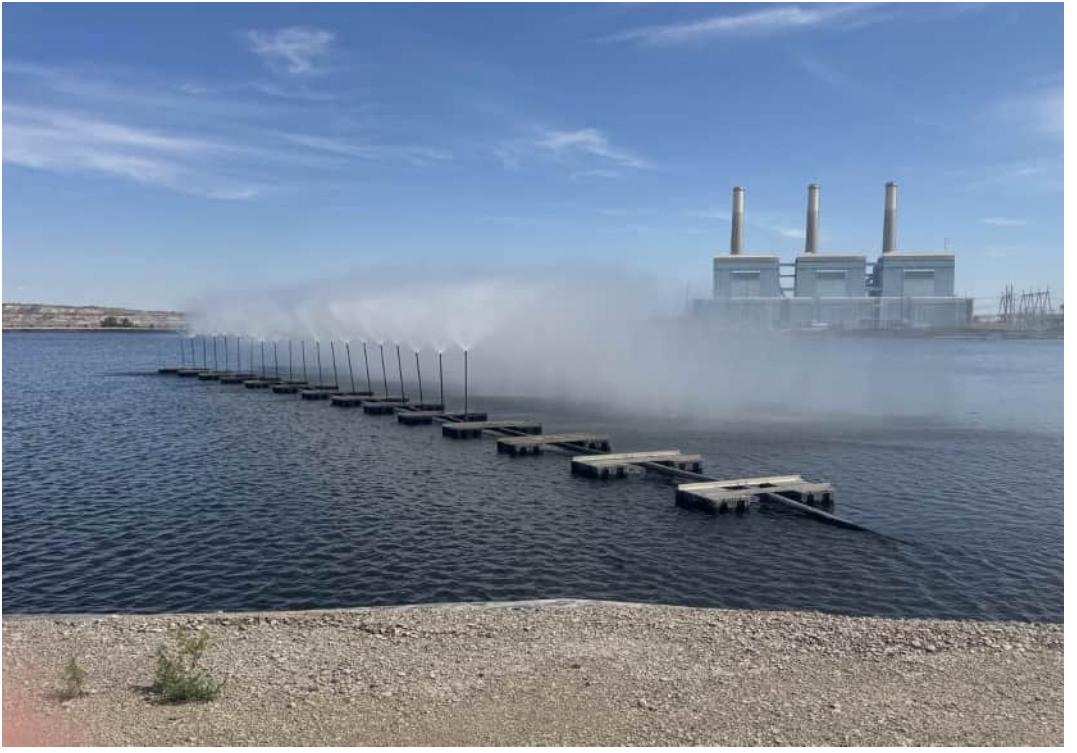
Client Name: Basin Electric Power Cooperative		Site Location: Laramie River Station, Wheatland, WY	Project No. 60732883
Photo No. 27	Date: 9/8/25

Direction Photo Taken:		East	
Description:		<p><u>Location:</u> Road between BAP-2 and BAP-1.</p> <p>Evaporators in BAP-1.</p>

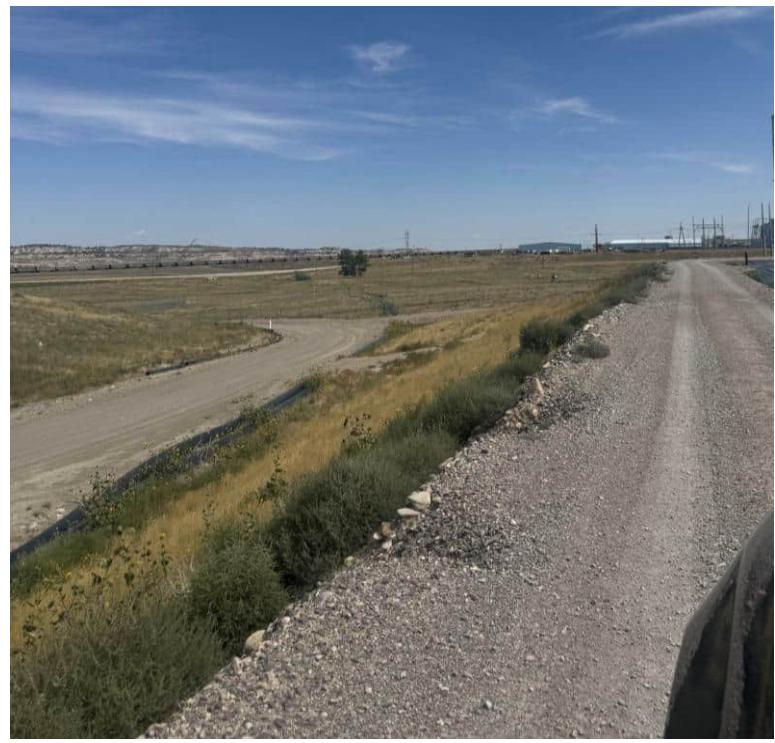
Client Name: Basin Electric Power Cooperative		Site Location: Laramie River Station, Wheatland, WY	Project No. 60732883
Photo No. 28	Date: 9/8/25

Direction Photo Taken:		East	
Description:		<p><u>Location:</u> Northern berm of BAP-1.</p> <p>Erosion along the edge of the roadway.</p>

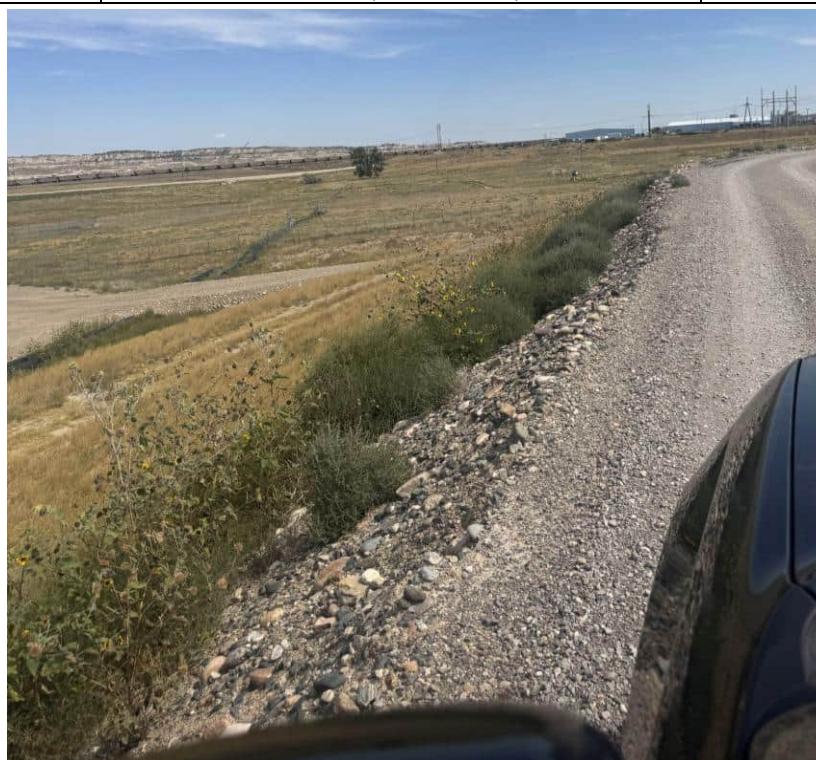
Client Name: Basin Electric Power Cooperative		Site Location: Laramie River Station, Wheatland, WY	Project No. 60732883
Photo No. 29	Date: 9/8/25		
Direction Photo Taken:

Description:		<p><u>Location:</u> Northern berm of BAP-1.</p> <p>Strong vegetation along berm.</p>
