Submitted by:
AECOM
Fort Collins, CO
60732883
January 2026

Basin Electric Power Cooperative Laramie River Station

Coal Combustion Residual Surface Impoundment Annual Inspection Report – 2025

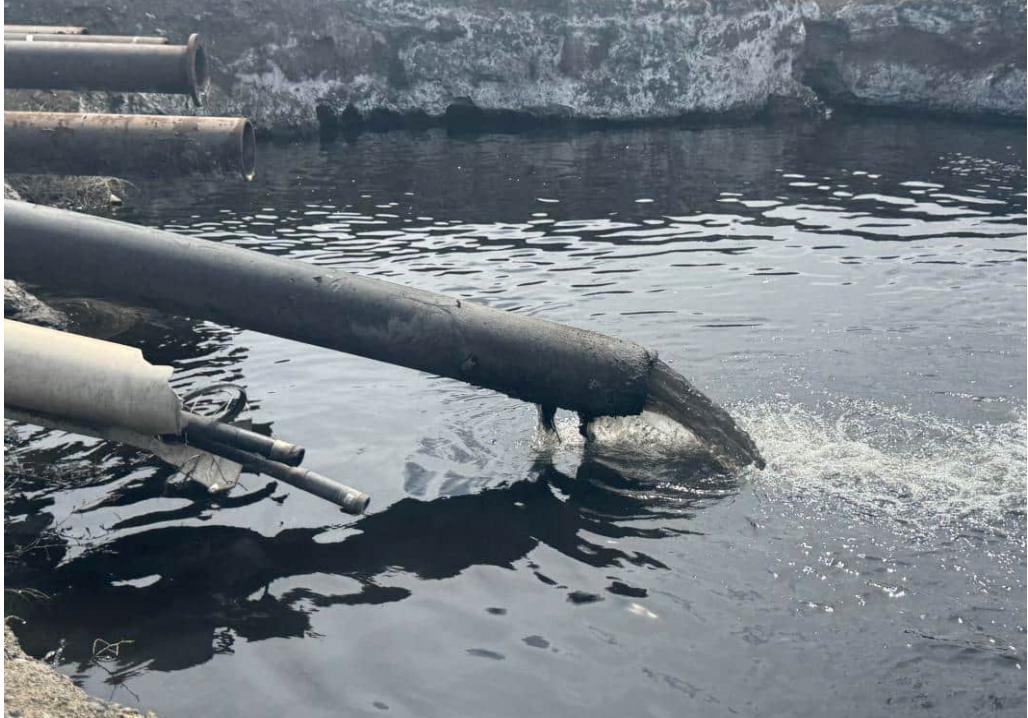
Client Name: Basin Electric Power Cooperative		Site Location: Laramie River Station, Wheatland, WY	Project No. 60732883
Photo No. 30	Date: 9/8/25		
Direction Photo Taken:

Description:		<p><u>Location:</u> Southeast corner of BAP-1.</p> <p>Outfall into BAP-1.</p>

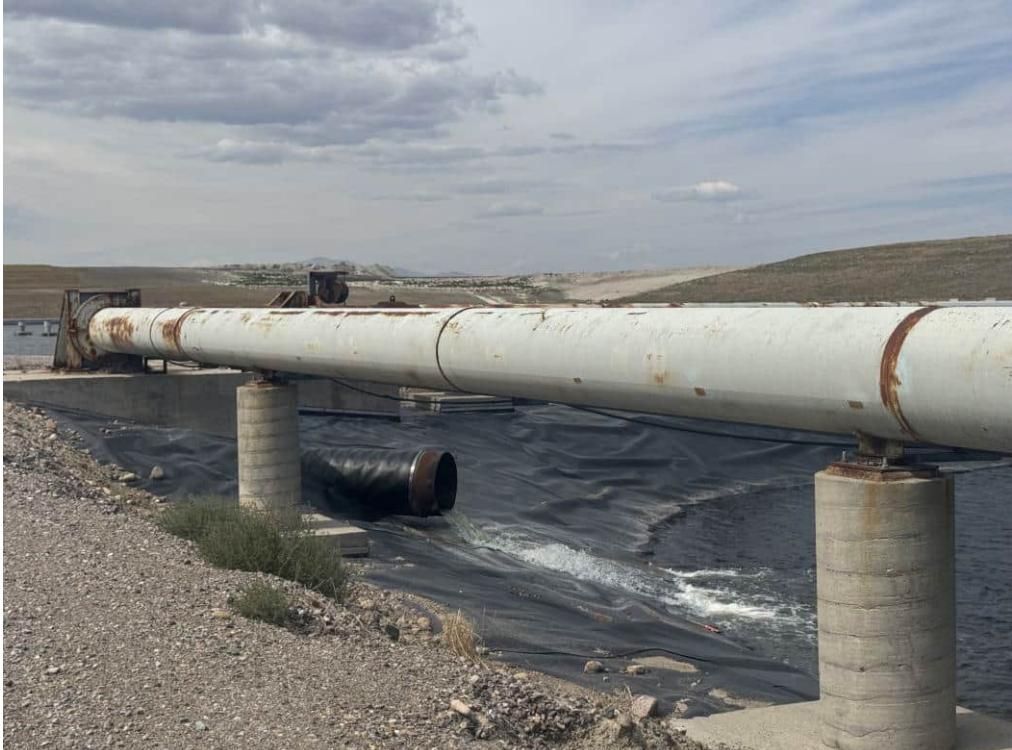
Client Name: Basin Electric Power Cooperative		Site Location: Laramie River Station, Wheatland, WY	Project No. 60732883
Photo No. 31	Date: 9/8/25

Direction Photo Taken: Northeast			
Description: <u>Location:</u> Southwest corner of BAP-1. Second outfall into BAP-1.

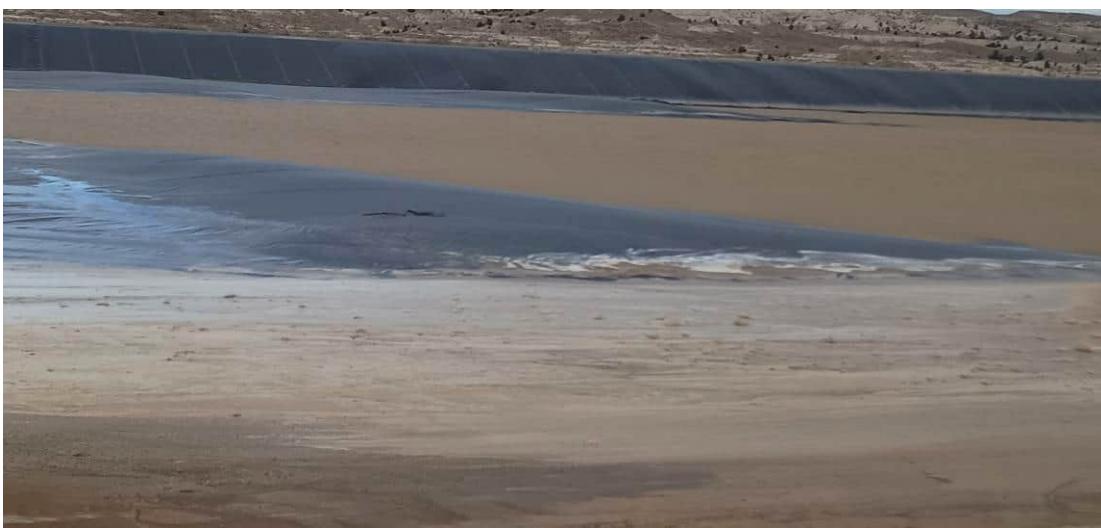
Client Name: Basin Electric Power Cooperative		Site Location: Laramie River Station, Wheatland, WY	Project No. 60732883
Photo No. 32	Date: 12/17/25

On December 17, 2025, LRS staff noted that a tear had occurred in the newly constructed liner on the bottom of the W-EHP due to high wind conditions. The tear of the liner was due to the recent extreme wind event and was approximately 5 to 10 feet (ft) in length. Upon closer inspection, there were also several smaller tears in close proximity to the larger tear that appeared to also be due to the wind event blowing debris onto the liner. The impoundment had been partially filled with liquid across the floor; however, the nearest fluid was 20 to 30 ft downslope of the tears so fluid entering the tears was not a concern and did not occur. The impoundment was immediately taken out of service and was repaired three days later, on December 20, 2025, before being returned to service.

Direction Photo Taken: Northeast			
Description: <u>Location:</u> Floor of W-EHP. A tear approximately 5 to 10 feet in length, which appeared to be in the seam of the liner due to high winds. It was repaired three days later.

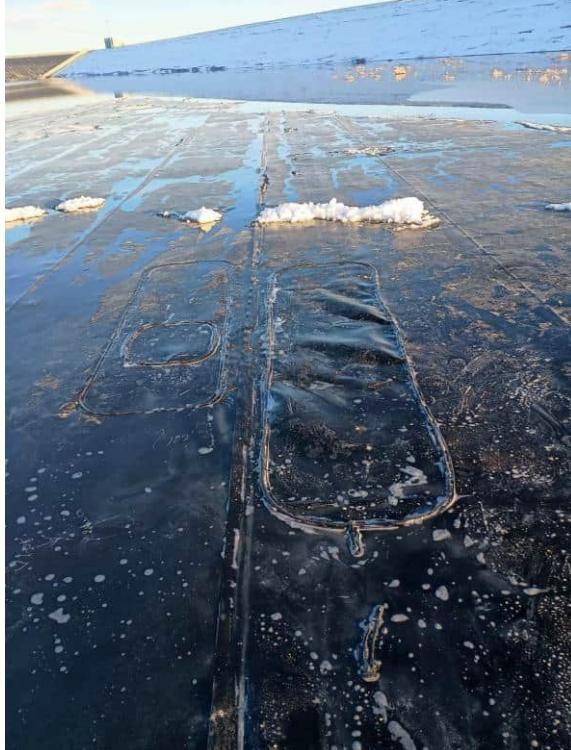
Client Name: Basin Electric Power Cooperative		Site Location: Laramie River Station, Wheatland, WY	Project No. 60732883
Photo No. 33	Date: 12/22/25

Direction Photo Taken: Birds-eye view			
Description: <p><u>Location:</u> Floor of W-EHP.</p> <p>The repaired tear as described above. There were also smaller tears in the area which were repaired.</p>

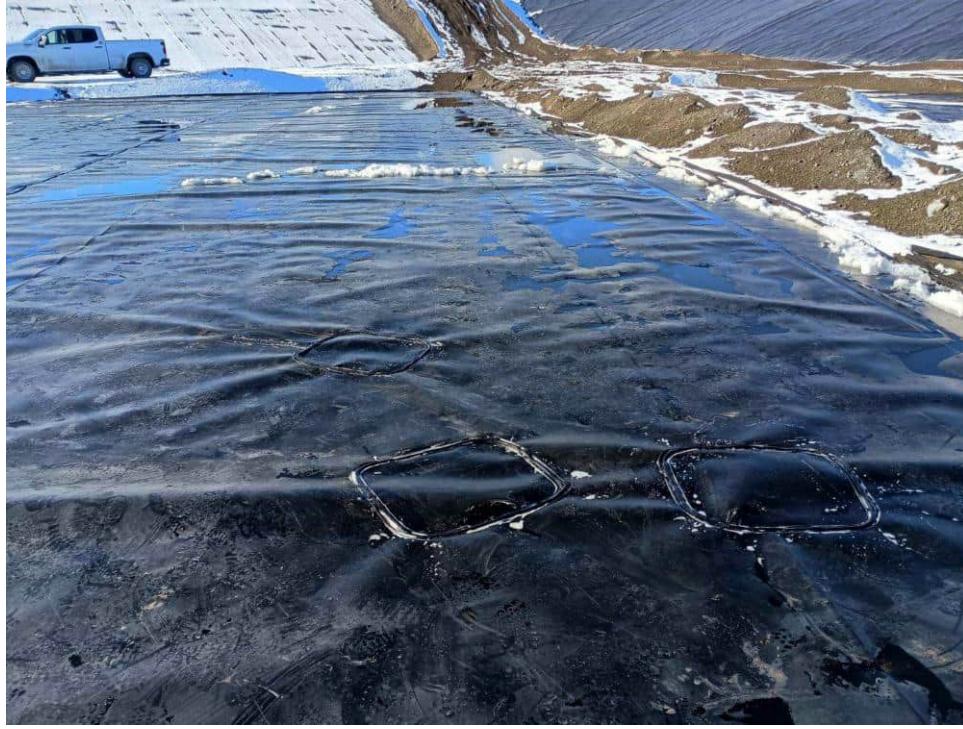
Client Name: Basin Electric Power Cooperative		Site Location: Laramie River Station, Wheatland, WY	Project No. 60732883
Photo No. 34	Date: 12/22/25

Direction Photo Taken: North			
Description: <p><u>Location:</u> Floor of W-EHP.</p> <p>A closeup of the smaller tears which were repaired.</p>
