## 2026 Annual Landfill Inspection

*William J. Neal Station Legacy Surface Impoundment*

Prepared for  
Basin Electric Power Cooperative

Prepared by  
Barr Engineering Co.

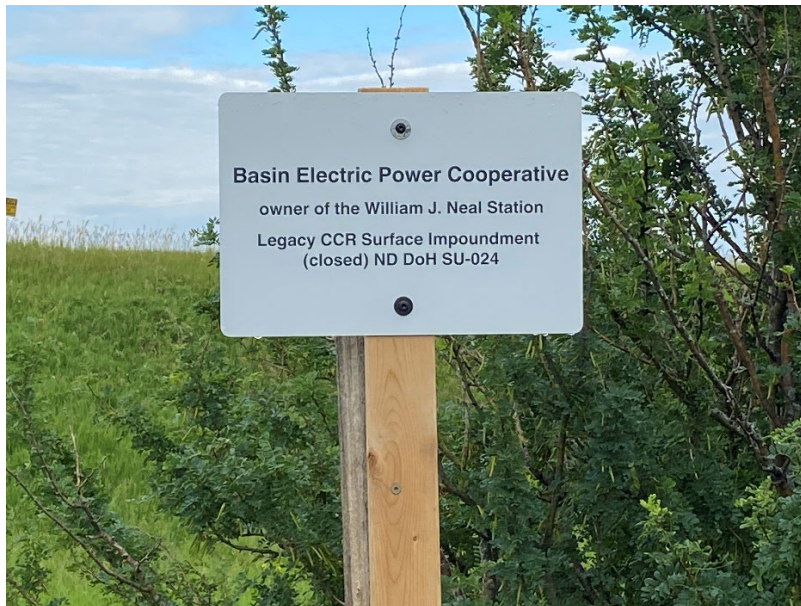
**Subject:** Sign at entrance to site

**Comments:** Sign appears consistent with Legacy Rule requirements.

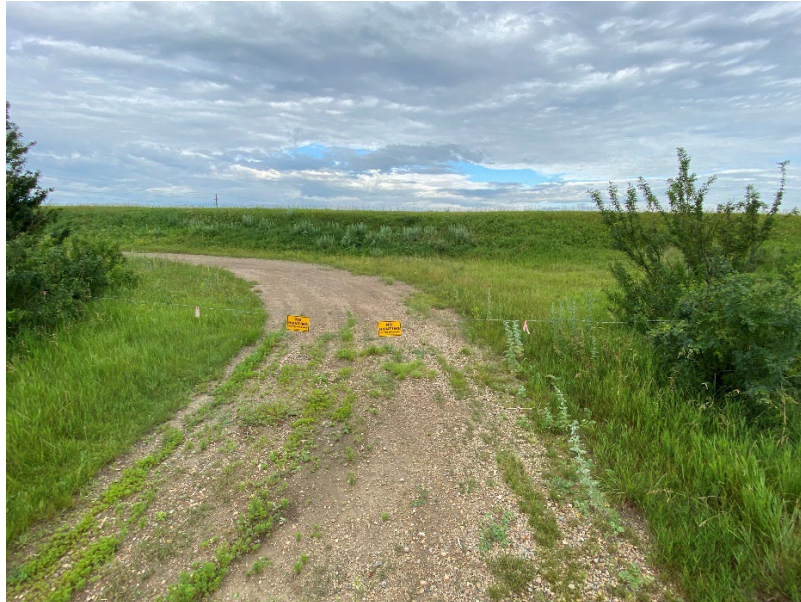
**Subject:** Access road, example of signage and chain gate

**Comments:** Access to site is controlled by a locked gate, fences, multiple signs along perimeter and natural barriers (shelterbelt).

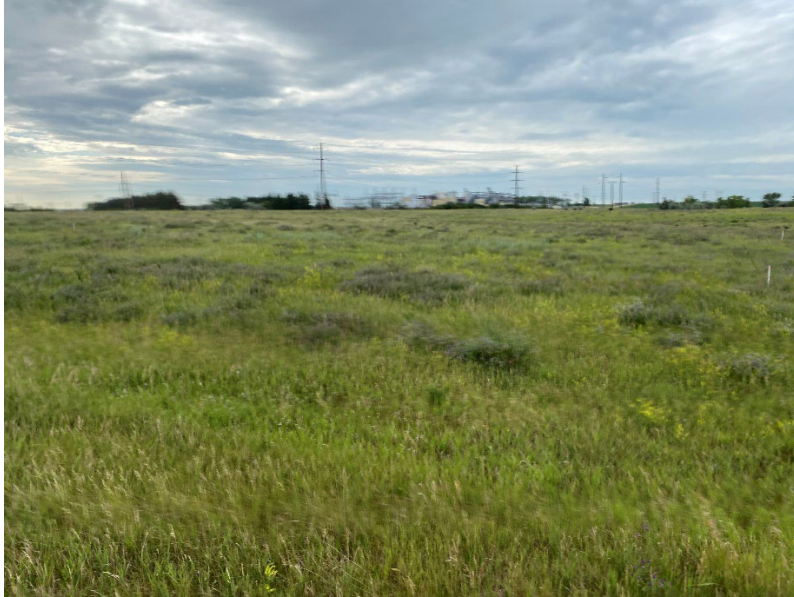
**Subject:** View to southeast across cover system, piezometers (white) in distance

**Comments:** Vegetation on cover system is uniform and thick, showing no evidence of erosion.

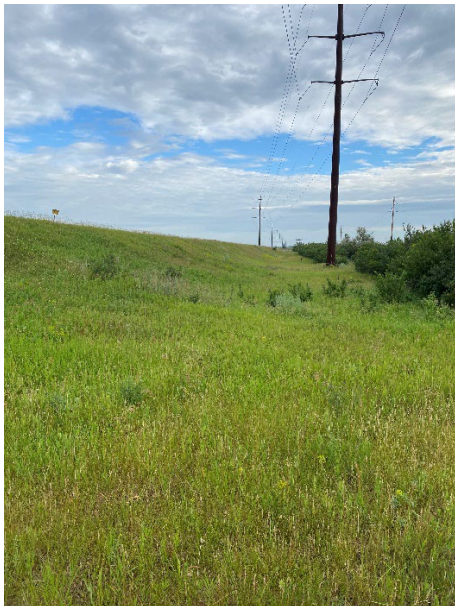
**Subject:** East perimeter embankment – view to north

**Comments:** Embankment is well-vegetated and shows no signs of erosion or instability.
