Submitted by:  
AECOM  
Fort Collins, CO  
60635022  
January 17, 2024

# Basin Electric Power Cooperative Antelope Valley Station

## Coal Combustion Residual Landfill Annual Inspection Report – 2023

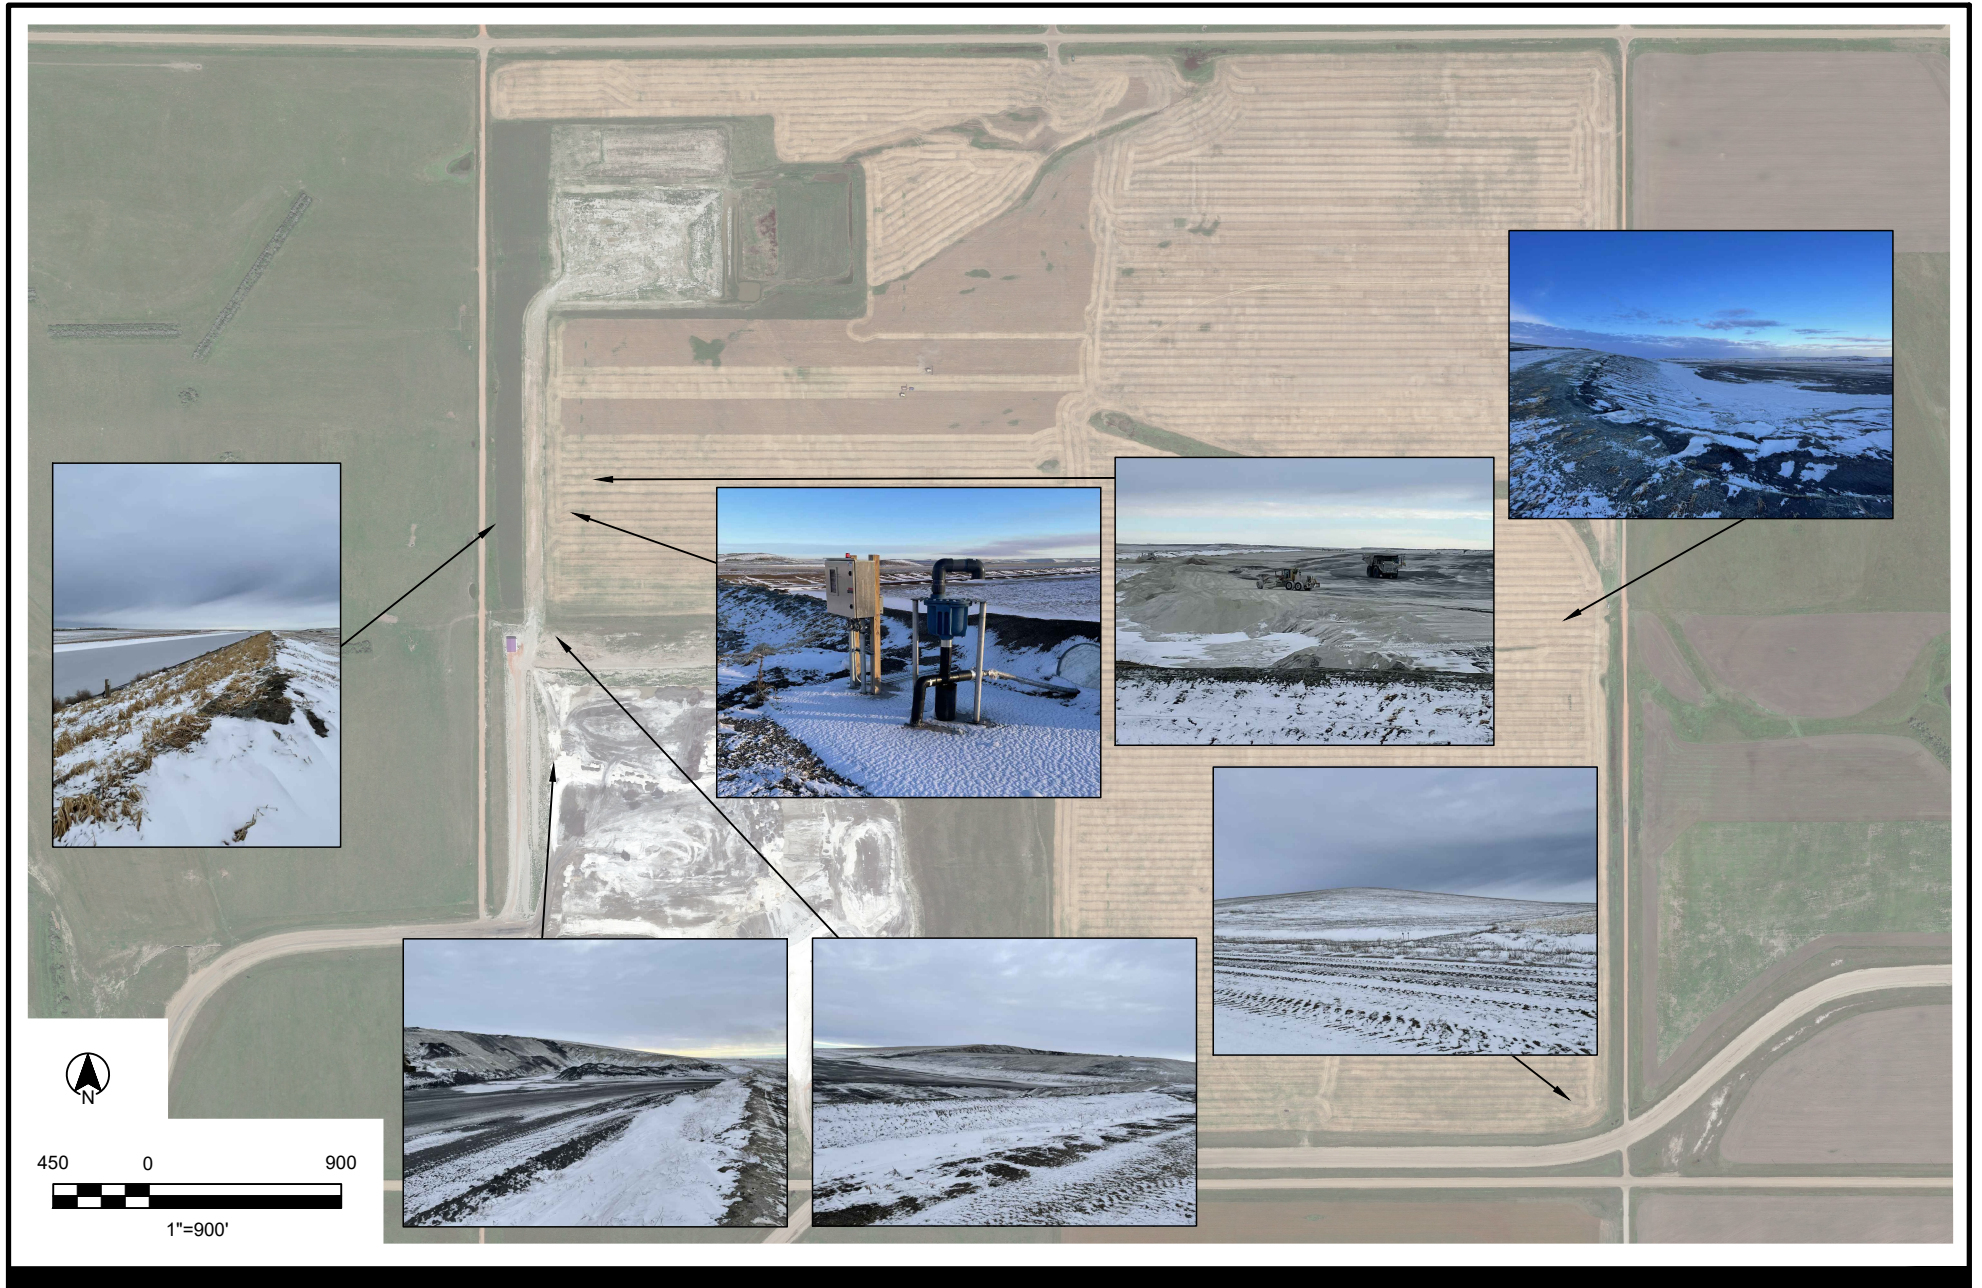
<b>Client Name:</b> Basin Electric Power Cooperative		<b>Site Location:</b> Antelope Valley Station, Beulah, ND	<b>Project No.:</b> 60635022
<b>Photo No.</b> <b>1</b>	<b>Date:</b> 12/12/23	 	
<b>Direction Photo Taken:</b>  Southeast			
<b>Description:</b>  <u>Location:</u> See Figure.  New landfill cell in the foreground with existing landfill cell in the background
