# Emergency Action Plan

Laramie River Station Owned by Missouri Basin Power  
Project Operated by Basin Electric Power Cooperative  
Wheatland, Wyoming

AECOM Project Number: 60704138  
September 20, 2023

**CCR Units:** Basin Electric Power Cooperative; Laramie River Station; Bottom Ash Ponds 1, 2, & 3; East and West Emergency Holding Ponds

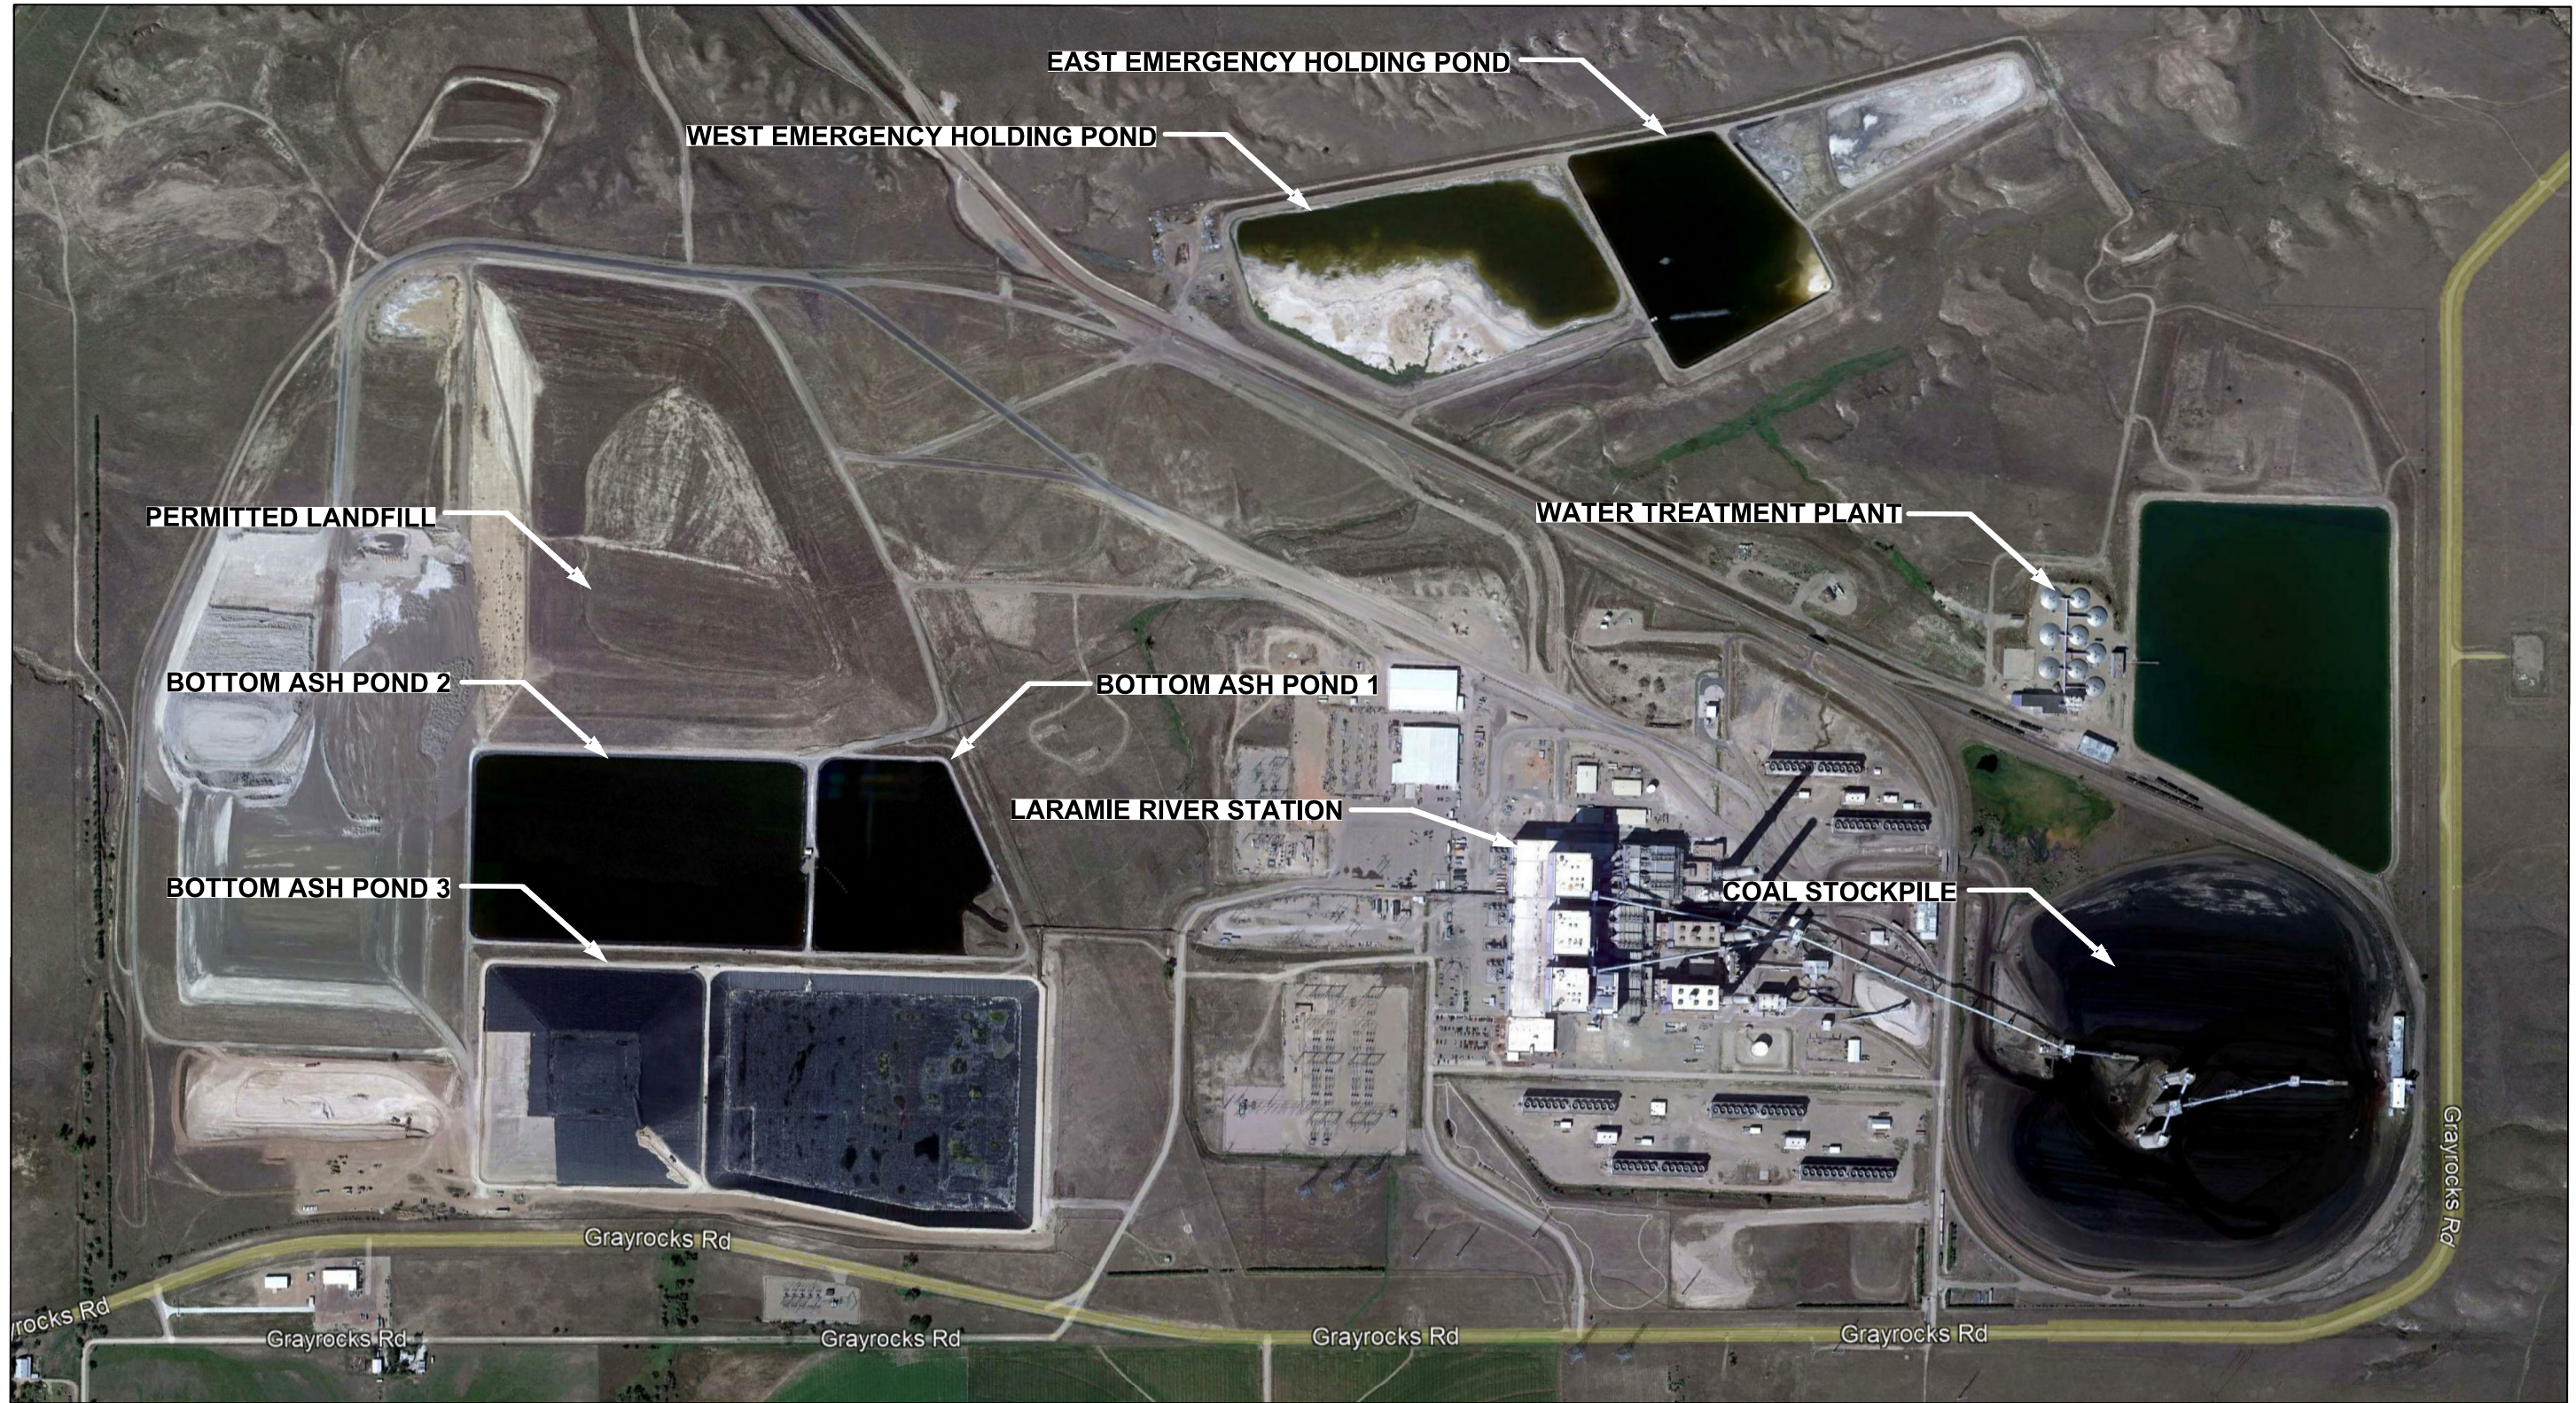
FIGURE 1

ADJACENT PROPERTY OWNERS MAP  
LARAMIE RIVER STATION  
EMERGENCY ACTION PLAN  
BASIN ELECTRIC POWER COOPERATIVE

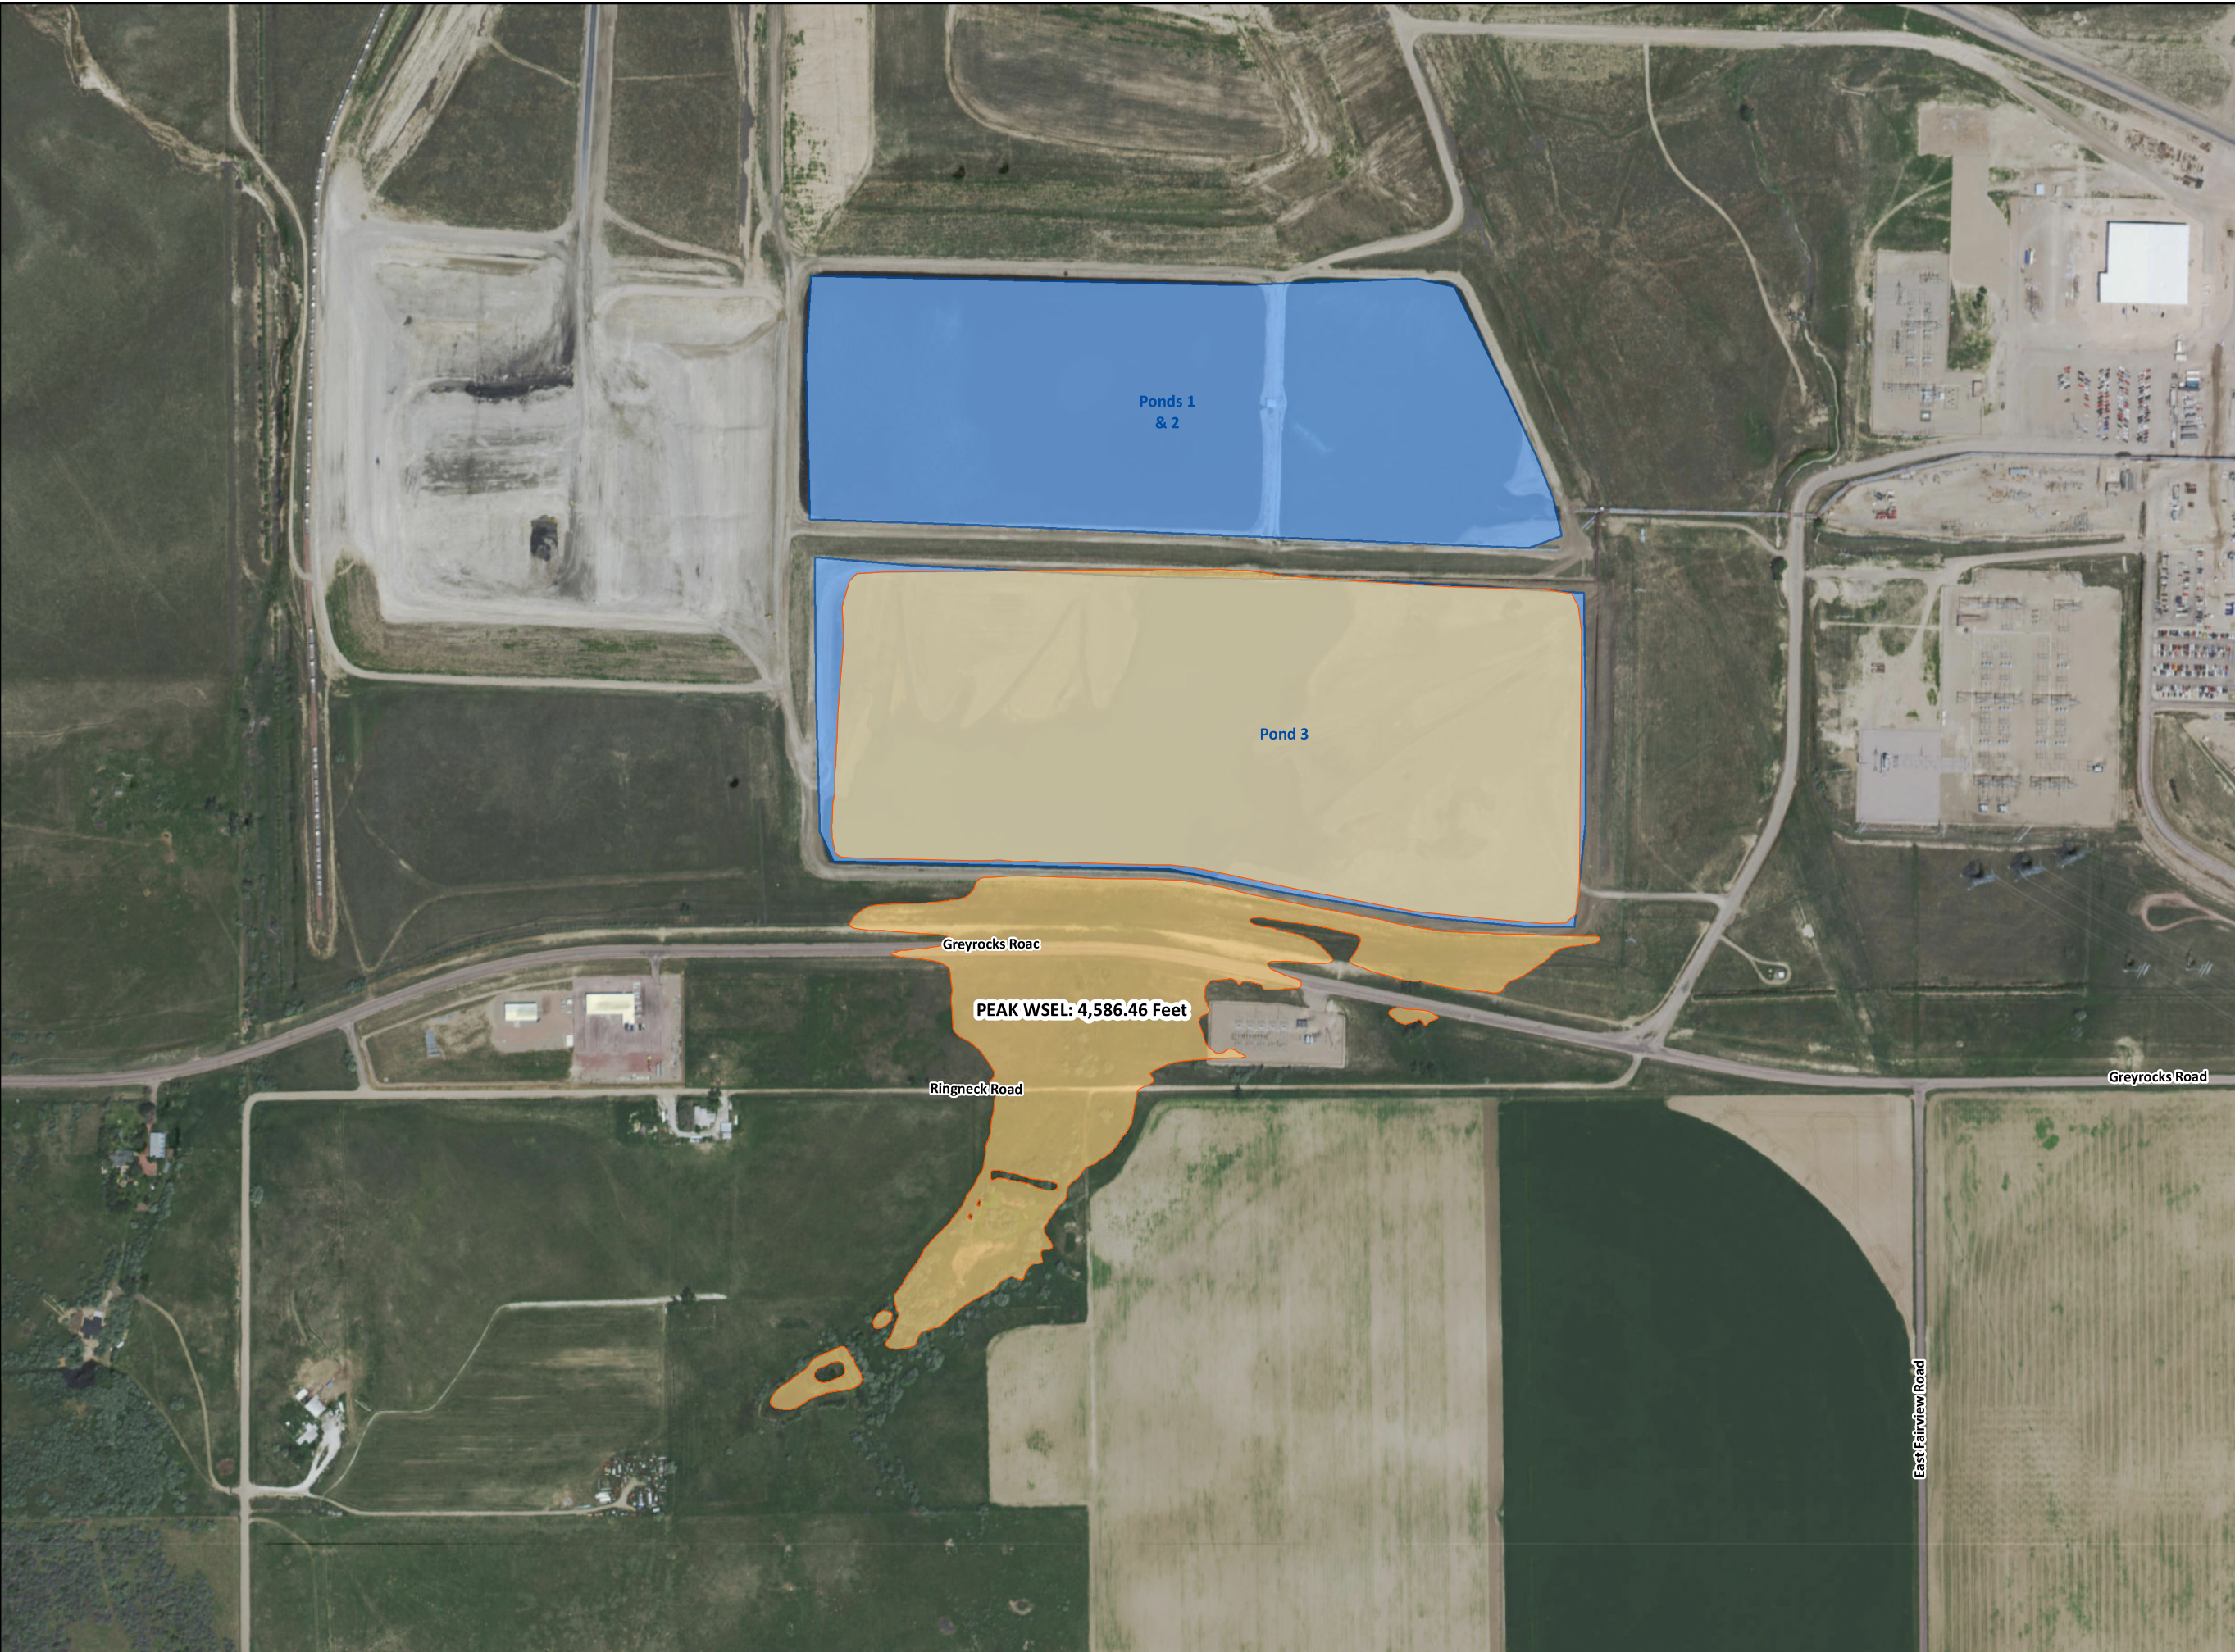
APPENDIX  
A.5

BOTTOM ASH POND 3 SOUTH

8.5 MILES DOWNSTREAM OF BREACH	
TIME OF ARRIVAL (HOURS)	2.6
TIME TO PEAK (HOURS)	4.6
MAX ELEVATION (FEET)	4,427.0
INCREMENTAL RISE (FEET)	1.6
PEAK FLOW (CFS)	9,167

0.2 MILES DOWNSTREAM OF BREACH	
TIME OF ARRIVAL (HOURS)	0.1
TIME TO PEAK (HOURS)	1.0
MAX ELEVATION (FEET)	4,571.3
INCREMENTAL RISE (FEET)	10.6
PEAK FLOW (CFS)	15,479

AECOM prepared a hazard potential classification assessment in March 2016 for each of the five (5) CCR surface impoundments. Significant upstream and downstream features which could be affected by a failure are included on the Hydraulic Shadow Maps included in **Appendix A**.

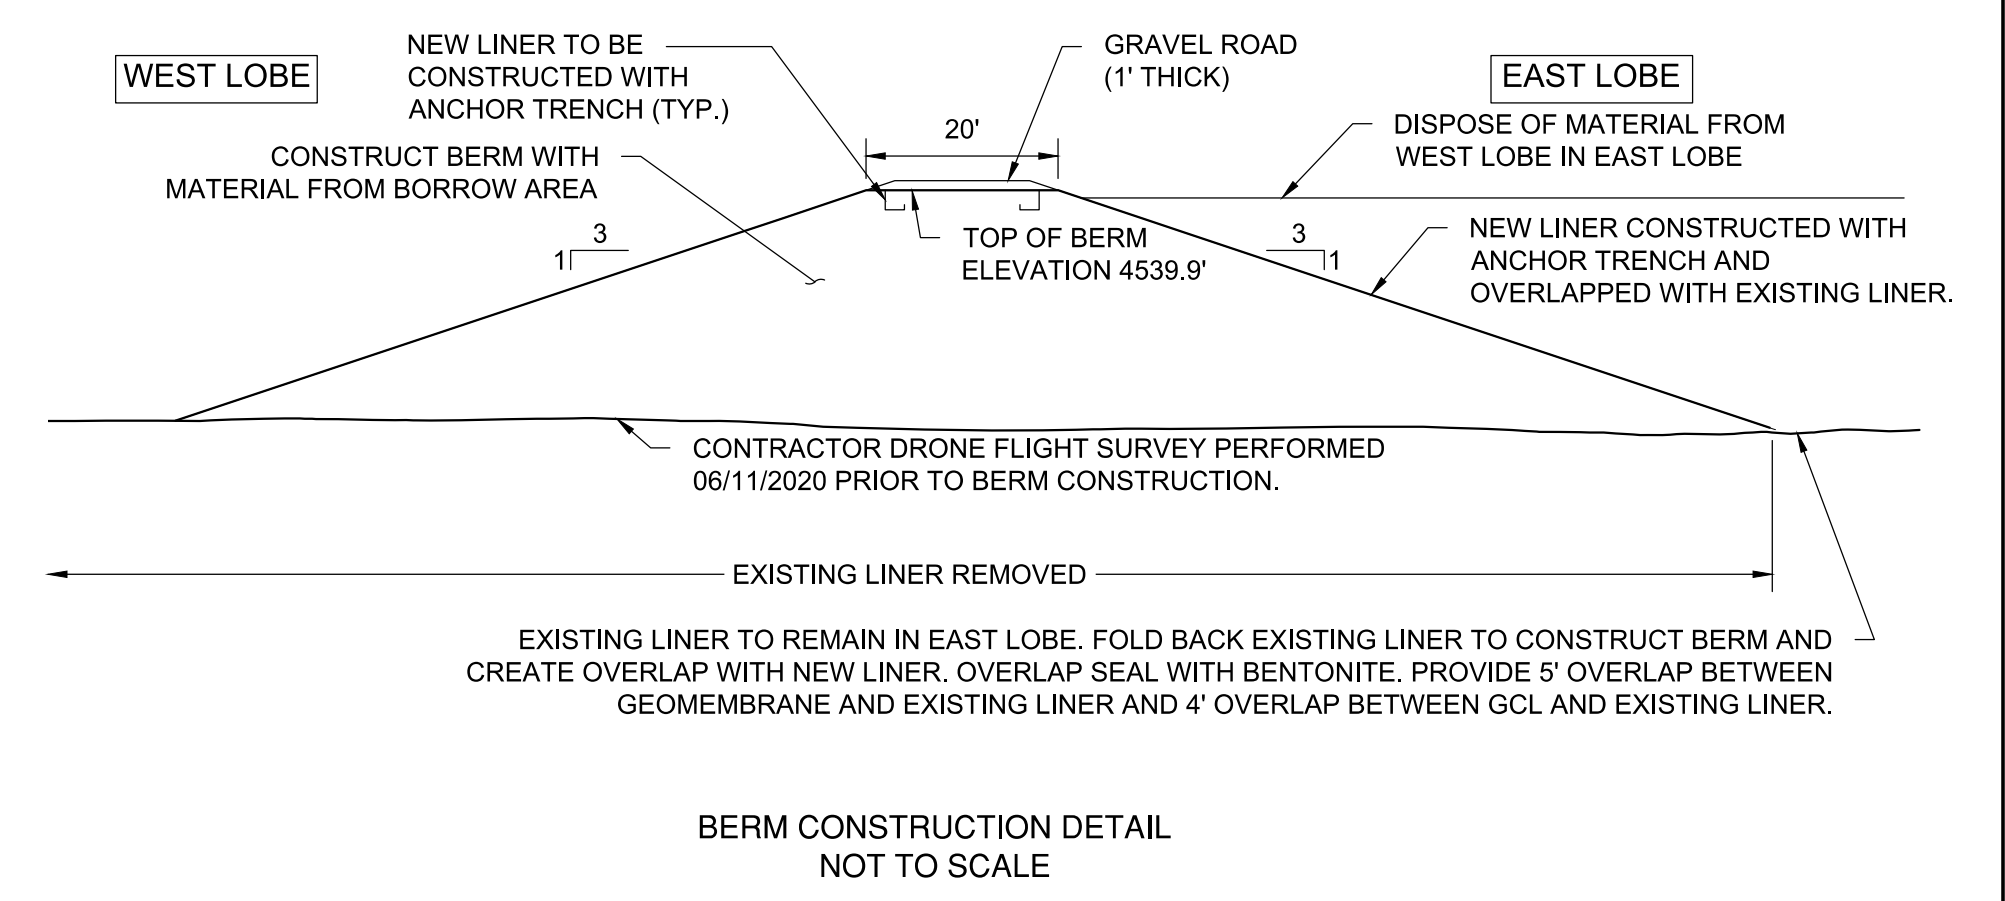
- NOTES:**
- DRAWING IS IN THE PLANT GRID COORDINATE SYSTEM
  - GROUND & BATHYMETRIC SURVEY FROM 06/13/18 WAS PROVIDED TO AECOM BY BASIN ELECTRIC.
  - EXISTING UTILITIES SHOWN ARE INDICATED IN ACCORDANCE WITH AVAILABLE RECORDS. OTHER UTILITIES MAY BE PRESENT. THE CONTRACTOR IS RESPONSIBLE FOR OBTAINING EXACT LOCATIONS AND ELEVATIONS OF ALL UTILITIES. ALL UTILITY OWNERS SHALL BE NOTIFIED 2 FULL BUSINESS DAYS IN ADVANCE OF GROUND DISTURBANCE.
  - GRADES SHOWN ON THIS SHEET DEPICT THE PRE-CONSTRUCTION EXISTING TOP OF SEDIMENT GRADE LINES AND THE AS RECORD SURFACE IN THE WEST AND EAST LOBES.
  - AS RECORD SURVEY WAS PERFORMED ON 08/03/21 BY CONTRACTOR. SUPPLEMENTAL SURVEY WAS PERFORMED BY CLIENT ON 06/08/21.
  - THE GRAVEL ROAD WAS RESTORED IN 2021 AROUND THE POND TO THE GRADES SHOWN ON THE DRAWING, AS SURVEYED ON 06/08/21.

THESE RECORD DRAWINGS SHOW THE WORK COMPLETED DURING CONSTRUCTION. THE DRAWINGS ARE BASED ON RECORD SURVEY DATA FURNISHED BY THE CONTRACTOR AND SUPPLEMENTED BY THE OWNER. INFORMATION NOT RECORDED WAS ASSUMED TO HAVE NO CHANGE FROM DESIGN. ACTUAL CONDITIONS MAY VARY. FIELD VERIFY ELEVATION AND LOCATION PRIOR TO OTHER WORK.
