# Frost bit

*Cooperatives rebuild in wake of ice storm*

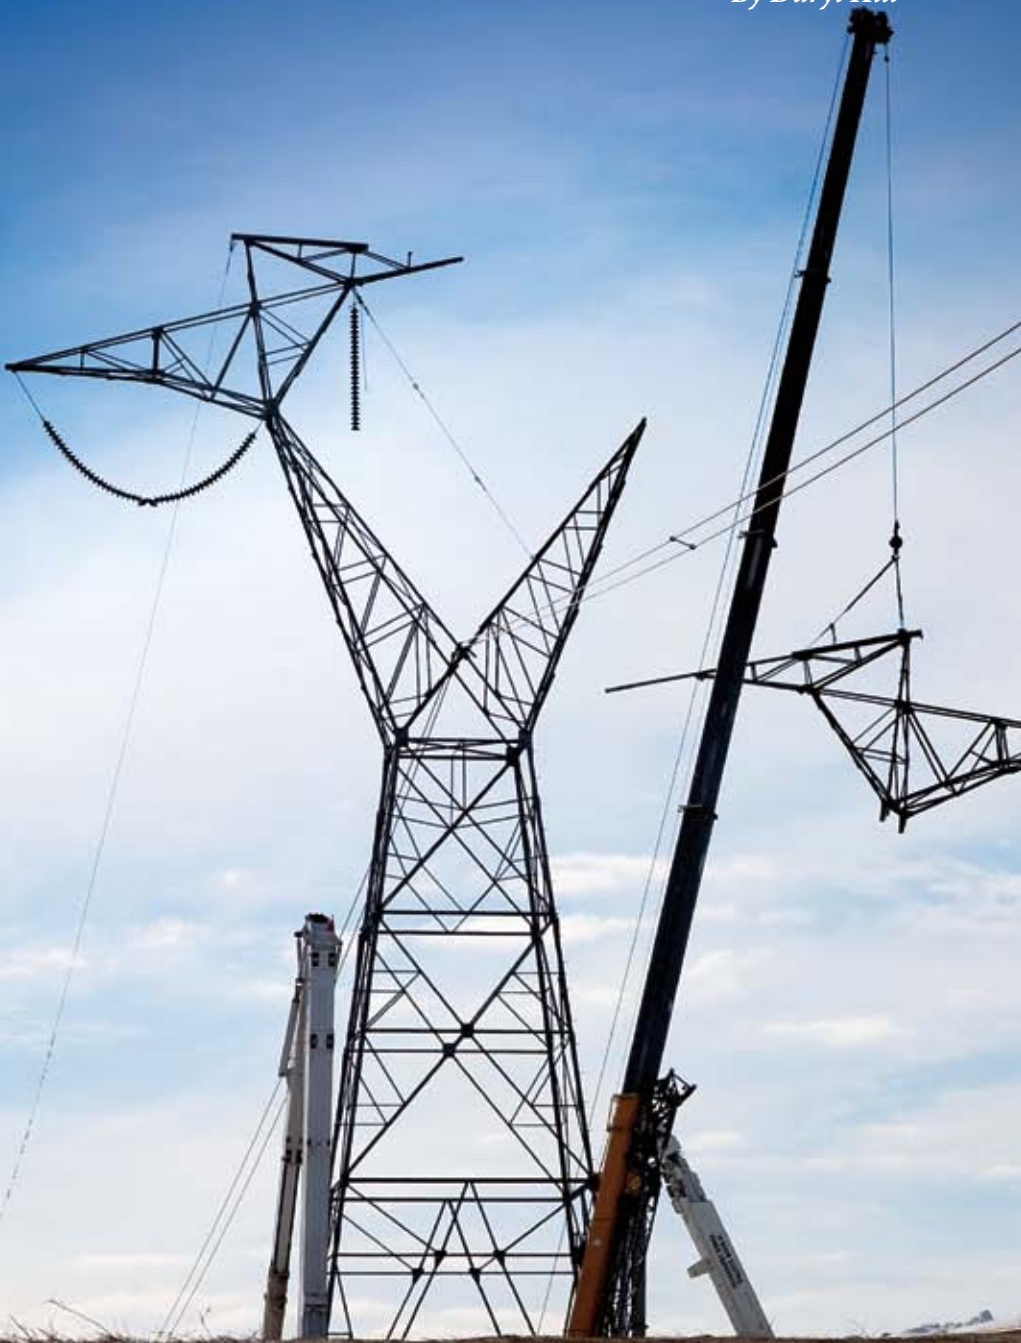
Basin Electric TSM crews employ Condor and Bronto bucket trucks and a Grove crane to replace a damaged arm.

The morning of Friday, Jan. 22, Bryan Keller, manager of Transmission System Maintenance (TSM) for Basin Electric, reported the 345-kilovolt transmission line from the Antelope Valley Station near Beulah, ND, to the Broadland substation near Huron, SD, had tripped out a few times already, but seemed to stabilize late that afternoon. He soon discovered that was only a false sense of security. The 299-mile transmission line tripped out of service Saturday morning and couldn't be re-energized.

“Our line crews from Groton and Gettysburg in South Dakota were reporting heavy frost and ice buildup on the bundled conductors and static wires,” Keller says. “With the data from our substation fault locator, we suspected the line had permanently faulted near Bowdle (SD).” He was right. Eight towers were damaged and about five miles of static wire were in disarray.

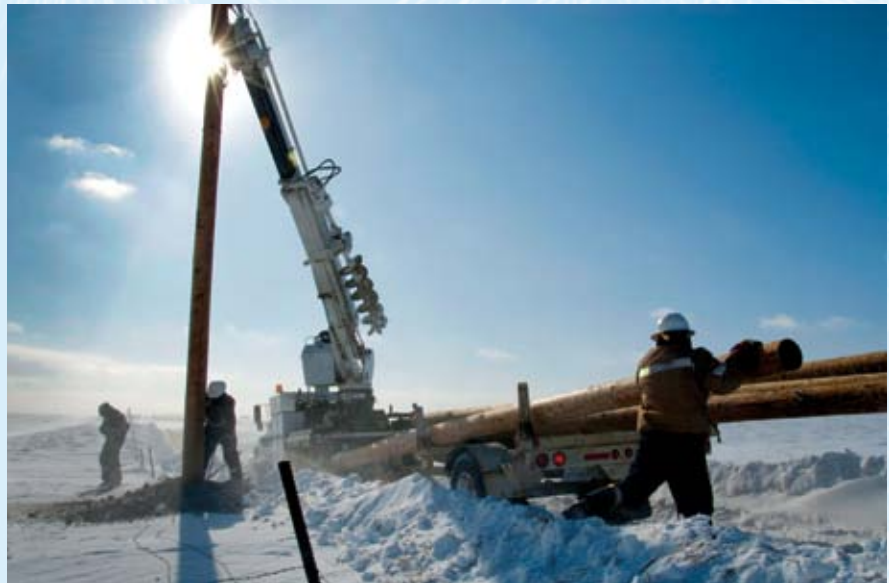
Crews from Cass County Electric Cooperative, Fargo, ND, assist KEM Electric in replacing poles. (Photo by J.C. Balcom of the North Dakota Association of Rural Electric Cooperatives.)

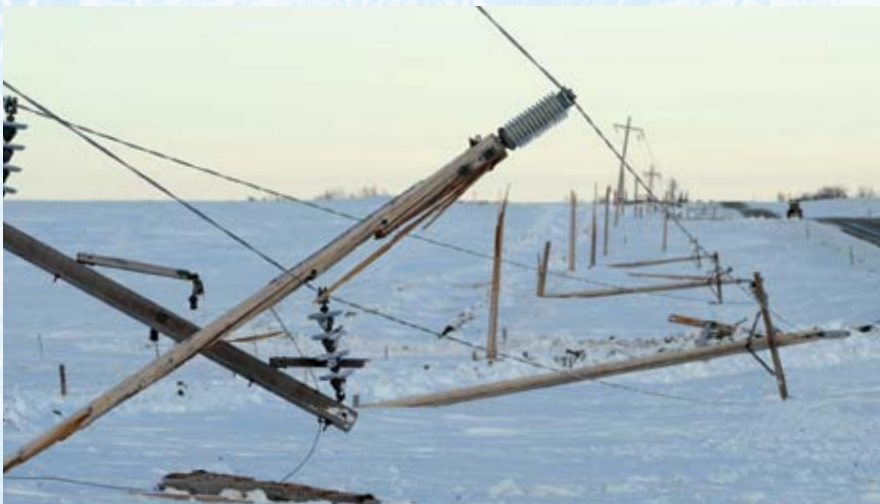
**Moreau-Grand Electric Cooperative estimated the weight the ice added to their lines approached 1,200 pounds per 250-foot span. (Photo by Michelle Schweitzer of Moreau-Grand.)**

The frost buildup followed by the freezing rain caused conductors to sag, placing a tremendous amount of strain on the poles, cross arms and insulators struggling to hold them in place. When the wind came up on Sunday, it caused the conductors to “gallop” – a condition similar to the movement of a jump rope. That caused everything to break loose – quite literally.

The weight of the ice, coupled with the windy conditions, was a disastrous combination for rural electric cooperatives in North Dakota and South Dakota as lines snapped from wind-driven galloping wires, and poles toppled, unable to support the added weight of the iced-up conductors.

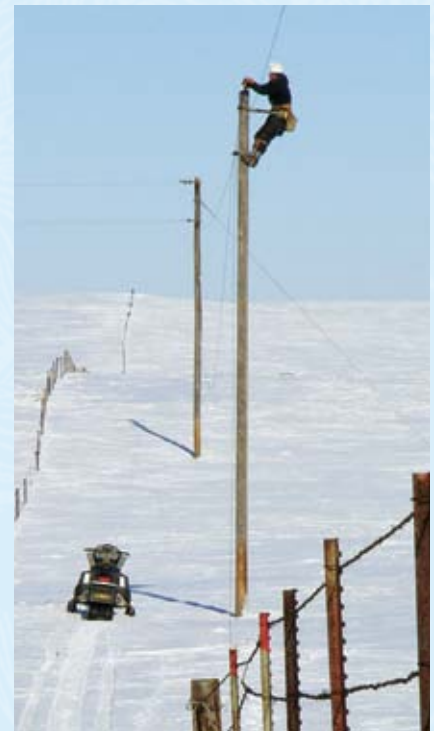
**Mor-Gran-Sou lost 1,000 poles in the storm. (Photo by Clarice Kesler of the North Dakota Association of Rural Electric Cooperatives.)**

At Mor-Gran-Sou, Franklund says 1,000 poles were snapped, and at the height of the storm, 6,000 of the cooperative's 7,500 consumers were without electricity.

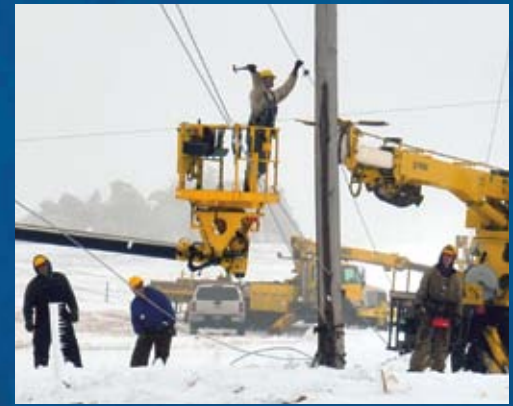
Corn Belt Power crews knock ice off power lines southeast of Sac City on Jan. 22. (Photo by Marena Fritzier of Corn Belt Power.)

At Corn Belt Power Cooperative of Humboldt, their transmission system was hit hard. “The ice load was far greater than what the line was designed for,” explains Kevin Bornhoft, vice president, engineering and system operations at Corn Belt Power. “It’s designed for a half-inch of radial ice. We had close to two inches plus of radial ice.”

System restoration required Corn Belt Power linemen to use hot sticks to knock ice off power lines. By Jan. 25, Corn Belt Power’s system was back to normal, but member distribution cooperatives’ work continued.
